MEASUREMENT THE THERMAL PROFILE OF STEELMAKING LADLE WITH SUBSEQUENT EVALUATION THE REASONS OF LINING DAMAGE

Based on the operational measurement, of which content was to determine ladle thermal profile, there were analysed causes of possible damage of lining in steel ladles by steel breakout through the ladle shell. There exists connection between thermal state of ladle lining during the operation and its lifetime. There were reached to the conclusion that the cause of failure in the lining of ladle is except for high temperature of bath, also wide interval of temperature change during the tap operation, in consequence with possible insufficient pre-heating of ladle, discontinuous operation of aggregate and damage of insulating lining layer, respectively deformation of ladles shell.

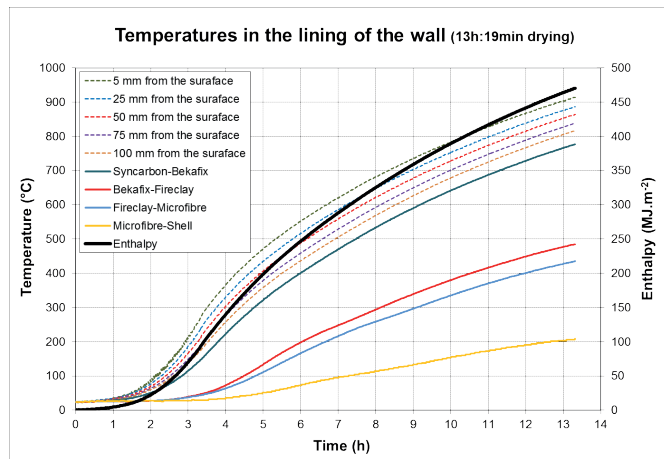
Temperature course of ladle lining was plotted into a several graphs. In Fig. 1, there are presented temperatures inside of lining during the drying process of ladle lining before the 1st tapping. Fig. 2 shows detailed view of the 1st melting.

Fig. 1. Temperatures inside the ladle lining during the drying process

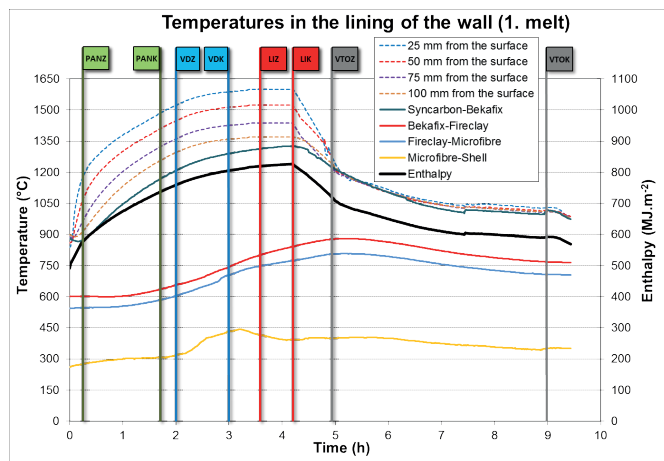
Fig. 2. Detailed view on 1st melt

Explanation of particular abbreviations from Fig. 2:

- PANZ (PANK) - start (end) of steel processing in ladle furnace
- VDZ (VDK) - start (end) of steel processing in cofferdam
- LIZ (LIK) - start (end) of casting
- VTOZ (VTOK) - start (end) of ladle high-temperature heating

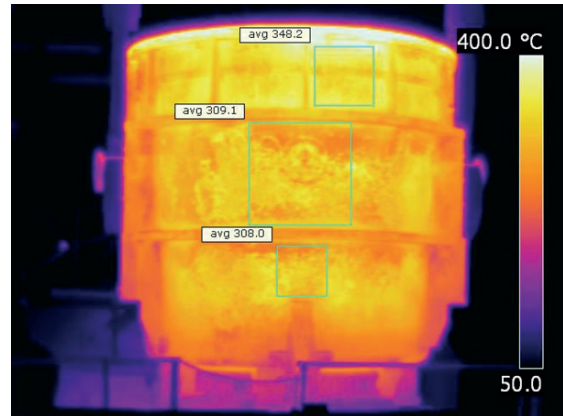
the tap age. Measurement by thermovision camera was focused on evaluation the shells temperature in dependence on ladle working time.

Fig. 3 presents thermovision view to ladle immediately after its taking out of the vacuum station cofferdam.

Fig. 3. Thermovision view of ladle
