A. KAJZER*#, M. ANTONOWICZ*, B. ZIĘBOWICZ**

STUDIES OF THE CORROSION RESISTANCE PROPERTIES OF BONE SCREWS MADE FROM 316L STAINLESS STEEL IN RINGER'S SOLUTION

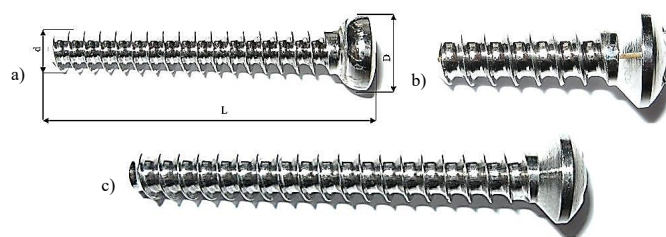
- Group I – four screws (1_1, 1_2, 1_3, 1_4) implanted into small bones for three months, with outer thread diameter $d = 3.5$ mm and screw length $L = 26$ mm (Fig. 1a)
- Group II – four screws (2_1, 2_2, 2_3, 2_4), implanted in cortical bone for six months, with outer thread diameter $d = 4.5$ mm, and screw length $L = 18$ mm (Fig. 1b)
- Group III – four screws (3_1, 3_2, 3_3, 3_4), intended for cortical bone but never implanted because of signs of visible mechanical damage and other production defects, with outer thread diameter $d = 4.5$ mm and screw length $L = 40$ mm (Fig. 1c).

Fig. 1. Examples of bone screws from each tested group: a) I, b) II, c) III [30]

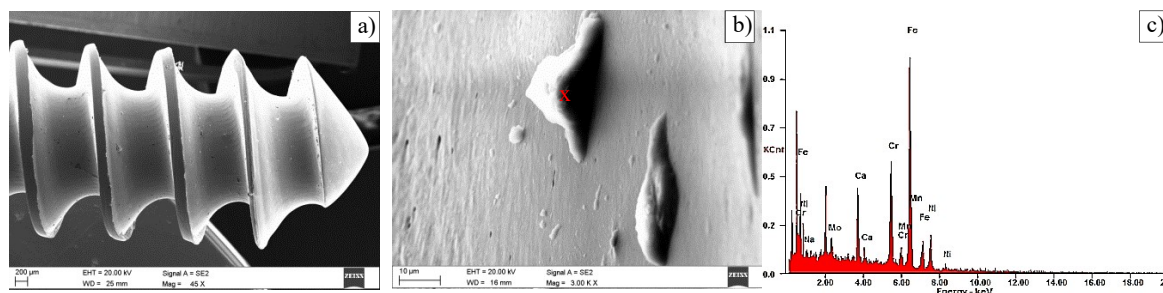
Macroscopic observations of screws implanted in the body for three months (Group I) showed visible cracks and damage to the screws and to the screw heads at the point of the contact with the plates and in the area of the screw sockets. This damage probably resulted from the implantation procedure and/or during removal of the screws due to the impact of surgical instruments or fitting of the stabilization system into the patient's bone. In Group I screws, signs of corrosion and mechanical damage were observed on following parts of the implants:

- on the surface of the screws under the head at the point of contact with the plate of the thread visible,
- the distortion of the thread contour on the whole length of the screw.

On the basis of observations carried out with the use of the SEM images, various degrees of clear distortion were noticed. On the screws from Group I and II, the thread contour deformation, jagged and irregular surfaces were observed. Considerable wear of the front surface was also observed for the screws from Groups I and II. The screws from Group III were characterized both by defects on the surface and the unfinished ending of the screw. The above mentioned defects might have been caused by wrong machining parameters applied during finishing process. An approximate analysis of the chemical composition of the surface of the screws after implantation showed the presence of calcium on the screws from Groups I (example Fig. 3c) and II, which confirms the use of these implants in the patient's body. Whereas the chemical elements, such as Cr, Ni, Mo confirm the application of corrosion resistant steel type 316L. The chemical analysis was not carried out for the screws from Group III because of economic reasons. The SEM results are shown in Figs. 3-5.

Fig. 3. Results of SEM test for Group I bone screws: a) irregular thread contour and mechanical damage to the surface of the screw, mag. 45×, b) a single molecule of calcium, the residue of bone of the patient, mag. 3000×, c) EDS spectrum of the elemental composition

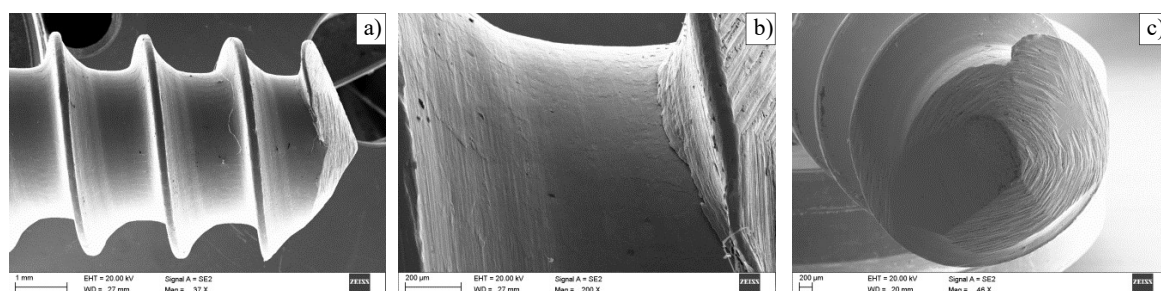
In Group II, we observed minor visible mechanical damage to the thread around the screw head, considerable damage to the end face of the screw, but no signs of corrosion. In Group III (non-implanted screws) we observed many small decrements and defects, distributed over the entire length of the screws (Fig. 2).

Fig. 4. Results of SEM test for Group II bone screws: a) thread contour is regular, visible minor damage, mag. 37×, b) the surface of the screw with a small number of calcium molecules, mag. 200×, c) Visible considerable wear of screw front surface, mag. 46×

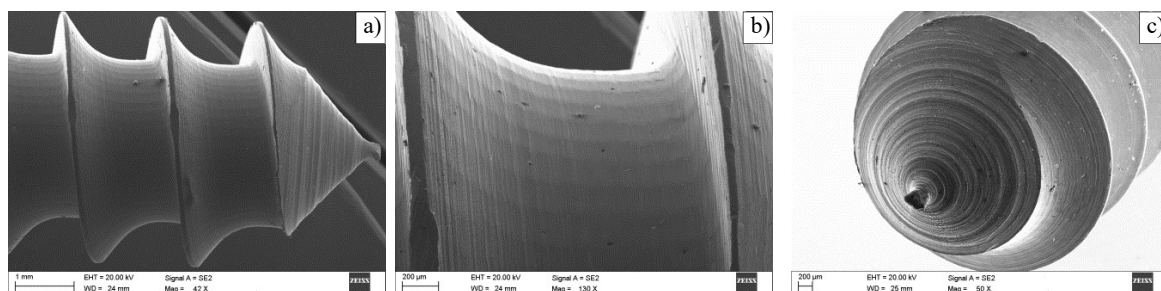
Fig. 5. Results of SEM test for Group III screws: a, c) an outline of the irregular thread contour, visible poorly finished tip, mag. 42× and 500×, respectively, b) surface coated with precipitates and visible decrements, mag. 130×

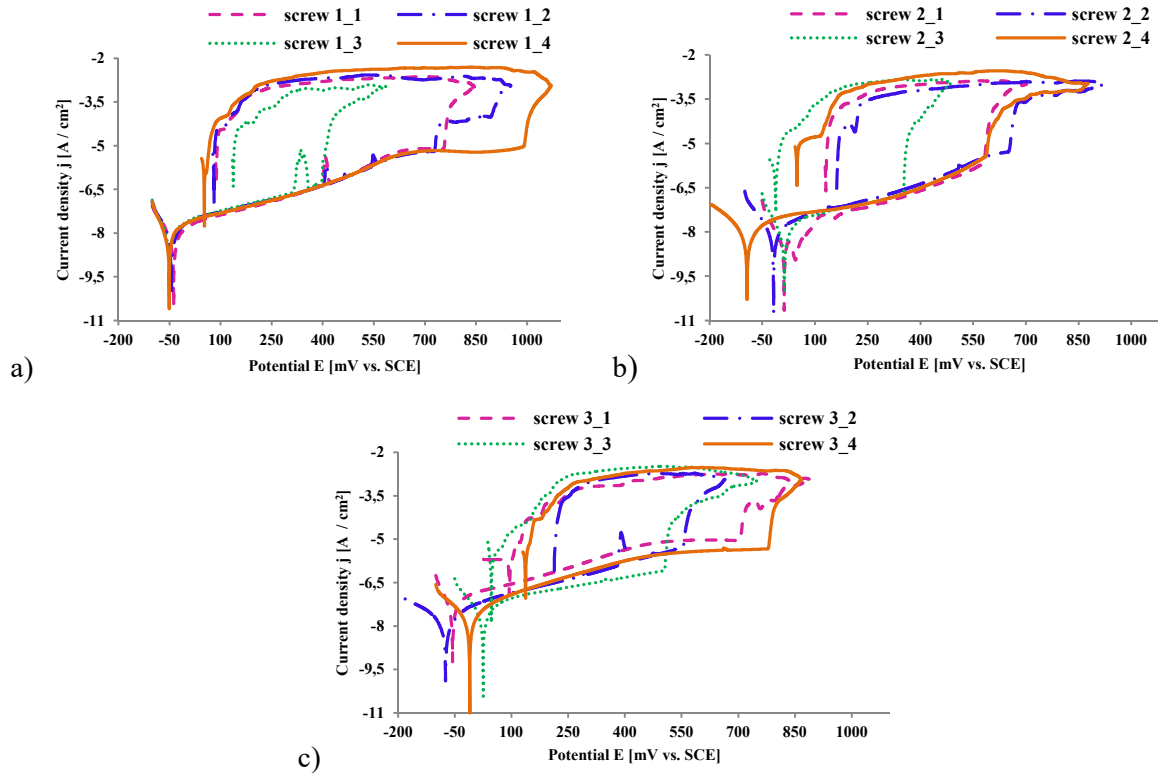
Based on the results of the surface observation and potentiodynamic testing (Fig. 6 and Table 2) it can be determined that the damage of the thread causes the decrease in the corrosion resistance of the screws from Groups II and III. The values of breakdown potentials E_b did not exceed +741 mV and +804 mV for Groups II and III respectively. For screws from Group I, the largest value of E_b was +1004 mV which indicates a permanent interruption of the passive film on the surface due to extensive mechanical damage. After reaching the breakdown potential, the electromagnetic field intensity in areas, where passive film is the thinnest is so big that chloride ions penetrate through the film and form oxide chloride compounds with increased solubility. This formation results in local damage of oxide layer. Further pits development is caused by autocatalitic processes with returnable coupling. In pitting corrosion there are three stages of expansion:

pit nucleation, initial growth state (depending on conditions, can be ended by pit overpassivation or transition to the thrid stage) and the last one is stable pit growth. For Group I of screws, the highest value of polarization resistance was recorded $R_p = 2.24 \, \text{kW} \times \text{cm}^2$, in comparison to the highest value of $R_p = 1.47 \, \text{kW} \times \text{cm}^2$ for the screws from Group III and $R_p = 2.22 \, \text{kW} \times \text{cm}^2$ for the screws from Group III. It was observed that the highest value of the corrosion potential $E_{cor} = +11$ mV occurred in Group II of screws. On the basis of potentiodynamic research, the obtained hysteresis loops (Fig. 6d) confirm the presence of corrosion pits (example for the Group I) as verified by the SEM study.

Fig. 6. Polarization curves: a) Group I, b) Group II, c) Group III

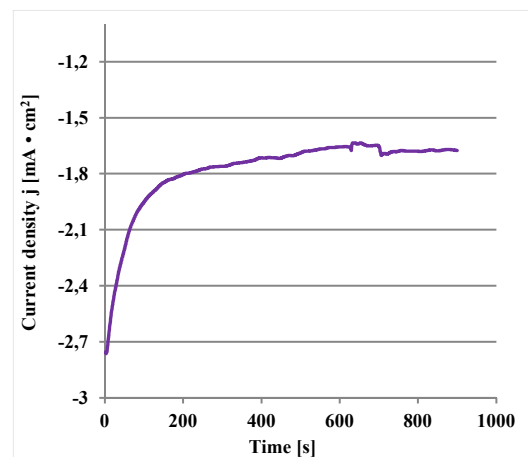
The curve shows a significant increase in current density which confirms that the analyzed screw made from 316L steel is not crevice corrosion resistant. It can be concluded that cor-

Fig. 7. Potentiostatic curve obtained from crevice corrosion

rosion damage at the point of contact between the screw head and the bone plates may have been caused by a corrosion cell in the screw – implant system due to the occurrence of the crevice corrosion [21,37-39].

To sum up, the corrosion resistance of bone screws can be influenced by biomaterial used, the duration of the implantation and the size of the mechanical damage to the surface of the screw. An increase in the resistance to both pitting corrosion and crevice corrosion can be achieved by using alternative biomaterials, such as titanium or titanium alloys, and surface of the screws modification technique such as nitriding and anodization polymer counting.
