Dependence of Reoxidation Effect on a Type of Gating System in Investment Casting Technology

Abstract

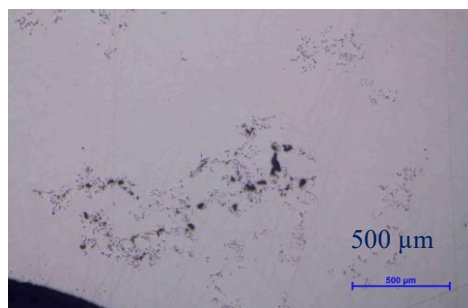
First, the cause of the most common defects has to be experimentally detected. Two types of material which are ordinarily cast in the air and have similar defects have been selected. There are some available metallographic samples in the following pictures that show internal defects in castings. In the structure there are a lot of inclusions formed in the shape of membrane. It means, that they must develop as a film on the melt and then infiltrate in the casting. There are also inclusions of another shape. However, the samples show a lot of oxide films and other smaller inclusions around developed probably from destroyed films.

Fig. 7. Metallographic image of the defect

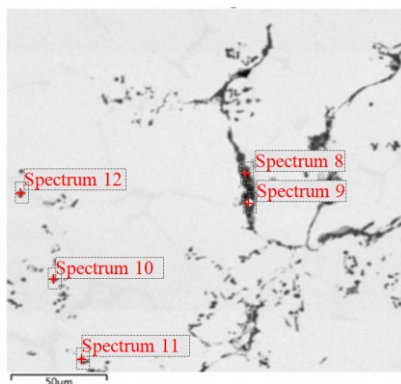
Fig. 8. The analysis of oxide film (AISI 304L)

In Fig. 8 there are marked areas, which were analyzed on micron microscope.
Table 2 represents a summary of analyzed areas:

- Spectrum 8 – It looks that this analyzed area contains about 30 % of the base. If there is higher content of certain chemical element than in the base, then this element is probably in oxidized state. In this case for example Mn or Al (MnO_2, Al_2O_3).
- Spectrum 9 – This area looks like pure base.
- Spectrum 10 – There is about half of the base and a probably Al_2O_3.
- Spectrum 11 – It consists of mostly pure base and some oxidized inclusions (Al_2O_3).

- Spectrum 12 – There is also only pure base.

The analysis of membrane shows that in two analyzed areas there was found only the pure base (Spectrum 9, Spectrum 12). In the others areas there is for sure at least a portion of pure base and surprisingly quite a lot of Al probably occurring in oxidized state as Al_2O_3.

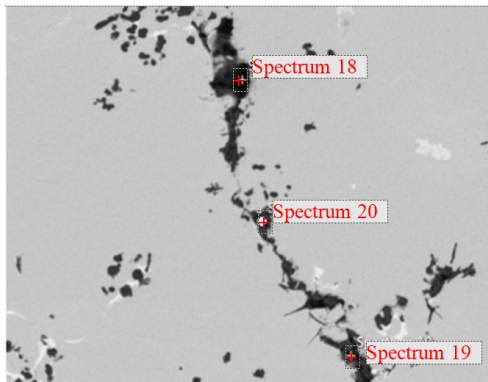
Fig. 9 and Fig. 10 show the analysis of AISI 661. Also increased content of aluminium and oxygen. The type of defect is comparable to material AISI 304L defects.

Fig. 9. The analysis of oxide film (AISI 661)

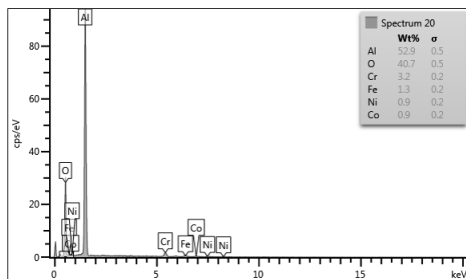
Fig. 10. The chemical composition results of Spectrum 20

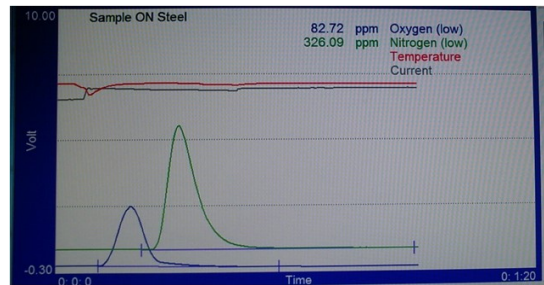
The problem appeared immediately. The results show that there was no problem to measure the content of nitrogen in samples but oxygen levels were outside sensitivity of the device (Fig. 11, Fig. 12). Only in one case (Sample number 3) there was a possibility to find out the amount of oxygen content. Especially this Sample was poured under lower pressure (15 mbar). It was only an experiment how to reduce the problem with inclusions, however other technological problems occurred.

Fig. 11. Signal from detectors for Standard: blue line – Oxygen content, green line – Nitrogen content

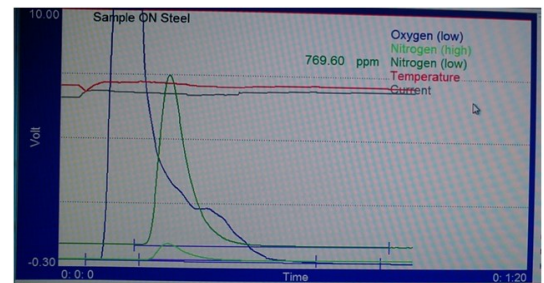
Fig. 12. Signal from detectors for Sample number 1: blue line – Oxygen content, green line – Nitrogen content
