STANISŁAW BARYCZ*, KAROL FIREK*, WOJCIECH KOCOT*,
AGNIESZKA MALINOWSKA*

THE EFFECT OF PREVENTIVE CONSERVATION MEASURES ON THE TECHNICAL CONDITION OF A RELIGIOUS BUILDING LOCATED IN THE MINING AREA

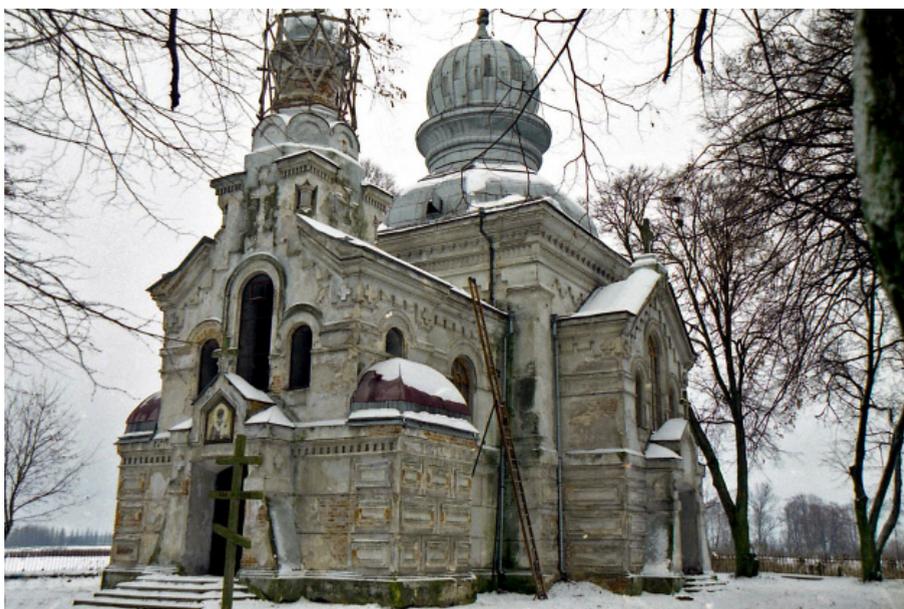
Fig. 1. The Orthodox Church in Dratów (as of 2002), the view from the south-west.

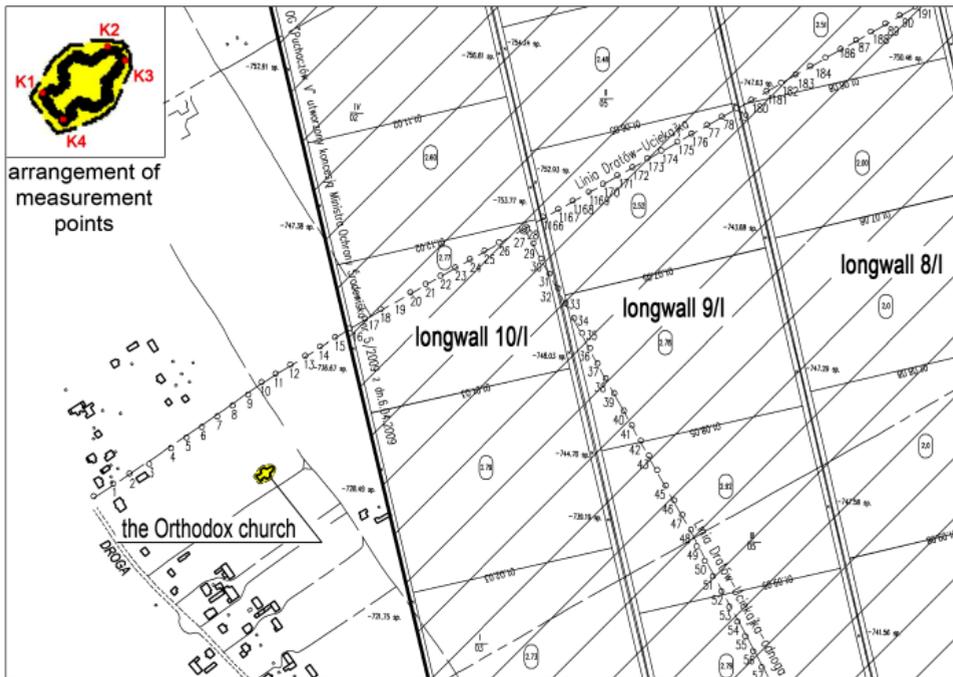
Fig. 7. Location of panels and a measuring line relative to the church, as well as distribution of calculation points at the building structure.
Source: Data regarding..., 2014

commenced in July 2002 with the 10/1 wall, which was located to the north-east of the church building (Fig. 7). The exploitation front pace ranged from 5 to 11 m per day. While analyzing the impact of consecutive walls on the surface deformation in the area of the church, it should be emphasized that only the longwalls 10/1 and 9/1 affected the deformation in this area. Assuming that the average range of direct impact is about 750 m, it can be concluded that the mining operation carried out after October 2005 had no effect on the surface deformation in the vicinity of the church.

The calculations were conducted at four points (K1, K2, K3, K4), located at the corners of the church building (see Fig. 7).

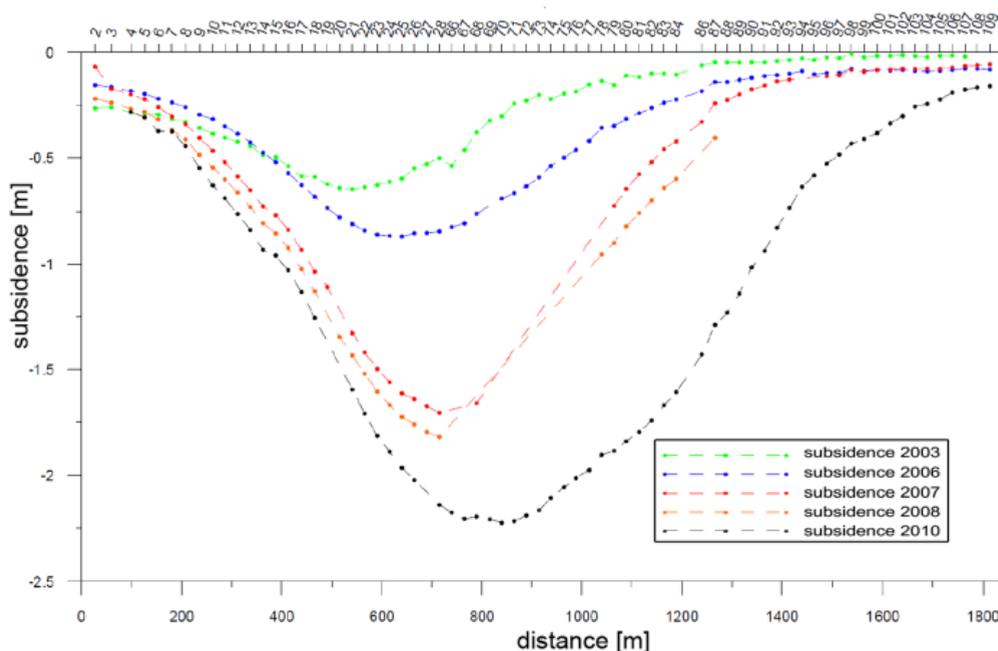
In the area of Dratów, there are two fixed observation lines: Dratów-Uciekajka and Dratów-Uciekajka branchline. Dratów-Uciekajka will be the subject of further analysis, due to its advantageous location with respect to the panels. This is a line that runs north of the church building, at a distance of about 90 m. The measurement line includes 145 permanently marked reference points. The average distance between the points is about 25 m. The leveling measurements on the line began in 2002. Subsequent measurements were performed in the years 2003, 2006, 2007 and 2008. Since 2010, the leveling has been performed at annual intervals. The observations carried out along this line made it possible to trace the process of surface deformation (Fig. 8).

Fig. 8. Profiles of the measured surface subsidence along Dratów-Uciekajka observation line.
