# The role of structural analyses and queries in recognizing damage causes and selecting remedies in historic buildings: case of the Dominican monastery in Lublin

Anna Halicka<sup>1</sup>, Anna Ostańska<sup>2</sup>

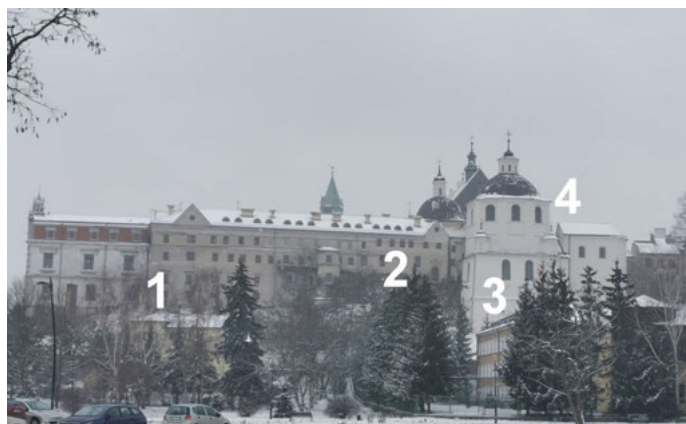
Fig. 1. Present view of the Dominican monastery in Lublin from the foot of the Old Town Hill; the numbers designate locations described in this article: 1 – south-east corner, 2 – east wing, 3 – Tyszkiewicz Chapel, 4 – corner between the Chapel of the Immaculate Conception of the Blessed Virgin Mary and side-chapels

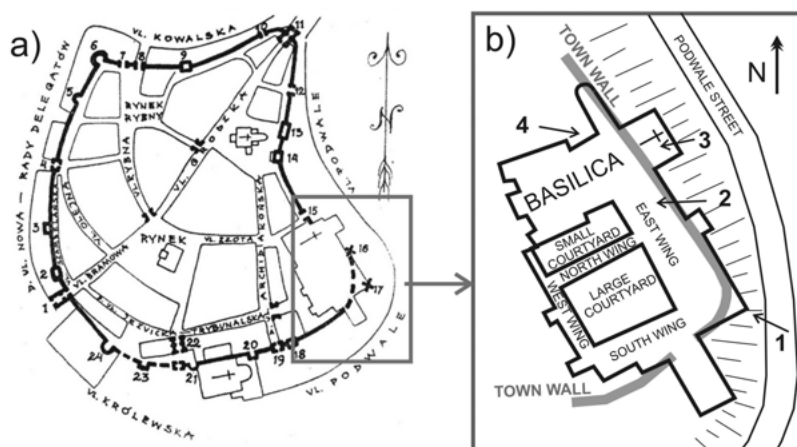
Fig. 2. The complex of the Dominican monastery in Lublin: a) location of the monastery in the Old Town inside the town walls in the 17<sup>th</sup> century – illustration by unknown author presented in the guidebook of Lublin [23]; the town wall is marked with the black bold line, the bold dash line denotes sections whose exact location was unknown up until restoration works; the town towers and gates are designated with numbers, b) present horizontal projection of the monastery with the outline of medieval town walls whose course was confirmed during restoration works. Places described in this article are designated as follows: 1 – south-east corner, 2 – east wing, 3 – Tyszkiewicz Chapel, 4 – corner between the Chapel of the Immaculate Conception of the Blessed Virgin Mary and side chapels

As mentioned above, the monastery was incorporated into the town's fortification system in the 17<sup>th</sup> century. The walls of the added east wing were erected partly on the town wall itself. Fig. 2a shows the layout of the Lublin Old Town with the defensive wall surrounding it after the expansion of the monastery. This layout corresponds with the knowledge from before the monastery's rehabilitation works and comes from the Lublin guide book from 2000 [23]. The bold continuous line indicates the documented position
