# The landslide in the slope and side of the Warta River valley in the village of Wronki – process analysis, exploratory research, preventive measures, monitoring

Michalina Flieger-Szymańska<sup>1</sup>, Jerzy Sobkowiak<sup>2</sup>,  
Katarzyna Machowiak<sup>3</sup>, Dorota Anna Krawczyk<sup>4</sup>

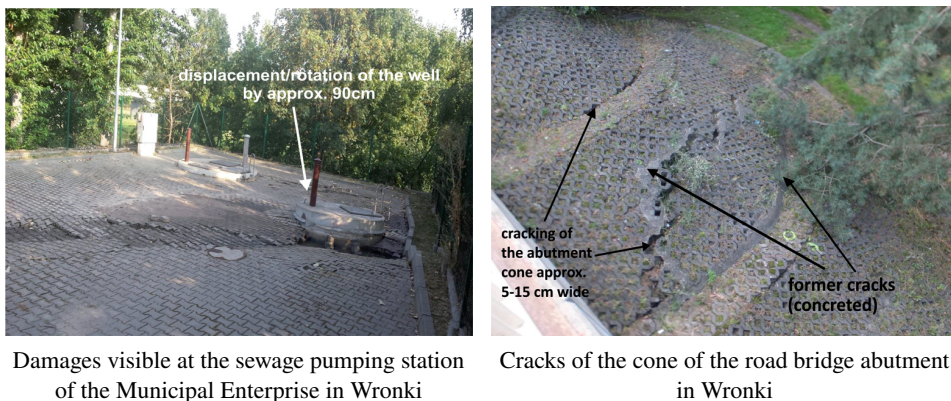
Fig. 3. The discussed area in Wronki [9]

During the field inventORIZATION, numerous photographic documentation of the damages and deformations of the ground was also made. Selected damages that occurred in the discussed area in August 2018 are shown in the photos below (Fig. 3).

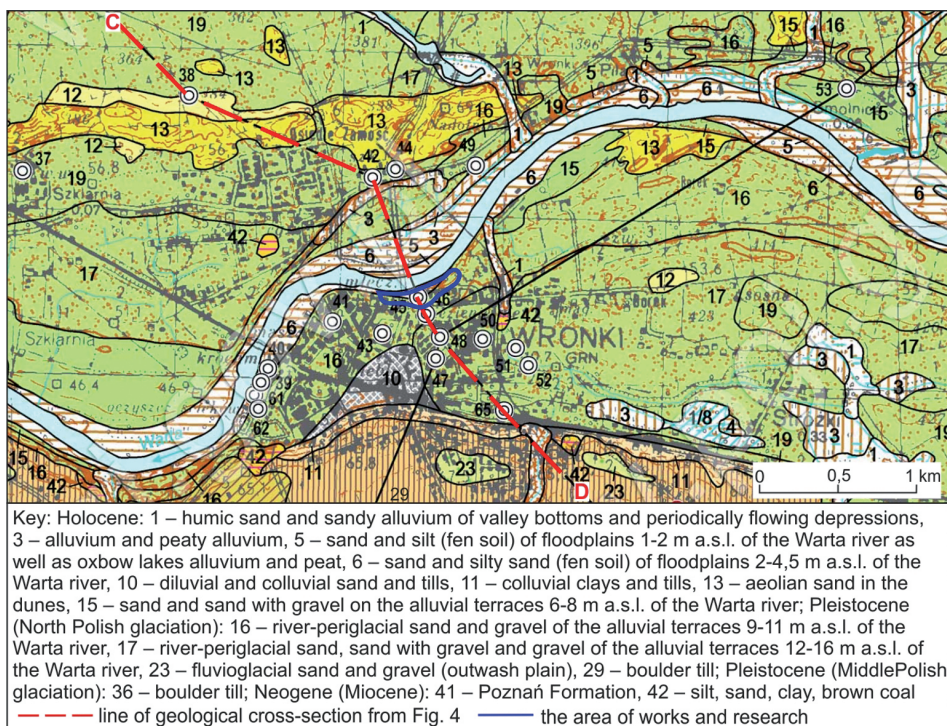
Fig. 4. Location of the research area against the background of a fragment of the detailed geological map of Poland, sheet 392 – Wronki, scale 1:50 000 [5]

In order to determine the causes of the landslide, the geological structure of the study area was analyzed in detail. The detailed geological map of Poland (Wronki sheet) shows the presence of mainly non-cohesive soils in the subsurface zone, i.e. river-periglacial sand and gravel of the alluvial terraces of the Warta river and sand and silty sand of floodplains of the Warta river (Fig. 4) [5].

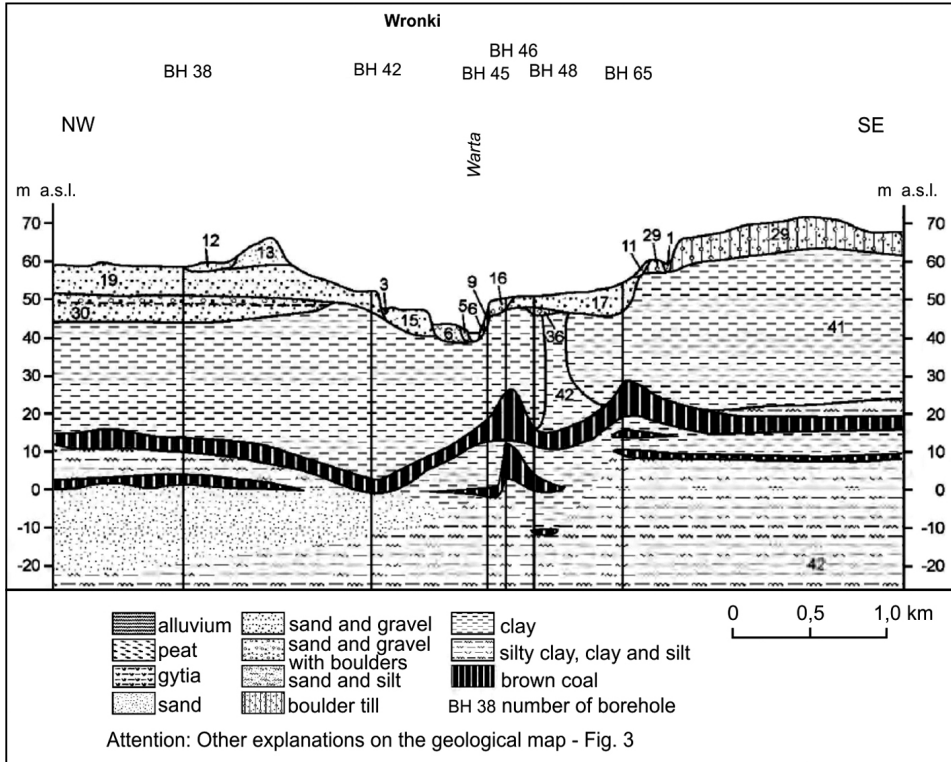
Fig. 5. The fragment of the C–D geological cross-section [6]

In turn, the sediments that appear below are illustrated by the geological cross-section included in the explanations to the above-mentioned map [6]. The mentioned sands (marked with number 6 and 17) lie on cohesive soils formed as Neogene clays of the Poznań series (marked with number 41), and locally on the boulder tills of the Middle Polish glaciations (marked with number 36). The Warta river bed is eroded in Neogene sediments, on which a layer of sand with a small thickness lie (Fig. 5).

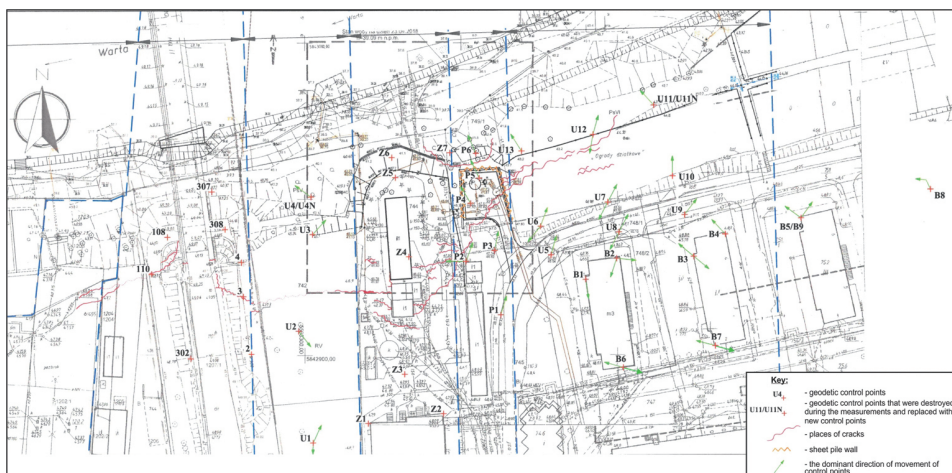
Fig. 7. Distribution of geodetic control points [13–15]

The measurement network is arranged so that it is possible to analyze all the critical points of interest, thus it covers the area of active landslide and allows to determine the displacement of surface points in the X, Y, Z direction. The presented map shows the distribution of geodetic control points in the zone where the greatest landslide movements occurred in 2018 (Fig. 7). Measurements are carried out from December 4, 2018. 13 control points marked with the letter U are located in the area belonging to the Wronki City Hall (currently measurements are carried out for points U1–U9) and 6 control points marked with the letter P are located on the premises belonging to the Company Municipal in Wronki. Points marked with the letter Z are located on the premises of the Correctional Facility in Wronki, where currently measurements are no longer carried out (completed in December 2018) [13–15].

In the Documentation of the subsoil research in March 2019, it was recommended to extend the monitoring by additional checkpoints in the area at Mickiewicz Street and a housing estate [10]. From October 28, 2019, measurements are carried out in the area belonging to Słowacki housing estate in Wronki using 8 control points marked with the letter B (Fig. 7).
