# Slope stability analysis of post-mining dumps with the use of photogrammetric geometry measurements – a case study

Magdalena Wróblewska<sup>1</sup>, Magdalena Kowalska<sup>2</sup>,  
Marian Łupieżowiec<sup>3</sup>

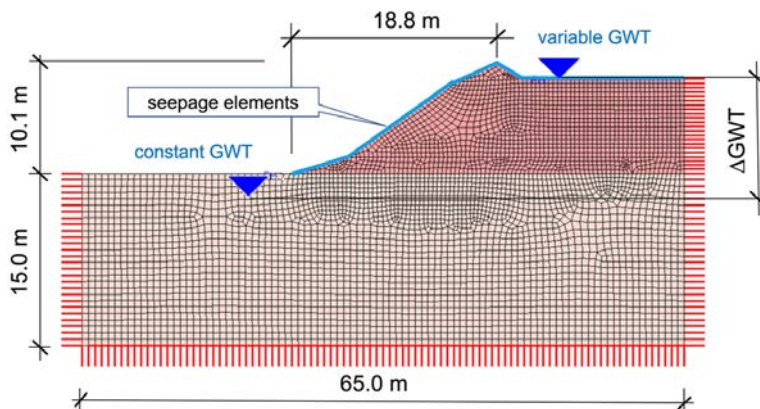
Fig. 5. Numerical FEM model of the analysed case

The initial dimensions of the numerical model represented the P1 section of the dump measured in January 2022. The model contained the scarp with the appropriate width of the crown and base – see Fig. 5, which ensured that the boundary conditions did not affect the obtained results. The depth of the analysed subsoil was chosen in a similar way. The correctness of the model dimensions was verified by confirming that a larger size of the model did not influence the location and shape of the failure surface. Four-node quadrangular finite elements were used to create the mesh. At each node, the searched unknowns were the two components of the displacement vector (in the horizontal and vertical directions) and the value of the pore water pressure. The standard geotechnical boundary conditions were applied: the displacements at the lower edge of the model were blocked in both perpendicular directions, together with the horizontal displacements at the side edges. The seepage through the base and the side edges of the model was made impossible. In the filtration analyses, the water table level at the base of the escarpment was fixed (left side in Fig. 5) at the bottom of the drain located at the toe. On the other side of the slope, several variants were considered with the groundwater table (GWT) at different depths below the top ground surface ( $\Delta\text{GWT} = 2\text{--}10.5\text{ m}$ ). The steady state of flow was assumed. The other considered factor was the value of the distributed flux through the slope and the upper surface of the dump ('seepage' elements). It simulated various rainfall intensity.
