# Expansive soils as the root cause of a historic underground potable water reservoir failure

Tomasz Godlewski<sup>1</sup>, Radosław Mieszkowski<sup>2</sup>

**Abstract:** The paper describes the root causes of damage to an underground potable water reservoir. It is made of reinforced concrete and consists of two chambers founded on subsoil diversified for its age and origin (folds of glacitectonically disturbed septarian clays and postglacial loams). The documented damage results from subsoil deformation caused by volumetric changes in the ground (shrinkage and swelling) due to the facility's exposure to various external factors determining the phenomenon's intensity for over one hundred years. The analysed example presents problems arising from founding the facility on expansive soils. It highlights the hazards resulting from negligence in landscape architecture development and emphasises the role of identifying the subsoil. Comprehensive geotechnical examination and geophysical measurements of the structure and subsoil, making the inventory and evaluating the nature of the damage helped identify the potential factor detrimental to the facility's technical condition. The conclus

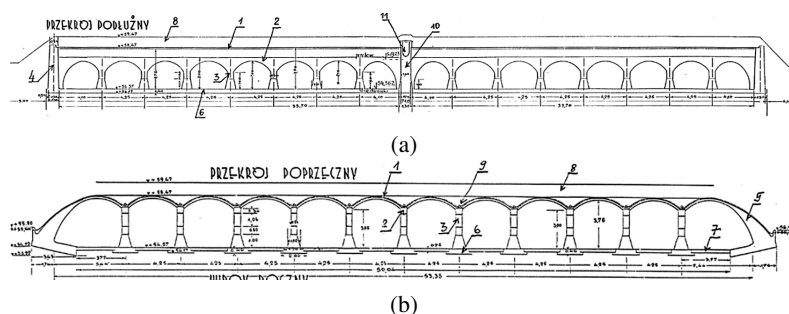
Fig. 1. Cross-sections of the reservoir structure: (a) lengthwise section in the binding joist axis (chamber I exposed); (b) cross-section according to a drawing from 1949 based on [4], describing the structure components: 1 – arch vault, 2 – arch binding joint, 3 – column, 4 – outer wall, 5 – outer arch-like wall (vault abutment), 6 – continuous footing, 7 – bottom plate, 8 – cover layer (fill) above the reservoir, 9 – drainage (stoneware pipes) in the spandrels, 10 – central wall, 11 – unused canal supplying water to the reservoir chambers

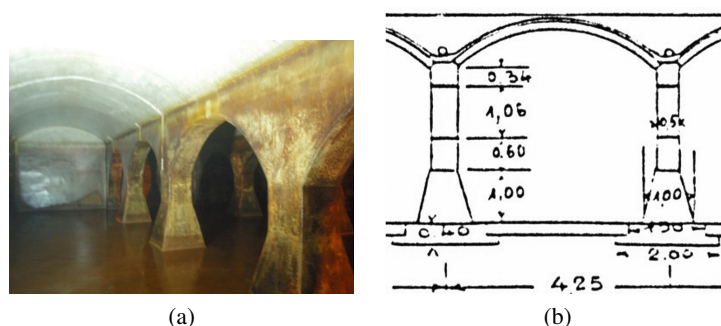
Fig. 2. (a) Sample general view of the reservoir's essential structural components (photo by T. Godlewski); (b) dimensioned diagram on the binding joist axis according to a drawing dating back to 1949 in [4]

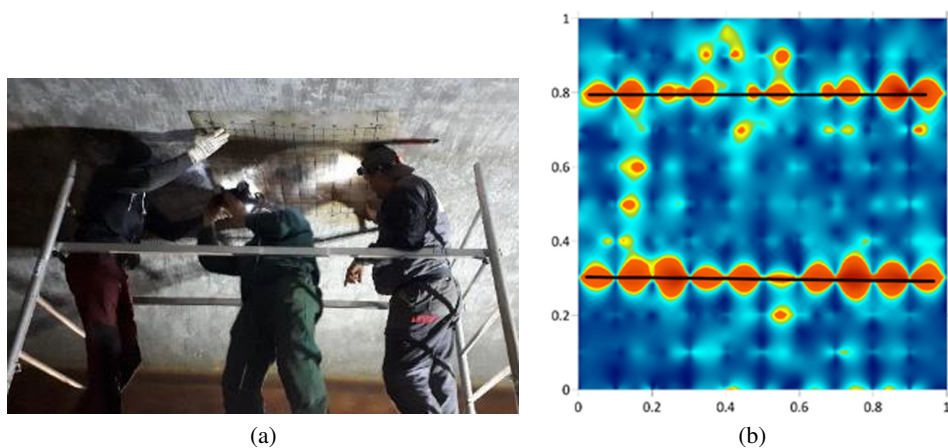
Georadar tests (GPR) were performed to verify the reinforcement rate of the structure components; for the bottom plate and the subsoil, they were meant to identify non-homogenous and excessive damping areas. The concept of the GPR method is described in detail, e.g. in [2], [5] and [8]. The signatures of GPR anomalies in the subsoil include reflective horizons, diffraction hyperbolas and areas of the recorded wave signal amplification. The GPR measurements were performed with 1.6 GHz and 750 MHz antennas all over the bottom plate's surface and in selected areas of the ceiling (vault), columns, floors and binding joists. A total of 700 GPR profiles were made in the reservoir. Three hundred had cruciform arrangements, 0.5 m spacing, and a prospection range of ca. 1.2–1.4 m (linear measurements). Four hundred profiles also had cruciform arrangements, 0.1 m spacing and a prospection range up to 0.5 m (spot measurements) – Fig. 8.

Fig. 8. (a) View during the vault's GPR test (1.6 GHz antenna) in a cruciform arrangement, 0.1 m spacing, prospection range up to 0.5 m (spot measurements), (Photo T. Godlewski); (b) sample imaging result (prospection at 0.1 m depth) as a map of anomalies, regular anomalies (electromagnetic wave signal amplification areas) represent reinforcing elements [4]

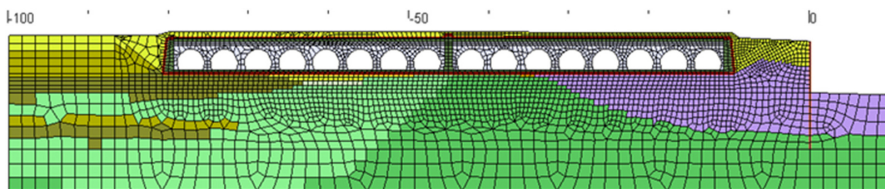
Assessment of the structure's interaction with subsoil under variable load and consideration of the interaction with the adjacent palisade (retaining wall) required multi-stage numerical analyses. To that end, ZSoil 2018 software based on the finite element method (FEM) was used. The analysis covered all relevant phases and possible variants of the reservoir loading. Additionally, the potential influence of clay swelling under the reservoir and the phenomenon impact range were evaluated in the analysis – model in Fig. 10. Geometric parameters were determined based on in situ test results and the course of “triaxial” tests. A non-linear elastic Hardening Soil model with small strain stiffness (HSs) was used. The reservoir structure was modelled as concrete, assuming a simplified Hoek-Brown condition as the failure criterion. The material parameters were adopted assuming the compressive strength of concrete as 10 MPa and 1 MPa tensile strength. Reduced strength and strain parameter values were adopted for the components (e.g. columns) spaced at set distances, considering the impact of their spacing on the structure's model global behaviour. The palisade at the road was modelled with beam elements, where the assumed parameters corresponded to those of 0.6 m diameter concrete piles spaced every 1.06 m [4].

Fig. 10. Computational geotechnical model of the reservoir structure interaction with the subsoil
