A. ZIEWIEC*, J. CZECH**, E. TASAK*

WELDED JOINT CRACKING IN MARTENSITIC STAINLESS STEEL PRECIPITATION-STRENGTHENED WITH COPPER**PEKANIE ZŁĄCZ SPAWANYCH STALI NIERDZEWNEJ MARTENZYTYCZNEJ UTWARDZANEJ WYDZIELENIOWO MIEDZIĄ**

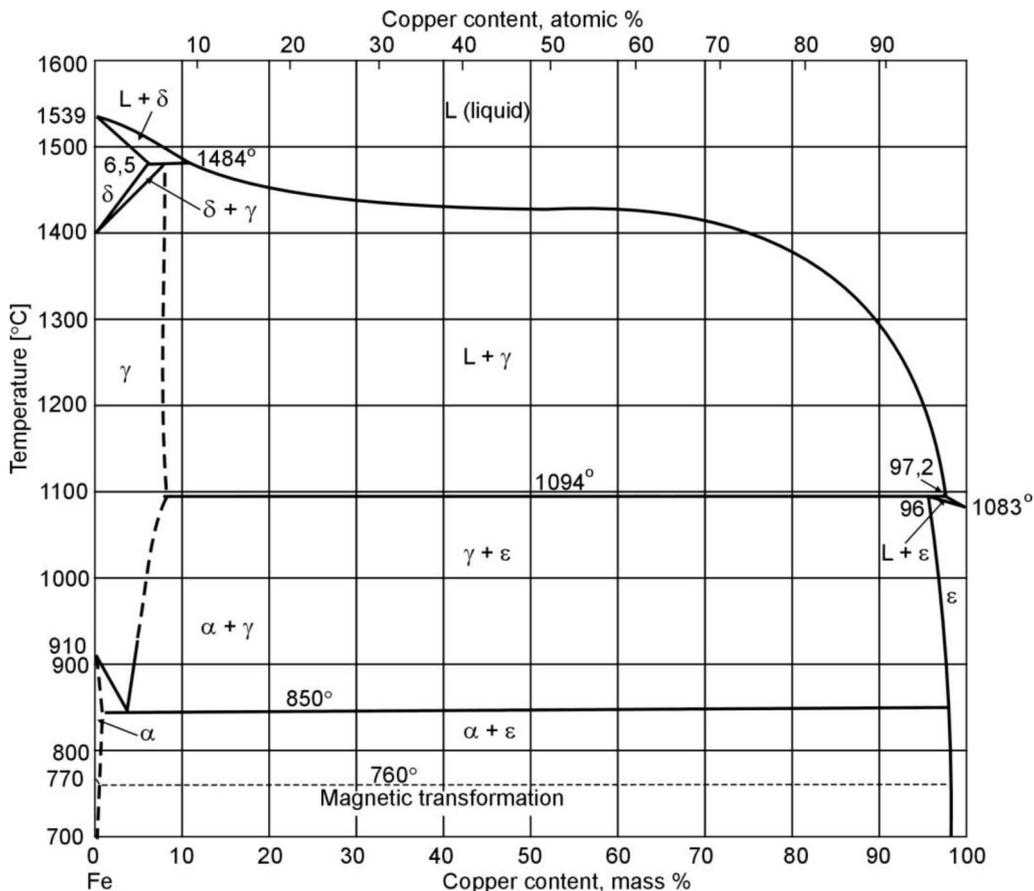
Fig. 9. Fe-Cu equilibrium diagram [9]

It is also possible that Cu vapours are being oxidised in the shielding gas stream and then Cu oxides would be deposited on the base metal surface. Melting point of Cu_2O is approx. 1200°C and for Cu_2O -Cu eutectic it is approx. 1065°C . Therefore, in the area adjacent to the weld bead, where temperature on the steel

surface may reach around 1100°C a liquid layer of pure Cu or Cu_2O may be present. The weld shrinkage during cooling causes the development of stresses and that produce deformation of the material in the vicinity of the weld joint. This deformation in the presence of a liquid phase on the base metal surface results in a hot cracking phenomena. Small amount of liquid promote the development of shallow cracks – up to an observed maximum of $50\ \mu\text{m}$. The development of liquid phase on the base metal surface can be facilitated by relatively little Cu enrichment. Enrichment at the level of 8% of Cu is sufficient to develop liquid phase containing 97.2% of Cu (Fig. 9) as a result of incipient melting at 1094°C [4]. Therefore, even slight enrichment in copper may lead to development of a liquid phase rich in copper, which has a very high wettability of steel and causes hot cracks in the presence of tensile stresses. In the literature [5t÷8], this type of hot cracking in the presence of liquid metals is referred to as LME – Liquid Metal Embrittlement. It must be stated that without tensile stresses and the deformation caused by them – LME does not occur and base material is enriched in Cu by diffusion mechanisms.
