M. HAWRYLUK^{*#}, Z. GRONOSTAJSKI^{*}, M. KASZUBA^{*}, J. KRAWCZYK^{*},
P. WIDOMSKI^{*}, J. ZIEMBA^{*}, M. ZWIERSZCHOWSKI^{*}, M. JANIK^{**}

WEAR MECHANISMS ANALYSIS OF DIES USED IN THE PROCESS OF HOT FORGING A VALVE MADE OF HIGH NICKEL STEEL

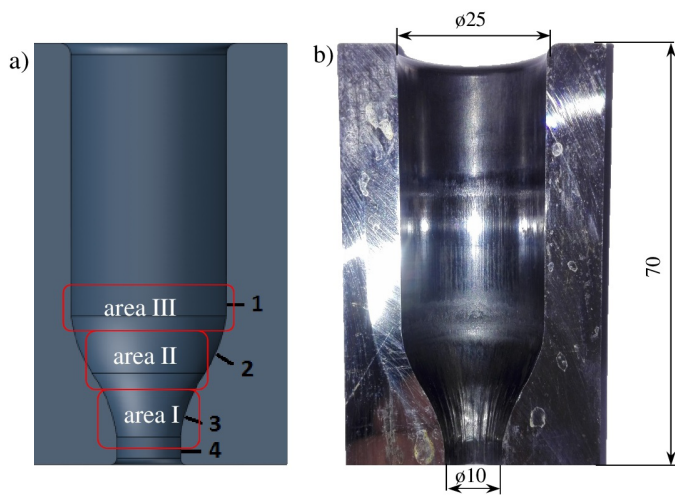
A detailed analysis was performed on dies used in I operation of hot forward extrusion of a long shank tipped with a preliminarily formed element called ‘bulb’. Fig. 2a shows a CAD model together with the distribution of the areas (measure points) of the surface of the tool section, for a better understanding and analysis of the obtained test results. Fig. 2b, in turn, presents an image of one half of a worn die.

Fig. 2. View of the tool section: a) CAD model with marked selected measurement areas, including the microhardness test points, b) exemplanary image of a die's half with main dimensions in mm

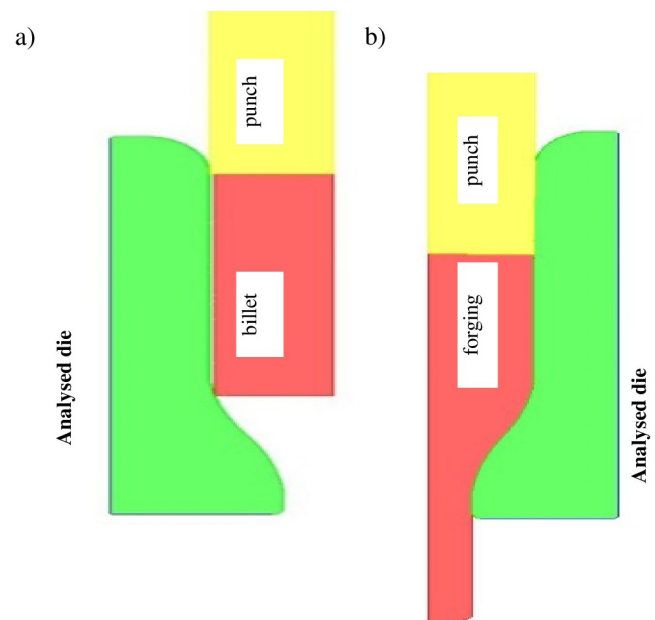
Fig. 5. General view of the model: a) before, b) after I forging operation

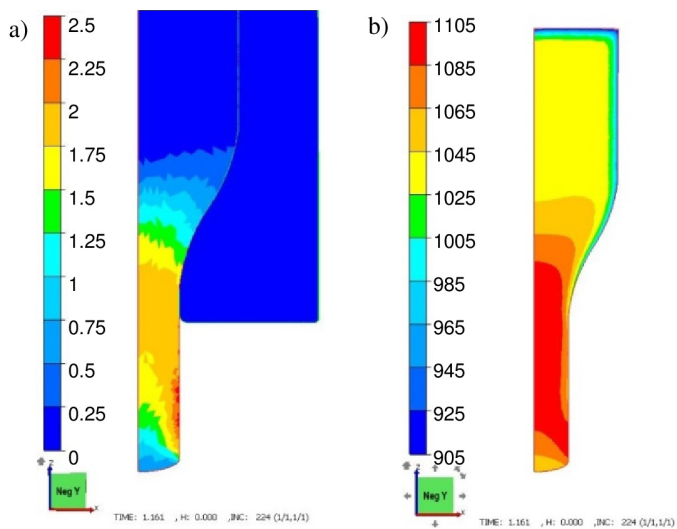
Fig. 6. Distribution of: a) plastic strain (deformation), b) temperature for the forging in the last forging stage in °C

Based on the presented results, it is possible to observe that the highest temperature is present in the area of intensive deformation of the charge material (reduction of forging section). It should be noted that due to the relatively small size of both the forging and the die, these elements have a very small thermal capacity, which may cause the conditions to dramatically change in the case of instability of the forging process, e.g. too long a shutdown, or overheating of the charge/die. This is especially visible in the case of the temperature field distribu-

tion on the forging during the extrusion, where a small thermal capacity caused big differences in the forging temperature in the deformable part as well as in the contact with the cooler tools.

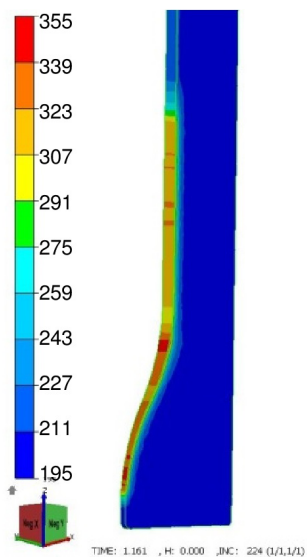
Fig. 7. Temperature distribution on the die in the last forging stage in °C

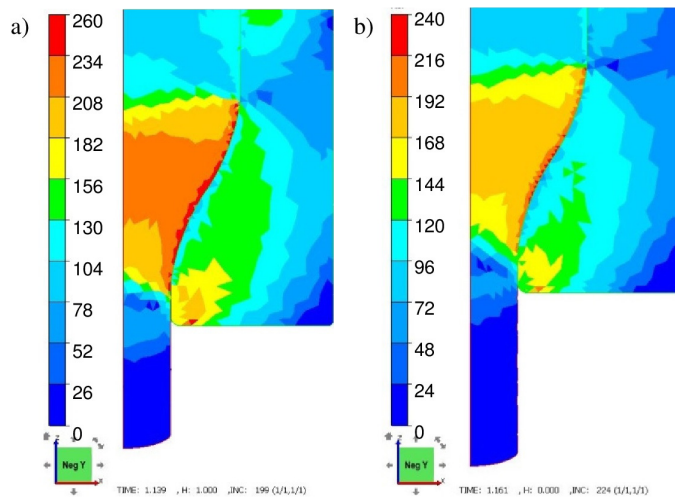
Fig. 8 Distribution of reduced stresses (von Mises): a) 1 mm to the full pocket of the punch, b) full pocket of the punch (last forging stage) in MPa

The presented distributions show not very high values of stresses, which should not cause the risk of plasticization or tool damage. The differences in the stress value can be explained by the fact that in the final stage the material fills the die pattern and the pressure is distributed on the whole surface. Much more information would be provided by the distributions of circumferential and radial stresses, as they are the ones which decide about a possible presence of longitudinal cracks on the die, which, in turn, could correlate with the cracks observed in the macro- and microstructural tests. Fig. 9 shows the path of friction on the die in the last forging stage. Based on the presented results, we can conclude that the area in the die through which the most material

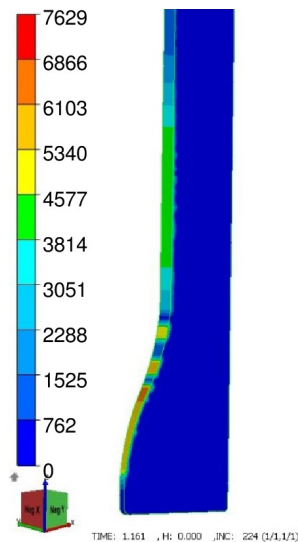
Fig. 9. Path of friction in the last extrusion stage in MPa mm

of the formed forging flows is the area which is the key zone for the process, where ridging occurs as a result of scale friction and sticking of the forging material.

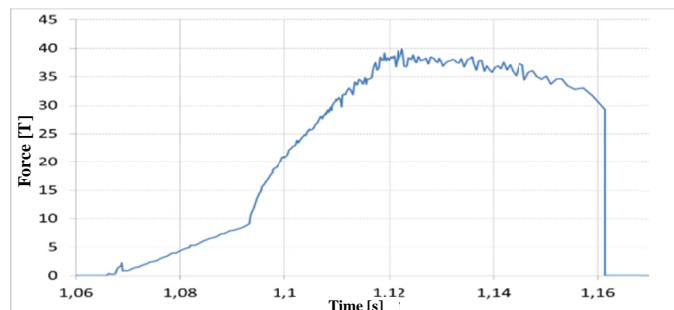
Fig. 10. Diagram of the force in I operation of extruding a valve-type element

The forging force courses obtained from the numerical modelling show that, in the case of a valve forging, the press works in the lower scope of the nominal load, which, for this forging unit, equals 700 kN, that is 70 tons.
