PANSI XIE^{*,**}, YONGPING WU^{*,**}**DEFORMATION AND FAILURE MECHANISMS AND SUPPORT STRUCTURE TECHNOLOGIES FOR GOAF-SIDE ENTRIES IN STEEP MULTIPLE SEAM MINING DISTURBANCES****MECHANIZMY POWSTAWANIA ODKSZTAŁCEN I PEKANIA ORAZ TECHNOLOGIE WZMACNIANIA I ZABEZPIECZANIA ŚCIAN CHODNIKÓW W WYROBISKACH NACHYLONYCH**

Entries in steeply pitching seams have a more complex stress environment than those in flat seams. This study targets techniques for maintaining the surrounding rock mass stability of entries in steep seams through a case study of a steep-seam entry at a mine in southern China. An in-depth study of the deformation and instability mechanisms of the entry is conducted, employing field measurement, physical simulation experiment, numerical simulation, and theoretical analysis. The study results show that the surrounding rock mass of the entry is characterised by asymmetrical stress distribution, deformation, and failure. Specifically, 1) the entry deformation is characterised by a pattern of floor heaving and roof subsidence; 2) broken rock zones in the two entry walls are larger than those in the roof and floor, and the broken rock zone in the seam-floor side wall is larger tha

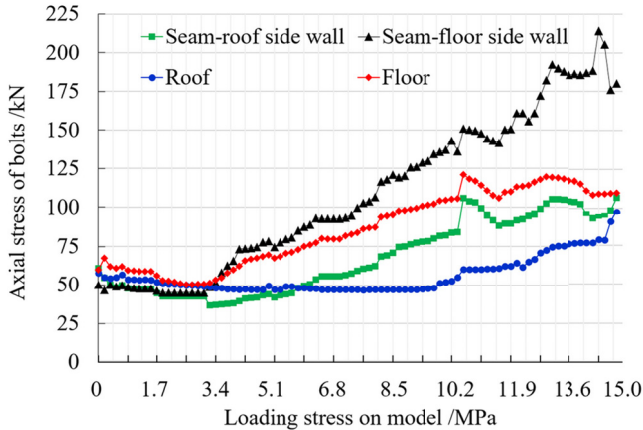
Fig. 9. Axial stress curves of rock bolts

Throughout the physical simulation experiment, the stresses experienced by the rock bolts (initial force: 50 kN) were monitored using a load cell, as shown in Fig. 9. The monitored results indicate that the rock bolts located in different cross-sectional areas of the entry model experienced different stresses. The rock bolts in the seam-floor side wall experienced the greatest axial stress, with a maximum value of 213.4 kN, followed by the bolts in the floor, with a maximum value of 119.6 kN. The maximum axial stress experienced by the bolts in the seam-roof side wall was 105.0 kN. Finally, the bolts in the roof experienced the smallest axial stress, with a maximum value of 99.6 kN. The uneven stresses experienced by the bolting structure can be attributed to the uneven deformation distribution shown in Fig. 8a. The largest deformation occurred for the seam-floor side wall; thus, the rock bolts in that location experienced high tensile stress. The deformation

of a similar magnitude occurred for the seam-floor side of the floor; thus, the rock bolts in that location also experienced high axial stress. The seam-roof side wall had high-strength surrounding rocks and good structural integrity, and it could buffer the stress; hence, smaller deformation occurred and the rock bolts in that location experienced relatively even load and small axial stress.
