NON-DESTRUCTIVE TESTING AND ANALYSIS OF A XIX-CENTURY BRICK MASONRY BUILDING

A. HOŁA¹, Ł. SADOWSKI², J. SZYMANOWSKI³

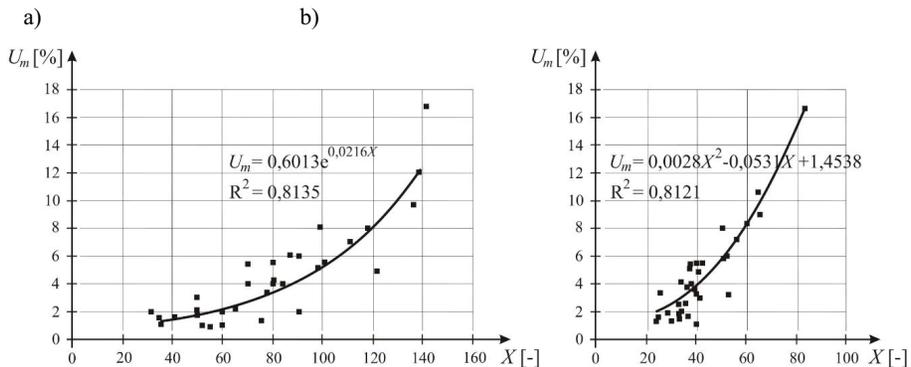
Fig. 7. Correlational relationship between the indications X of the meter and the mass moisture content U_m of the masonry wall: a) for the dielectric meter; b) for the resistance meter.

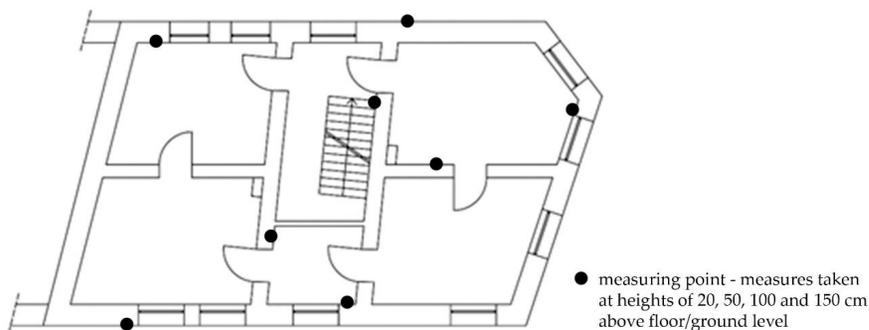
The brick external and internal walls of the ground floor were subjected to the tests. Measurements were taken in eight measuring places, in each place at four heights above floor/ground level, as shown at Figure 8. In total, for each of methods 32 measurements were obtained.

Fig. 8. The location of measuring places of the mass moisture content U_m of the masonry walls

The average values of the moisture content in the subsurface zone, determined at heights of 20 cm, 50 cm, 100 cm and 150 cm above the floor level, were equal to 6.40% (SD = 3,50), 4.70% (SD = 2,38), 3.50% (SD = 0,55) and 2.60% (SD = 1,11) respectively for the internal walls, and for the external walls they were equal to 10.20% (SD = 3,37), 6.80% (SD = 1,33), 3.80% (SD = 0,64) and 2.35% (SD = 0,59), respectively. This state is illustrated in Figure 9. Table 1 presents the classification of the moisture content adopted from literature [29-31], and the determined degree of dampness of particular batches of the tested walls. The measurement results clearly show that the building's walls are excessively damp up to a height of about 130 cm above floor level.
