# The role of structural analyses and queries in recognizing damage causes and selecting remedies in historic buildings: case of the Dominican monastery in Lublin

Anna Halicka<sup>1</sup>, Anna Ostańska<sup>2</sup>

**Abstract:** The article presents the process of structural diagnostics of the Dominican monastery in Lublin. In order to establish the underlying cause of cracks, not only *in situ* investigations but also detailed analyses of documents were executed. Inventory drawings were examined in order to identify the building's structural system. The query of historical documents and city archives was carried out to understand the structure's performance. Conclusions were confronted with the crack pattern. It was established that the damage resulted from the original conditions of the structural system in place. These conditions were created in past, when the monastery incorporated sections of the medieval town wall into its structure.

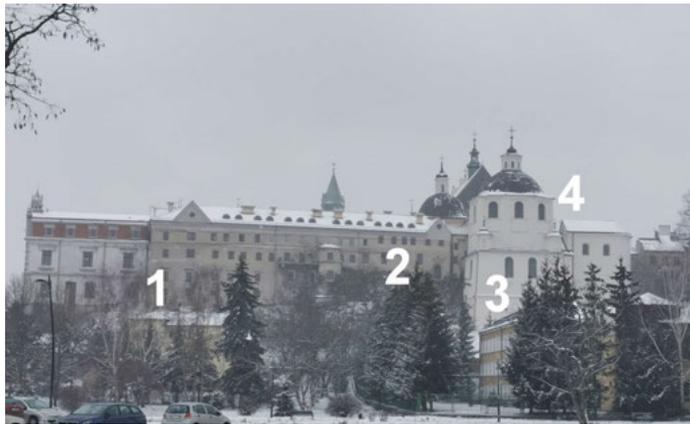
Fig. 1. Present view of the Dominican monastery in Lublin from the foot of the Old Town Hill; the numbers designate locations described in this article: 1 – south-east corner, 2 – east wing, 3 – Tyszkiewicz Chapel, 4 – corner between the Chapel of the Immaculate Conception of the Blessed Virgin Mary and side-chapels

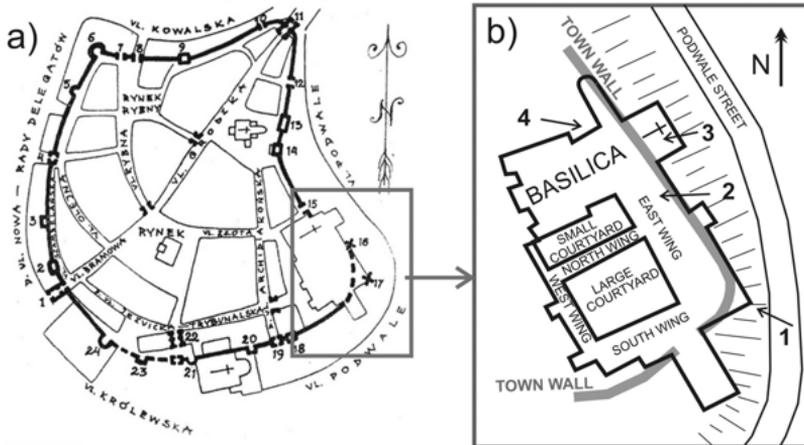
Fig. 2. The complex of the Dominican monastery in Lublin: a) location of the monastery in the Old Town inside the town walls in the 17<sup>th</sup> century – illustration by unknown author presented in the guidebook of Lublin [23]; the town wall is marked with the black bold line, the bold dash line denotes sections whose exact location was unknown up until restoration works; the town towers and gates are designated with numbers, b) present horizontal projection of the monastery with the outline of medieval town walls whose course was confirmed during restoration works. Places described in this article are designated as follows: 1 – south-east corner, 2 – east wing, 3 – Tyszkiewicz Chapel, 4 – corner between the Chapel of the Immaculate Conception of the Blessed Virgin Mary and side chapels

As mentioned above, the monastery was incorporated into the town's fortification system in the 17<sup>th</sup> century. The walls of the added east wing were erected partly on the town wall itself. Fig. 2a shows the layout of the Lublin Old Town with the defensive wall surrounding it after the expansion of the monastery. This layout corresponds with the knowledge from before the monastery's rehabilitation works and comes from the Lublin guide book from 2000 [23]. The bold continuous line indicates the documented position
