Settlement of a historic building due to seepage-induced soil deformation

3. Soil seepage-induced deformations within the area of the St. Nicholas basilica in Gdańsk – case study

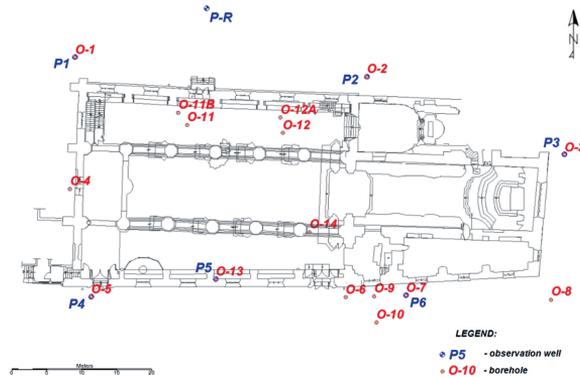
Fig. 4. Location of subsoil test boreholes and groundwater level observation piezometers [40]

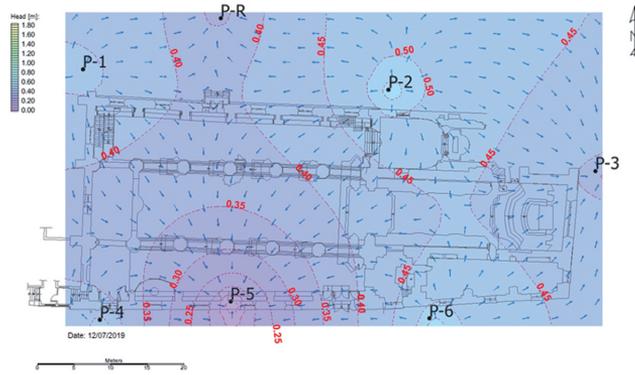
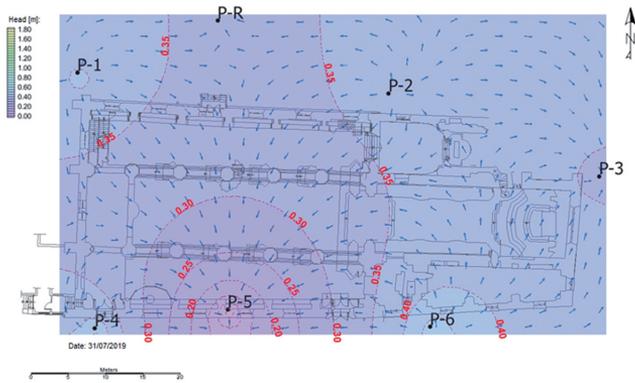
Fig. 9. Groundwater table level map with seepage directions for a) 12/7/2019 and b) 31/7/2019, against the background of the Basilica basement level plan

Obtained water flow direction visualisations (Fig. 9–12) indicate that the water flow direction in the Basilica building area also changes. Their intensity over such a small area is significant and unnatural. The magnitude of the flow direction changes themselves is important from the perspective of ongoing adverse seepage phenomena in the subsoil.

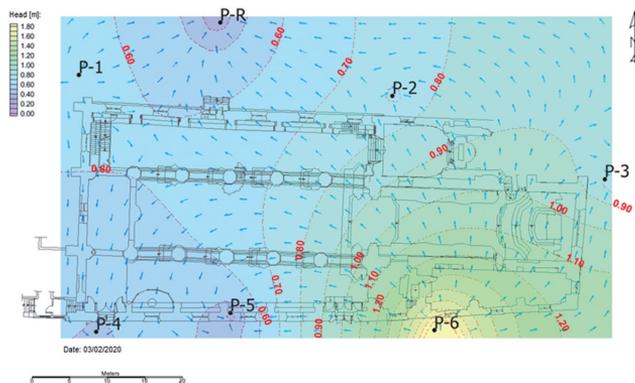
Fig. 10. Groundwater table level map with seepage directions for 3/2/2020, against the background of the Basilica basement level plan
