ARCHIVES  
of  
FOUNDRY ENGINEERING

# Cavitation Erosion of Nodular Cast Iron – Microstructural Effects

A.W. Orłowicz, M. Mróz \*, M. Tupaj, A. Trytek, M. Jacek, M. Radoń

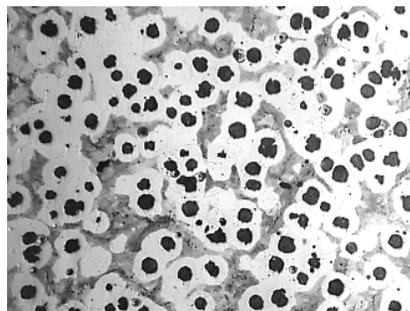
Fig. 2. Microstructure of the nodular cast iron used in the present study. Ferrite, pearlite, graphite. Magnification  $100\times$ . Section etched with 4%  $\text{HNO}_3$

Microstructure of the nodular cast iron used for the purpose of the present study is shown in Figure 2.

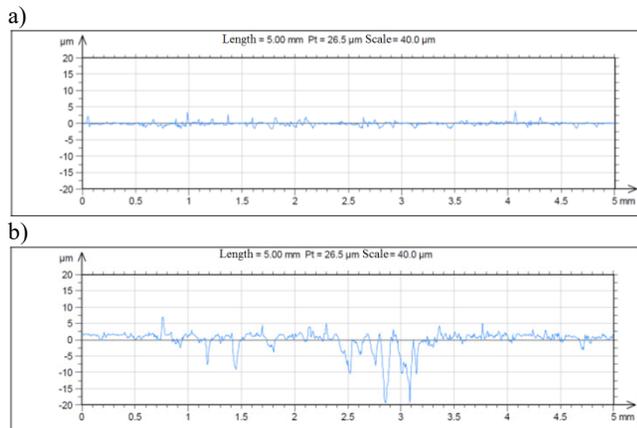
Fig. 3. Example profilograms of nodular cast iron specimen surfaces subject to cavitation erosion test for: (a) 30 minutes, (b) 120 minutes

Example 2D profilograms of specimen surfaces in the cavitation activity region after 30-min and 120-min test are shown in Figure 3.

Values of the parameter  $R_t$  characterizing geometrical structure of specimen surface after cavitation erosion resistance test in central portion of the cavitation interaction area are summarized in Table 1.

The obtained results indicate that with the increase of cavitation interaction time from 30 min to 120 min, value of parameter  $R_t$  increase more than fivefold.

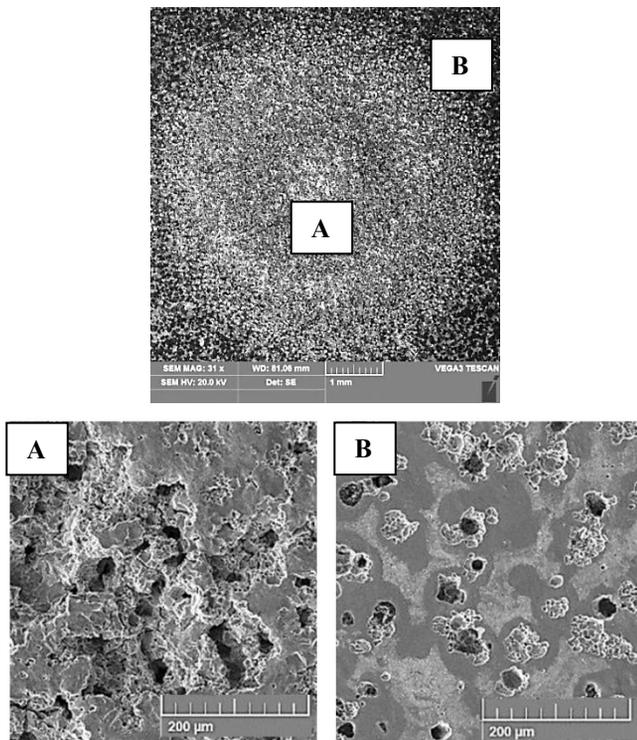
Fig. 4. Example views of specimen surface after 120 minutes of cavitation erosion resistance testing; A — central and B — outermost area of cavitation interaction spot

An example view of specimen surfaces after the cavitation erosion resistance test lasting 120 minutes is shown in Figure 4. To reveal microstructure of matrix, specimens were etched with 4%  $\text{HNO}_3$ .

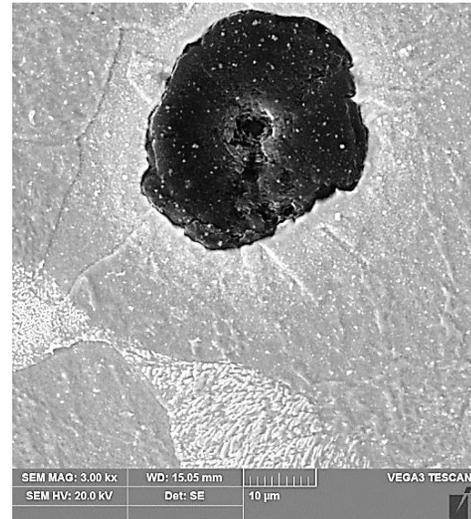
Fig. 5. The first stage of cast iron microstructure degradation. Outermost portion of cavitation interaction spot. Destruction of graphite precipitates in ferritic matrix progressing from center towards graphite-matrix interface

Figures 5–8 illustrate characteristic changes in microstructure of areas subject to cavitation interaction.

The obtained results allowed to establish the sequence of stages in which microstructure of nodular cast iron with ferritic-pearlitic microstructure is subject to degradation. Destruction starts with graphite precipitate tear-offs occurring in their central portions. The most durable is a thin graphite film in contact with matrix.

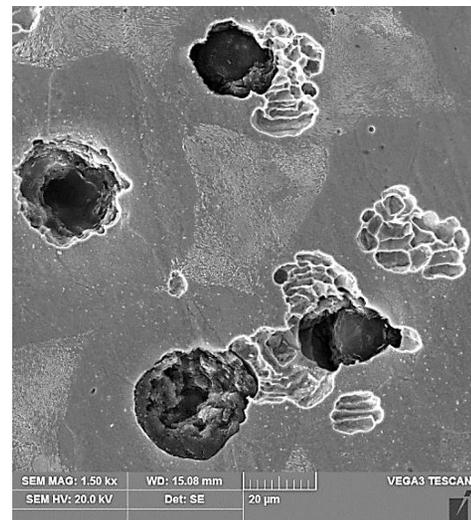
Fig. 6. The second stage of cast iron microstructure degradation. An outermost portion of cavitation interaction spot. Note high degree of graphite precipitate degradations progressing in layers but always from center towards graphite-matrix interface. Partial graphite tear-offs initiate degradation of ferritic matrix

In the next stage, degradation spreads onto ferrite precipitates surrounding graphite nodules. Further development of erosion of the ferritic matrix are suppressed by pearlite precipitation areas.

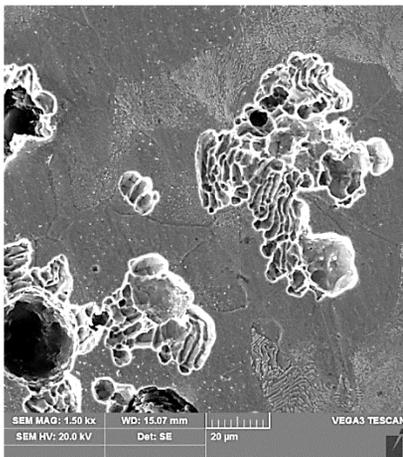
Fig. 7. The second stage of cast iron microstructure degradation. Uttermost region of the cavitation interaction zone. Significant progress in ferritic matrix degradation blocked locally by pearlite precipitation areas

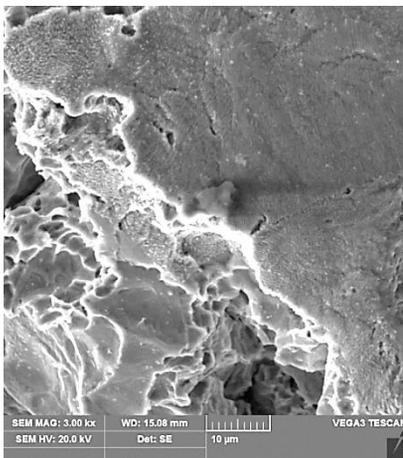
Fig. 8. The second stage of cast iron microstructure degradation. A central portion of the cavitation interaction spot. Deep cavitation-induced cavities in ferritic matrix with visible initial stage of destruction of an exposed, deeply lying graphite precipitate. No visible damages to pearlite precipitates

After the longer test cycle of 120 minutes, no evidence was found of degradation in pearlite precipitates. The obtained results do not confirm any structural response of nodular cast iron microstructure to cavitation interaction in aqueous environment reported by authors of [12]. It seems to be a reasonable assumption that the material examined in the above-quoted study was in after a heat treatment after which the cracks on the graphite-matrix interface occurred as a result of diffusion processes. The cracks could provide easy paths for propagation of cavitation-induced destruction.
