PROBLEM OF NON-MEASURED POINTS IN SURFACE TEXTURE MEASUREMENTS

This work is focused on the issue of non-measured points – one of the most important problems in surface texture measurements using optical methods. The fundamental aim of this research is to analyse errors of surface texture measurements caused by the presence of non-measured points. This study is divided into two parts. In the first part, circles with non-measured points were artificially created on peak portions of measured surfaces. In the second part – the results of measurement by a Talysurf CCI Lite interferometer were analysed. A measurement area of 3.3×3.3 mm contained 1024×1024 points. The measurements were performed with different intensity of light. Changes of parameters regarding the analysed errors depended on a surface type. The following parameters are susceptible to errors: skewness Ssk , areal material ratio Smr , as well as the following feature parameters: Spd , Sda , Sdv , Sha and Shv . Inaccuracies of measurement in valley parts of two-process textures led usually to larger errors of parameter computations compared with deviations in peak portions.

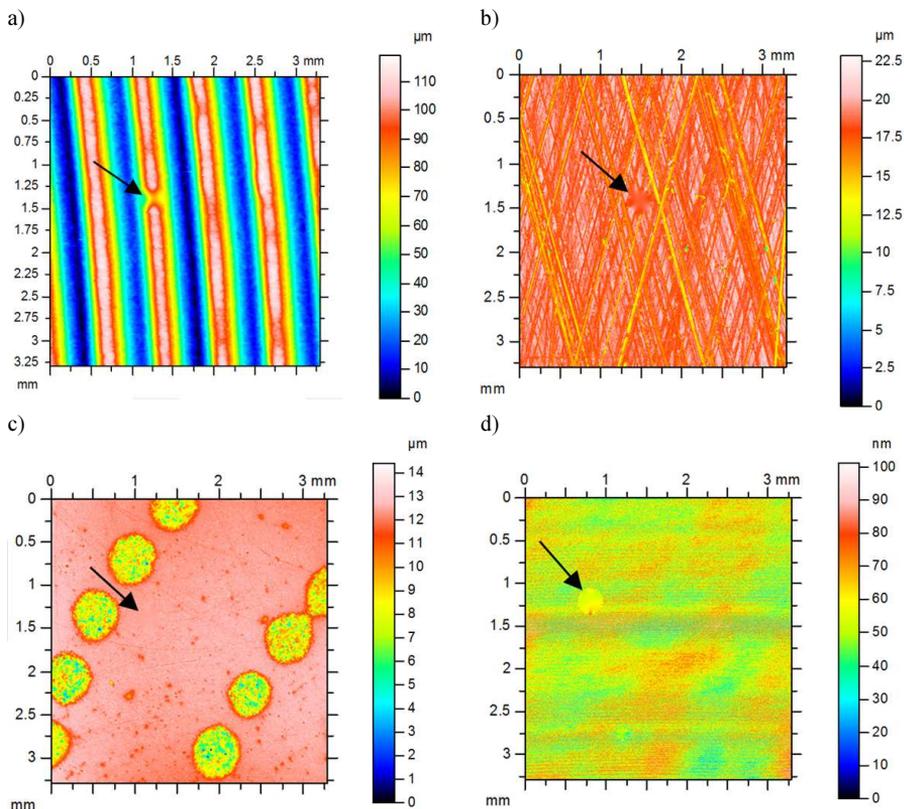
Ten surfaces were analysed; four of them were subjected to a detailed study. Fig. 1 shows examples of the analysed textures. The arrows indicate places where non-measured points are present after filling in. They indicate the effect of non-measured points on surface views. One can see that the corrected part of image is clearly visible on the surface after milling, as shown in Fig 1a, because the circle with non-measured points was located in a surface peak part. The modified circles on honed (Fig. 1b) and polished surfaces (Fig. 1d) are also visible. An anisotropic character of these textures is the most probably reason of visibility of the improved surface parts, because the corrected details are isotropic. However, it is difficult to find a circle with filled in non-measured points on the lapped surface with isolated oil pockets, created by the abrasive jet machining (Fig. 1c). The presence of dimples and an isotropic character of the peak surface part after lapping are the most probable reasons of a small visibility of the error.

Fig. 1. Contour plots of surface points after milling (a); honing (b); texturing by the abrasive jet machining after initial lapping (c) and polishing (d) after filling in non-measured points.

Although the error caused a change of the milled surface view (see Fig. 1a), the relative absolute changes of parameter values were not higher than 2%. A different tendency of changes of values for various height parameters was found: for statistical parameters Sa (arithmetic mean height) and Sq (root mean square height) as well as Spk (reduced summit height) and Sv (maximum valley height) they decreased, whereas for Sk (core roughness depth) and Sp (maximum peak height) parameters the changes increased. They were not higher than 0.7%. Due to a decrease of the Spk parameter as well as $Sr1$ ratio (upper bearing area) values, the $Sa1$ parameter value decreased; its changes were comparatively large (about 1.9%). The values of both skewness Ssk and kurtosis Sku increased. As a consequence of reduced statistical height parameter values, the values of hybrid parameters Sdq (root mean square slope) and Sdr (developed interfacial area ratio) decreased. The material volume Vm increased; its changes were the biggest of all the analysed parameters (about 2%). Among the feature parameters, Spd (peak density) and Sda (mean hill area) values increased. The spatial parameters were stable. Generally, it was found that the values of parameters related to a peak surface part ($Sa1$ and Vm) changed in the greatest degree.

It is interesting that – from the cylinder liner surface parameters – the closed dale volume Sdv value decreased the most (about 4%) (Fig. 1b). The maximum relative change of other parameter values was 1.7%. From the amplitude parameters only the value of Sq decreased, whereas Spk increased. Similarly to the milled surface, the Ssk and Sku parameter values increased, whereas those of Sdq and Sdr decreased. The functional parameter values from V family changed; those of Vm increased, whereas Vmc (core material volume) and Vvc (core void volume) decreased. The feature parameter values Spd and Sdv (mean dale volume) decreased while that of Sda increased. Generally, the same tendency of parameter value changes for the milled and honed surfaces was found.

The parameter values of textured surfaces shown in Fig. 1c changed marginally due to the presence of non-measured points. The maximum change of parameter values was 1% (Spd and Sdv values decreased). The values of the following parameters decreased: Spk , $Sa1$, Sdr , Vvc and Sda , whereas Sxp (extreme peak height) – increased.

The relative errors of parameters for the polished surface shown in Fig. 1d were comparatively large. Those for Sdv decreased by about 8%, for $Sr1$ increased by 2.4% and – consequently – for $Sa1$ increased by 3.5%, whereas for Ssk and Sda decreased by 3 and 1.6%, respectively. Changes for other parameters were smaller than 1%; for the following parameters they decreased: Sk , $Sr2$ (lower bearing area), Sp , Sa , Std (texture direction), Sdq , Sdr , Vvc and Spd , whereas for the following parameters they increased: Spk , $Sa2$ (oil capacity), Sku and Vm .

Generally, after analysis of parameter value changes for all ten tested surfaces it was found that deviations of the skewness Ssk and kurtosis Sku values occurred (up to 3%). The values of statistical amplitude parameters Sa and Sq typically decreased, whereas those of the parameters describing total height Sz , Sp and Sv were more stable. As a result of the amplitude reduction, the values of hybrid parameters also decreased. Since non-measured points were located in the peak regions of analysed surfaces, the values of parameters connected with a peak part: $Sr1$, Spk , sometimes Sk and consequently $Sa1$ typically changed (up to 4%); in most cases the peak density Spd value marginally decreased. The spatial parameters were usually stable; the main directionality described by Str , changed only for the anisotropic one-directional texture (Fig. 1d). Large changes of the feature parameters: Sdv and Sda deserve attention. Changes of parameter values depend on a surface type. For example, maximum changes of parameter values shown in Fig. 1c was 1%; it is difficult to find filled-in non-measured points on this graph.

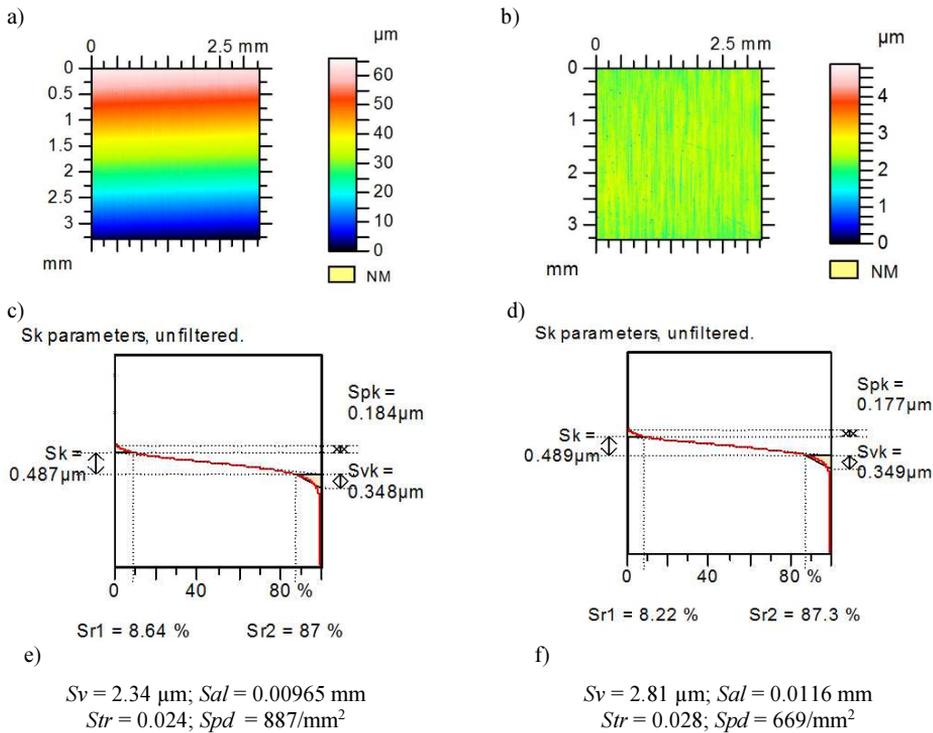
It was found that improper measurement conditions might cause serious inaccuracies in the parameter calculations. High errors of parameter computations occurred even for very small ratios of *non-measured* points (NM). Fig. 2 presents an example. Non-measured points of a small ratio (0.0268%) located in a valley surface part caused a considerable increase of roughness height in this part (the *Sv* value increased by more than 20%). In addition, the spatial parameter values changed; the autocorrelation length *Sal* increased by more than 20%, whereas the texture parameter *Str* by more than 15%. The peak density decreased by about 25%, whereas the values of feature parameters: *Sda*, *Sha* (mean hill area), *Sdv* and *Shv* (mean hill volume) increased by more than 25%. These changes are large, therefore analysis of the surface distortion due to the presence of non-measured points deserves attention. However, the changes of parameter values characterizing the material ratio curve, from the *Sk* family: *Sk*, *Spk*, *Svk* (reduced valley depth), *Sr1* and *Sr2* were smaller than 5%. An increase of the NM ratio from 0.00935 to 0.0268% caused non-visible changes of the contour plot; therefore it was presented in Fig. 1 only for the reference surface.

Fig. 2. Contour plots of the polished surface before (a) and after form removal (b) with material ratio curves (c, d) and selected parameters (e, f); graphs a, b, c, e correspond to NM ratio 0.00935%, but d and f – 0.0268%.

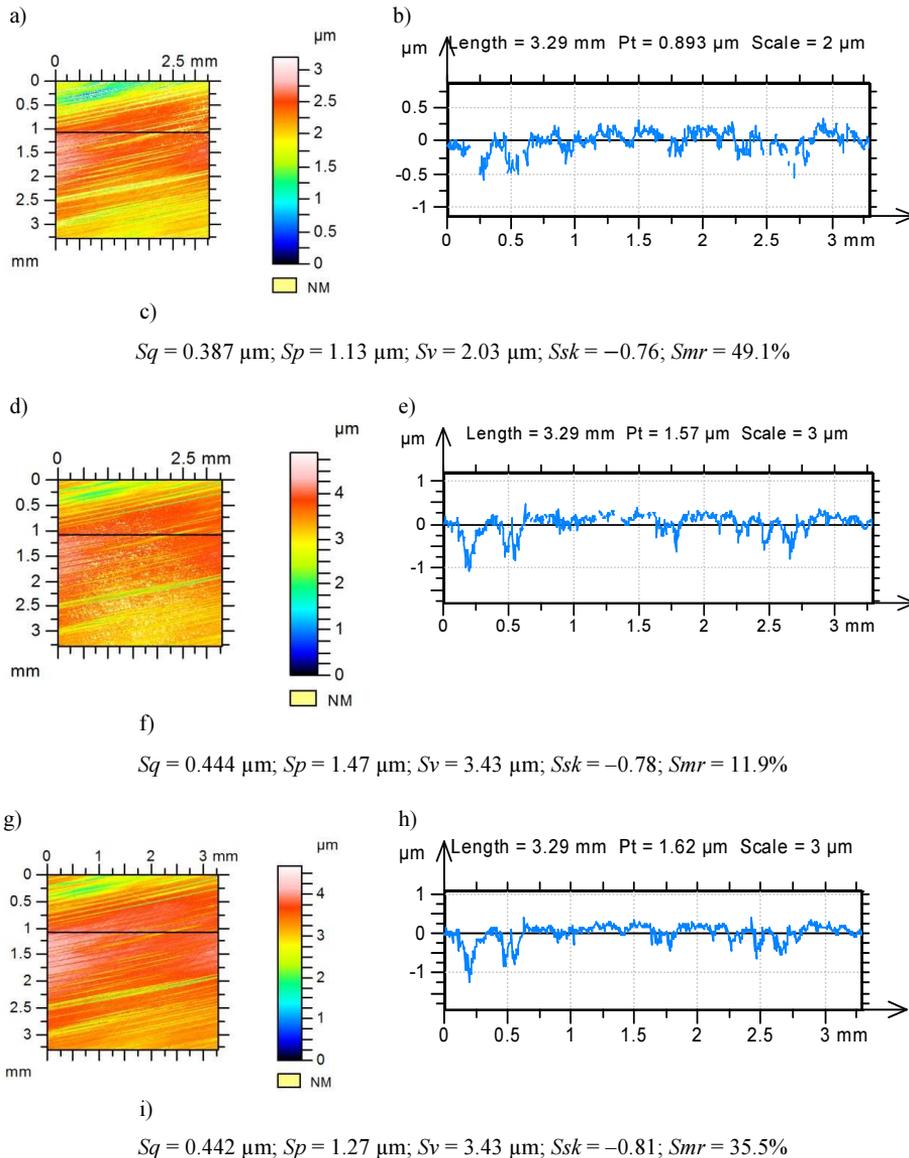
Fig. 3. Contour plots (a, d, g); extracted profiles (b, e, h) and selected parameters (c, f, i) of the polished surface with non-measured points located in a valley part, NM ratio 10.1% (a, b, c) with non-measured points located in a peak part, NM ratio 9.3% (d, e, f) with the smallest number of non-measured points, NM ratio 0.1% (g, h, i).

The changes of parameters depend on a location of non-measured points. Fig. 3 presents an example. A surface of a little asymmetric distribution after polishing was studied. An NM ratio of a texture shown in Figs. 3a and 3b is similar to that presented in Figs. 3d and 3e, however one can see from both views of contour plots and extracted profiles that non-measured points

are located in valley and peak parts, respectively. Due to the presence of non-measured points in a valley part the S_v parameter value decreased by about 40% and S_q – by nearly 12%. The presence of non-measured points in a peak surface part led to an increase of the S_p parameter value by more than 15% and a decrease of the S_{mr} value by more than 60%. Due to the presence of non-measured points the S_{sk} parameter value increased. A change of S_{al} parameter value was smaller than 10%, which was probably related to the fact that a mixed surface (S_{tr} about 0.35) was analysed.

The presented above tendencies are concerned mainly with one-process surfaces. However similar trends were observed also for two-process textures characterized by a negative skewness (usually smaller than -1). An increase of light intensity led in most cases to a decrease of skewness Ssk and usually to an increase of kurtosis Sku values. This is reasonable because a small skewness corresponds to a large kurtosis. This tendency was probably caused by the presence of non-measured points in the bottom of valleys (Figs. 3a and 3b).

For the surface shown in Fig. 3 the change of Ssk parameter value is small, but high errors of this parameter calculation can occur for two-process textures. As a result of it a surface machined well looks like a one-process texture and can be classified as a spoilage. An increase of the Ssk parameter value is related to a decrease of the Svk parameter value. Errors of two-process surface topography parameter estimations are very important, because the functional properties of two-process surfaces are better than those of one-process textures [28–31]. An inaccuracy of a valley part measurement typically led to larger errors of parameter computations compared with a disturbance in a plateau region. For example, the relative errors of parameter values for the surface shown in Figs. 5a and 5b are higher than those for the surface presented in Figs. 5c and 5d, although the NM ratio of the latter is higher. Fig. 6 presents relative changes of typical parameters. Negative changes correspond to underestimation, while positive ones – to overestimation of amplitude parameters. The Ssk parameter values of the surface shown in Fig. 5 are: in 5a and 5b -0.34 , 5c and 5d -1.26 , 5e and 5f -1.25 .

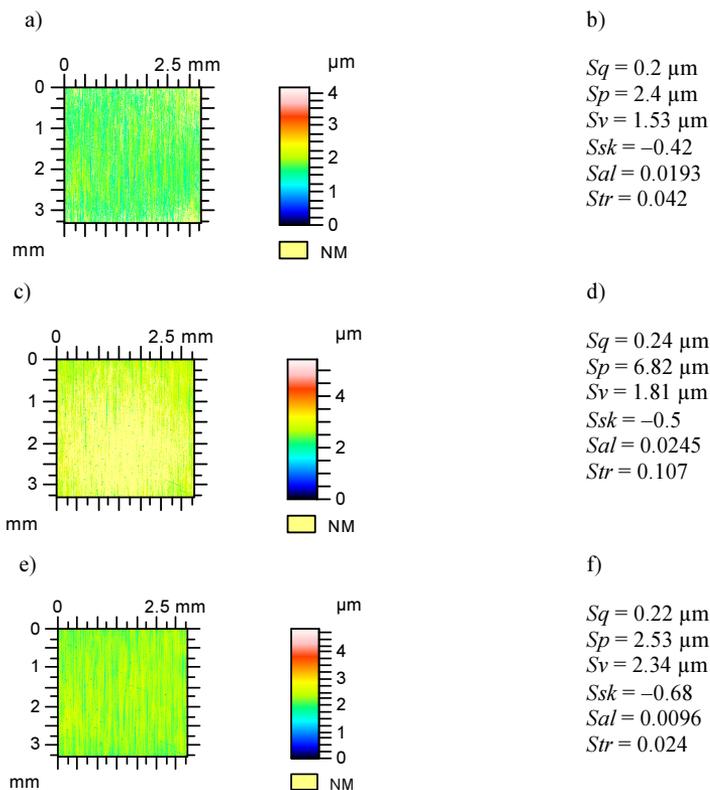
Fig. 4. Contour plots (a, c, e) and selected parameters (b, d, f) of the polished surface with non-measured points located in a valley part, NM ratio 24.2% (a, b) with non-measured points located in a peak part, NM ratio 58% (c, d) with the smallest number of non-measured points, NM ratio 0.00935% (e, f).

The statistical parameters S_q and S_a are stable for an extremely high number of non-measured points. When these points are located in a peak surface part (NM ratio was 58% – see Figs. 4c, and 4d) the S_q parameter value was overestimated by 9%. A similar error was obtained when non-measured points were present in a valley part (NM ratio was 24.2% – see Figs. 4a and 4b). Similarly to Fig. 3, the presence of non-measured points in a valley surface part caused large changes of the S_v parameter value, but in a peak part – of the S_p parameter value. In both cases, errors led to an increase of the parameter values: S_{al} , S_{tr} and S_{sk} .

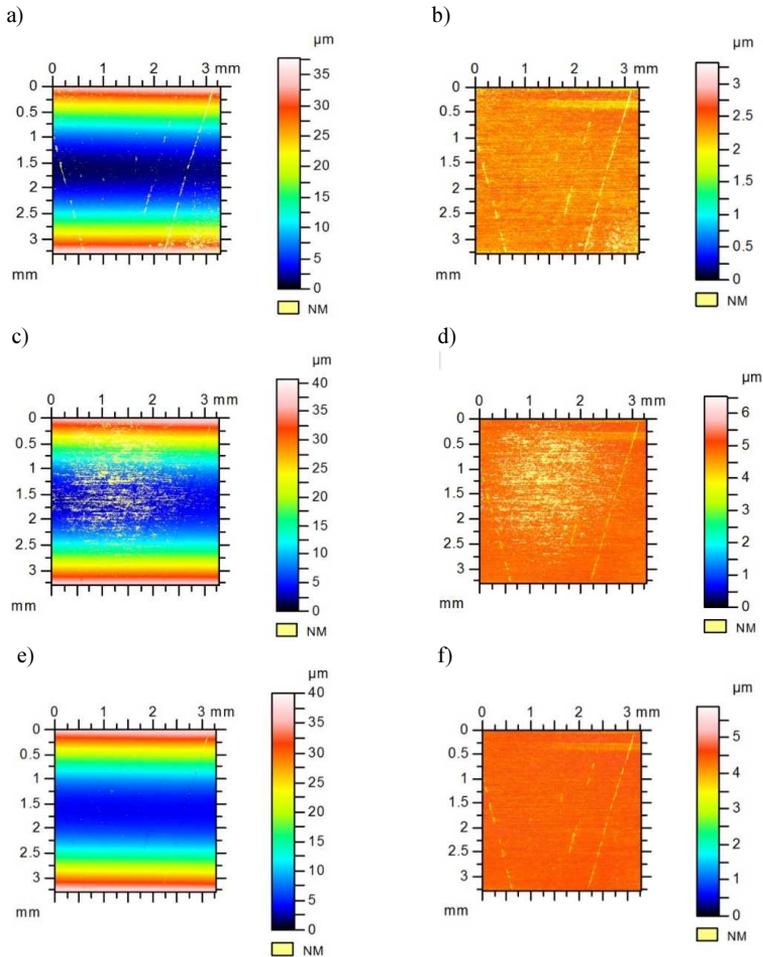
Fig. 5. Contour plots of a worn cylinder surface before (a, c, e) and after form removal (b, d, f) with non-measured points located in a valley region; NM ratio 4.31%(a, b), in a peak part; NM ratio 14.4% (c, d) and with their smallest number; NM ratio 0.102% (e, f).

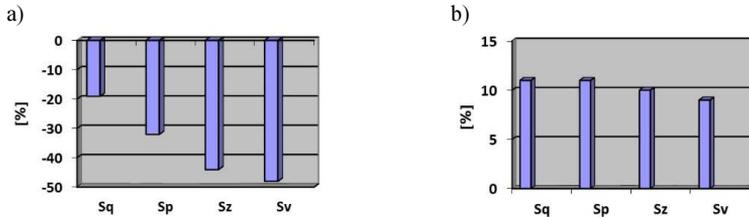
Fig. 6. Relative changes of parameters for the surface presented in Fig. 5a (a) and 5b (b).

An incorrect light intensity could lead to the presence of spikes (Fig. 6). However, erasing non-measured points from the whole honed surface can cause an increase of profile height (Fig. 7c and 7e), contrary to a similar correction of profile only (Fig. 7g). When the light intensity was smaller (Fig. 7b, 7d, 7f and 7h) the non-measured points appeared in the same place (see arrows), but without the presence of spikes. The same profile was obtained after correction of the whole surface or profile (see Fig. 7f and 7h). The Sp parameter value for the corrected surface after form removal with a smaller NM ratio was $1.21\ \mu\text{m}$, but with a higher one – $3.07\ \mu\text{m}$. The arrows indicate positions of errors.

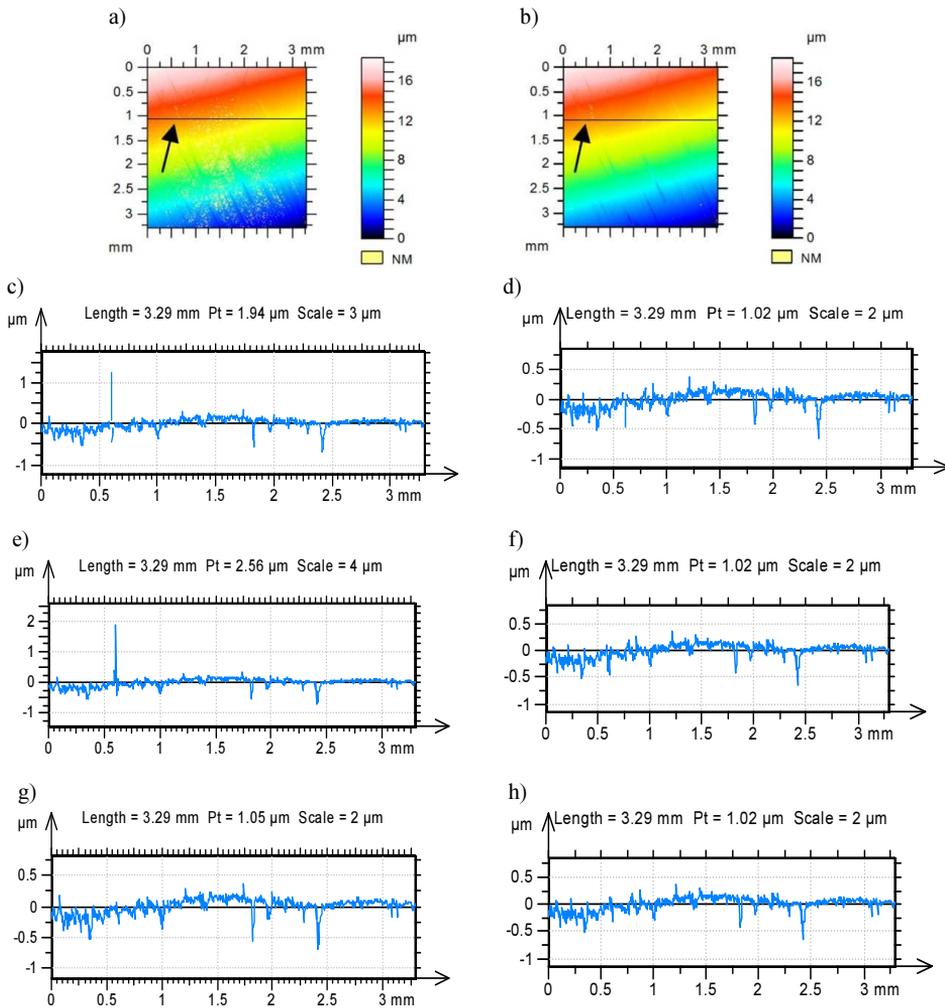
Fig. 7. Contour plots (a, b), extracted profiles before correction – filling in (c, d), after correction of the whole surface (e, f) and after profile correction (g, h); NM ratio 6.68% (a, c, e, g) and 0.079% (b, d, f, h).
