A Possibility to Improve Resistance of Cast-iron Hydraulic Valves to Cavitation Wear

A.W. Orłowicz, M. Tupaj^{*}, M. Mróz, B. Kupiec, M. Jacek, M. Radoń

Rzeszow University of Technology,

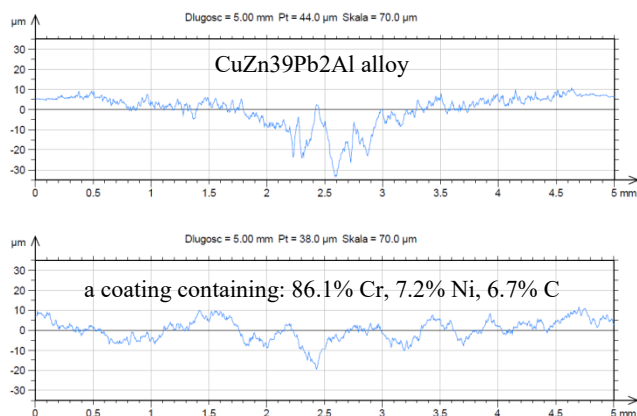
Fig. 5. Example profilograms of specimen surfaces in areas exposed to cavitation taken along a line crossing centers of cavitation craters

Figure 5 shows example profilograms of surfaces of the two compared materials after cavitation tests, with said profilograms being taken along lines crossing centers of respective cavitation craters.

The obtained results weight in favor of decidedly higher susceptibility of the material used earlier for valve seat sealing inserts to cavitation wear compared to the coating material used in the tests. It has been found that the cavitation crater occurring on the coating was less deep and less wide.
