PULL-OFF ADHESION STRENGTH OF POLY-P-PHENYLENE BENZOBISOXAZOLE (PBO) – REINFORCED TIMBER

The article discusses results of pull-off adhesion strength tests on poly-p-phenylene benzobisoxazole (PBO) mesh bonded to fir timber beams using epoxy resin. The tests were performed in accordance with the PN-EN 1542 standard. Timber elements reinforced with PBO fibres were subjected to pull-off tests to measure the adhesive strength of the mesh to the beams. The factors occurring during the test were also characterized, which may affect its results such as the method of application of the tearing force, selection of epoxy glue, surface preparation of the tested elements, occurrence of material defects in the wood and types of substrate destruction. The experimental data show that failure of the timber layer was not observed in all the specimens tested.

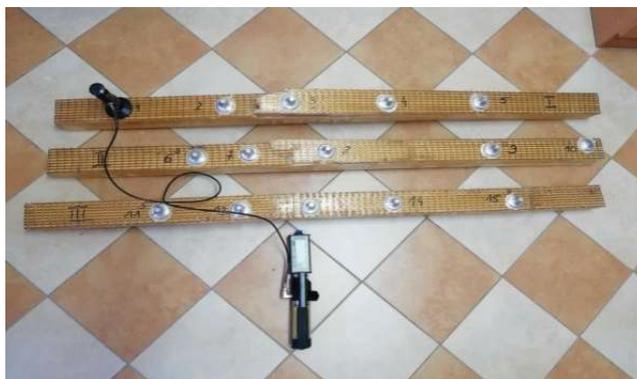
Fig. 2. View of the tested samples.

The PN-EN 1542 [23] standard specifies the number and placement of samples. According to the standard, at least one sample of the product or repair system is required, to be tested at least 5 times. Due to the fact that the timber beams had been subjected to a destructive test aimed at estimating their load capacity, it was decided to randomly arrange the samples for this test, as well as to deliberately distribute the samples in places of material defects and PBO mesh cracks (Figs. 1 and 2), located and described in Table 2.
