SEOK-WOO KO¹, HYEONWOO PARK², IL YOO³, HANSOO KIM²,
 JOONHO LEE^{2*}, BYOUNGCHUL HWANG^{1*}

IN-SITU OBSERVATION OF HIGH-TEMPERATURE FRACTURE BEHAVIOUR OF 347 STAINLESS STEEL SUBJECTED TO SIMULATED WELDING PROCESS

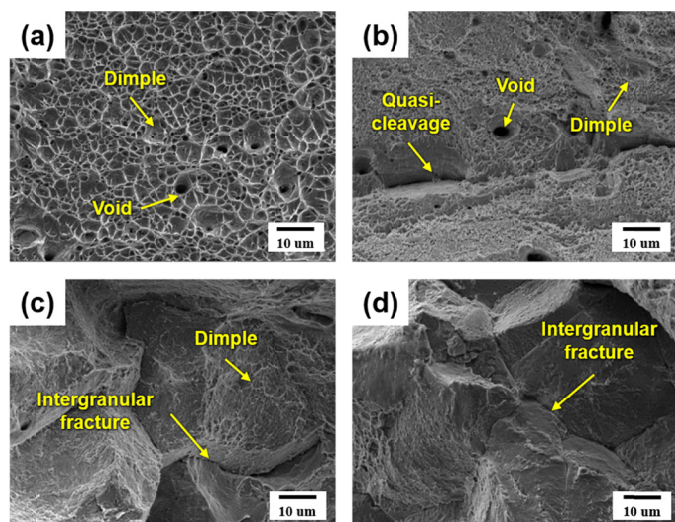
Fig. 5. SEM fractographs of the (a) solution- and (b) aging-treated specimens tested at room temperature, and the (c) solution- and (d) aging-treated specimens tested at the temperature of 800°C

Fig. 5 provides the SEM fractographs of the specimens tested at room and high temperatures. The solution-treated specimen exhibited mostly ductile fracture, where large dimples were observed particularly at room temperature. In aging-treated specimen, quasi-cleavage fractures were often observed owing to the formation of $M_{23}C_6$ carbides at grain boundaries and fine dimples were found near the quasi-cleavage fracture. Intergranular fractures were mainly observed in the solution- and aging-treated specimens tested at high temperatures.
