M. ROZMUS-GÓRNIKOWSKA\*, J. KUSIŃSKI\*, M. Blicharski\*

## THE INFLUENCE OF THE LASER TREATMENT ON MICROSTRUCTURE OF THE SURFACE LAYER OF AN X5CrNi18-10 AUSTENITIC STAINLESS STEEL

The influence of laser shock processing (LSP) on microstructure of the surface layer of an X5CrNi18-10 austenitic stainless steel was studied. The laser treatment was performed using a Q switched Nd:YAG ReNOVAL laser.

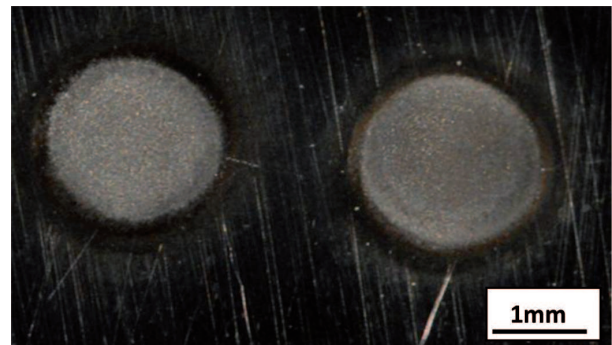
Fig. 2. A view of the surface of treated material after laser treatment

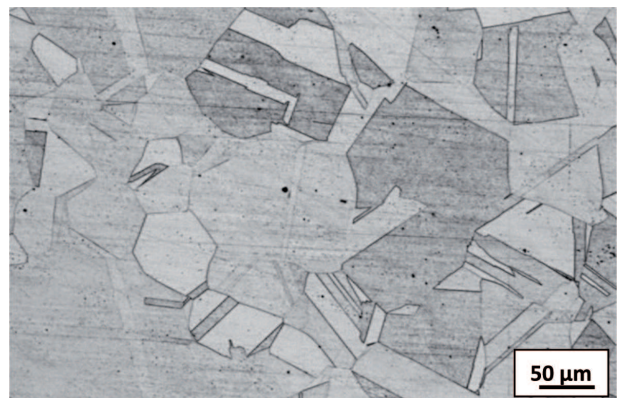
Fig. 3. Light microscopy image showing microstructure of the steel before the laser treatment

Microstructure of the austenitic stainless steel after annealing is shown in Fig. 3. Only one phase (austenite) was distinguished by the light microscopy. The average grain size determined from micrographs was about 150 μm.

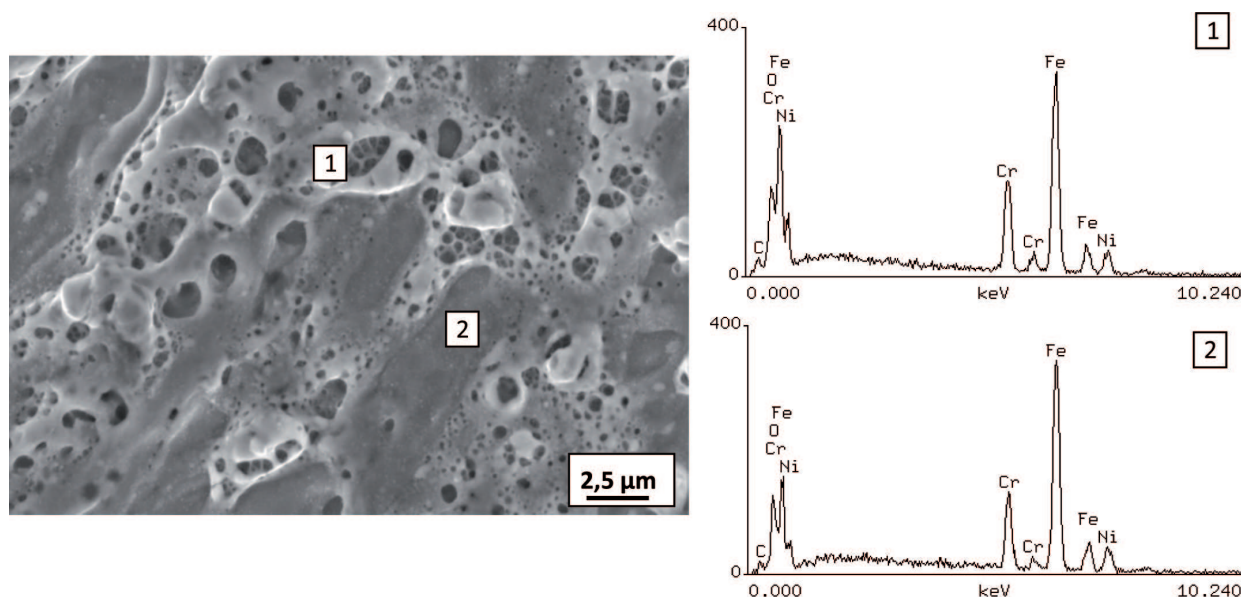
Fig. 4. Topography of the steel after LSP (SEM SE), the EDS spectras show the presence of iron, chromium, nickel as well as oxygen and carbon at the treated surface (points 1-2)

The surface of the austenitic stainless steel after laser treatment is presented in Fig. 4. The SEM images of the treated surfaces showed that the laser shock processing brought about ablation and melting of the surface layer of the investigated material. After initial laser pulses, a black paint was splattered from the treated surface probably, due to a high pressure of plasma. On the region without coating, the laser beam irradiates the material surface directly and leads to its ablation and melting. At the same time, after short time duration of laser pulses, due to an intensive cooling, the liquid metal has been frozen. It is worth to note that such heating and cooling cycle was repeated 15 times in the same area. The features most frequently observed on the surface after the LSP appear as craters, holes and solidified droplets. The surface layer after treatment also showed a high porosity level. Cracks have not been observed. An appearance of porosity is probably due to the ablation of the material during the process. The presence of droplets and porosity indicates that the process of the laser shock processing was thermo-mechanical rather than purely mechanical one.

The EDS analysis showed the occurrence of Fe, Cr, Ni, C as well as O in the ablated treated surface (Fig. 4). The presence of oxygen indicates a possibility of the surface oxidation during laser processing, while the carbon peak comes likely from the black paint.

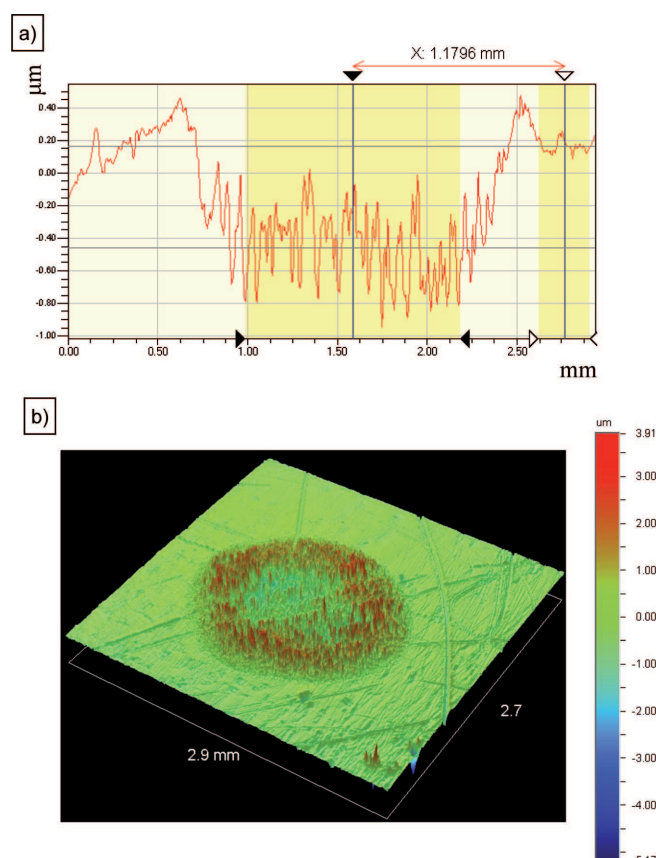
Fig. 5. Surface roughness of the steel after laser treatment (a) 2d (b) 3d

The typical roughness profile of the surface after laser treatment is shown in Fig. 5. The measurements indicated that Nd:YAG laser treatment produced an increase in the surface roughness. Ra (arithmetic average of the absolute values of all points of the profile) in-

creasing from  $0.1 \mu\text{m}$  before treatment to  $0.33 \mu\text{m}$  after LSP.

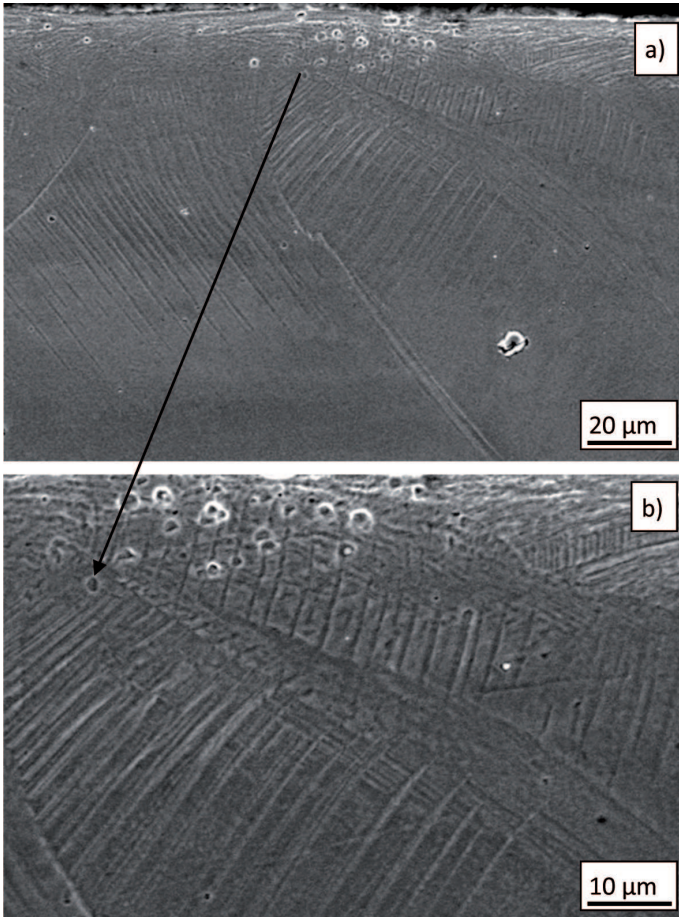
Fig. 6. SEM cross-section of the treated surface (a-b), clusters of slip band are visible

SEM images of the sample cross sections showed that clusters of slip bands were formed during the treat-

ment in the near surface region (Fig. 6). Such a feature is usually observed in austenite after plastic deformation and is often associated with the formation of deformation twins and stacking faults. The changes in microstructure came down to  $70\ \mu\text{m}$  below the surface.

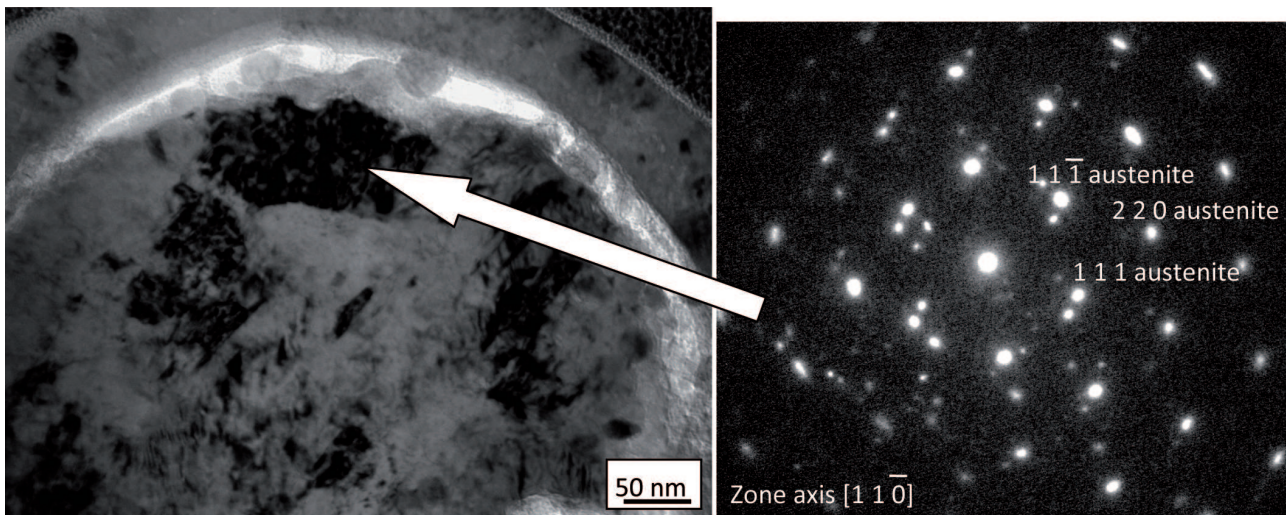
Fig. 8. Microstructure of the steel after LSP process in cross-section (TEM) and corresponding diffraction pattern

The TEM microstructure of the surface layer is presented in Fig. 7 and 8. The micrographs show very high density of dislocations and stacking faults. Transmission electron microscopy of the laser-shock treated steel revealed neither deformation twins nor martensite. This is believed to be mainly due to low shock pressure. In previous LSP studies at higher power density ( $1\ \text{GW}/\text{cm}^2$ ) twinning was found [10].
