DOI: 10.1515/amm-2015-0308

K. SIECZKOWSKI\*, J. ADAMIEC\*,#, G. SAWICKI\*\*

# THE STRUCTURE AND PROPERTIES OF MIXED WELDED JOINTS MADE OF X10NiCrAITi32-21 AND X6CrNiMoTi17-12-2 STEELS

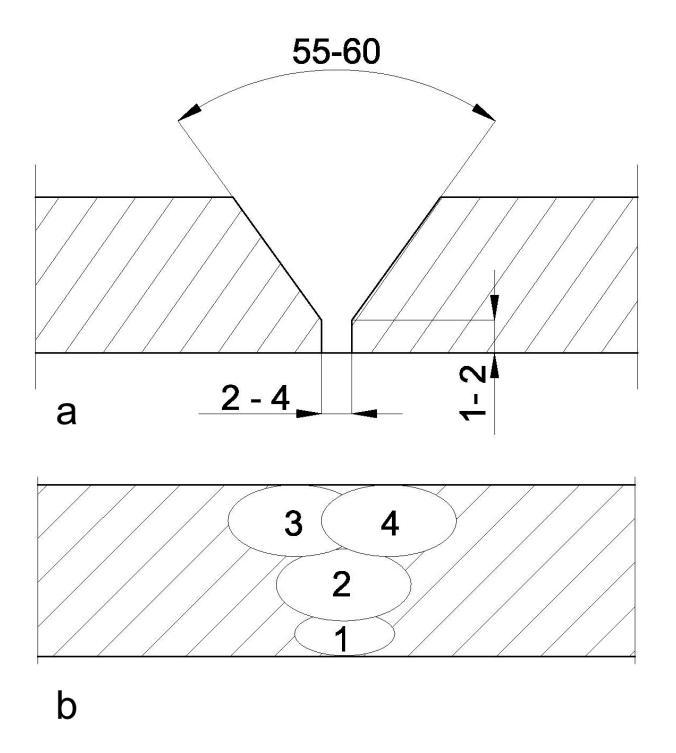
The welding tubes were bevelled at an angle of  $60^{\circ}$  (fig. 1a). The V- butt joint with a 2 mm threshold was performed with the TIG (141) method, using a direct current and linear energy of the arc not exceeding 1.2 kJ/cm, in argon shield, with the flow rate of 8-10 l/min. Figure 1.b presents the sequence of the beads. The interpass temperature did not exceed 150°C.

Fig. 1. Diagram showing a preparation of the joint for welding (a), sequence of the bead arrangement (b)

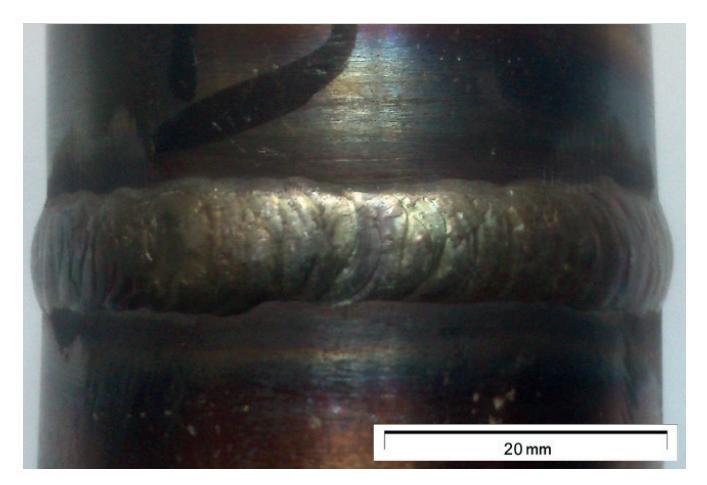
The visual tests were performed according to the requirements of the EN-ISO 17637 standard. The view of the face of the fusion weld is presented in Fig. 2. It was found that the joint had a correct even face. No black heat tints were revealed, which indicates a correct linear energy of the arc during the welding process.

Fig. 2. Face of a mixed joint made of X10NiCrAlTi32-21 and X6CrNiMoTi17-12-2 steels

The performed welding tests of tubes of  $\phi$  48.3 in diameter and wall thickness of 5mm, made of X10NiCrA1Ti32-21 and X6CrNiMoTi17-12-2 steels, showed that it was possible to get a correct joint with no welding imperfections. The joint has a smooth and even face (Fig. 3). No excess penetration bead or discontinuity from the side of the root were found. The fusion weld shape rate was at the level of 1.2 (Fig. 4). The structure of the joint consists of three typical areas, i.e. the native material made of polygonal austenite grains, a narrow heat-affected zone in which one can observe the process of partial melting of the grains and epitaxial crystalization of the crystals of the fusion weld, and of column crystals building up in the direction of the dissipation of heat in the fusion weld (Fig. 5).

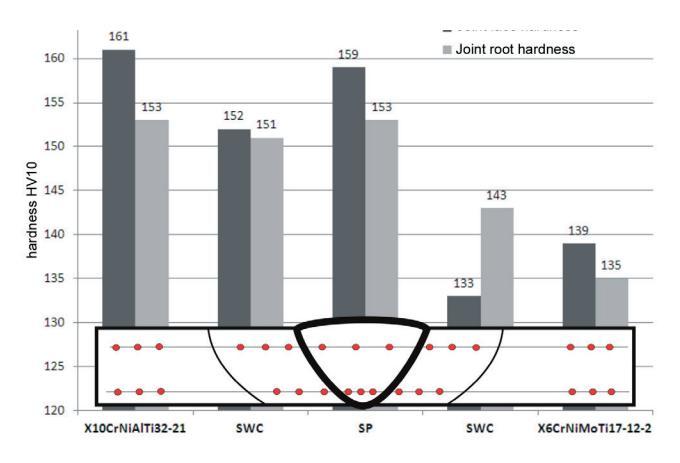
Hardness of the joint from the side of the face and from the side of the root was measured according to the PN EN ISO 6507-1:2007 and PN EN 1043-1:2000 standards. The measurements were taken with the application of the HPO 250 hardness tester, with the Vickers method, at the load of 98 N (HV10). The results (the average of three measurements) are shown in Figure 3. The hardness distribution analysis showed that the hardness of the native material made of the X10NiCrAlTi32-21 steel ranged from 146 HV to 164 HV. A similar range of hardness was measured in the HAZ (heat affected zone), i.e. from 145 HV to 160 HV. The average hardness in the fusion weld amounted to 159 HV from the side of the face (from 154HV to 163HV) and 153HV (from 152 HV to 158HV) from the side of the root. Hardness in the heat affected zone in the tube made of X6CrNiMoTi17-12-2 steel ranged from 132 HV to 149 HV, and in the material it was 137 HV (from 130 HV to 142 HV) on average (Fig. 3). The hardness of the joint is correct, one revealed no cures of the joint areas of a difference exceeding 100 HV, which is a prerequisite for the application of the developed welding technology in the power industry (according to PN EN ISO 12592).

Fig. 3. Distribution of hardness in the joint on the line from the side of the face and from the side of the root

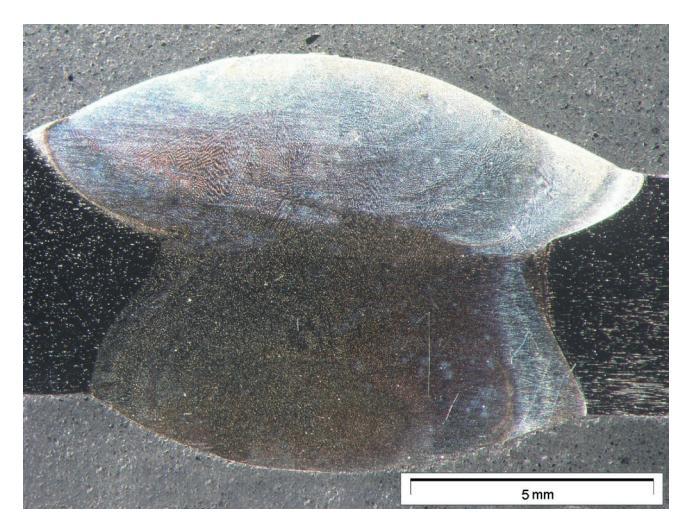
Fig. 4. Macrostructure of the mixed joint of the tubes made of X10NiCrAlTi32-21 and X6CrNiMoTi17-12-2 steels

The revealed macrostructure of the welded joint is correct and consists of three areas typical of welded joints, i.e. the native material (Fig. 4, C), a narrow heat-affected zone (Fig. 4, B) and the fusion weld area (Fig. 4, A). The shape of the fusion weld is normal, which is proved by the shape ratio (height to the width of the fusion weld) amounting to 1.2.

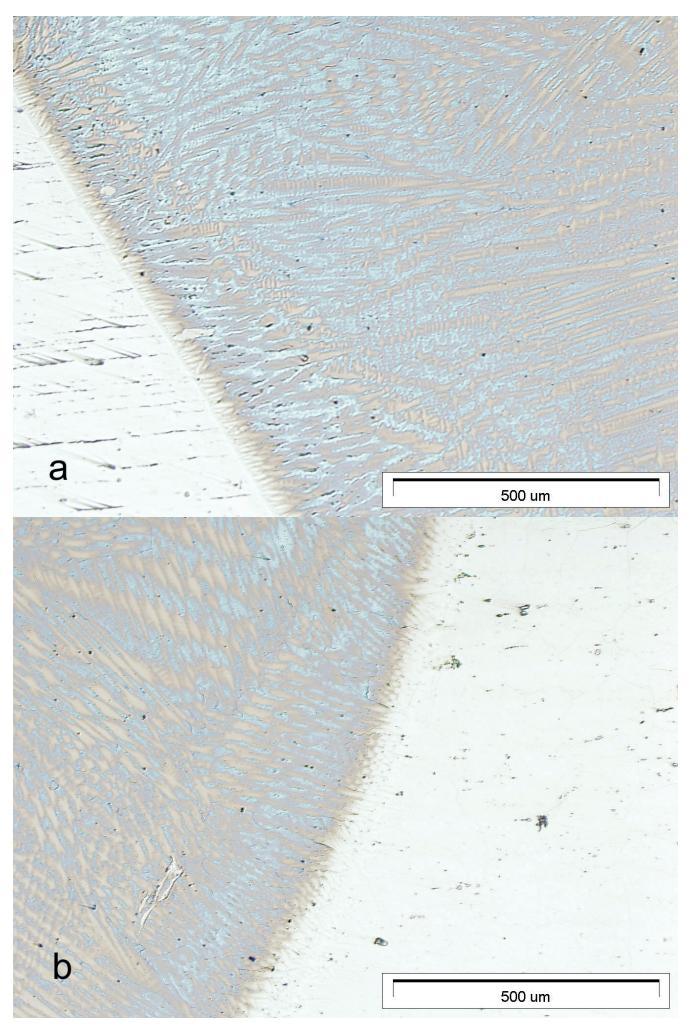
Fig. 5. Microstructure of the welded joint of the tubes made of X10NiCrAITi32-21 and X6CrNiMoTi17-12-2 steels: a) fusion line from the side of the tube made of the X6CrNiMoTi17-12-2 steel, b) HAZ in the X10NiCrAITi32-21 material

The native material of the tube made of X10NiCrAlTi32-21 and of X6CrNiMoTi17-12-2 steel grades consists of elongated polygonal austenite grains in a band arrangement, typical of the rolling process (figure

5a, b). In the HAZ on the fusion line the grains of the native material become partially melted and fusion weld crystals build up epitaxially (fig. 5a, b). In this area one can also see partially melted boundaries of the austenite grains, which shows that the partial melting zone was about 10  $\mu$ m wide (fig. 6). The fusion weld structure is mainly made up of column austenite grains, which build up in the direction of the heat abstraction.

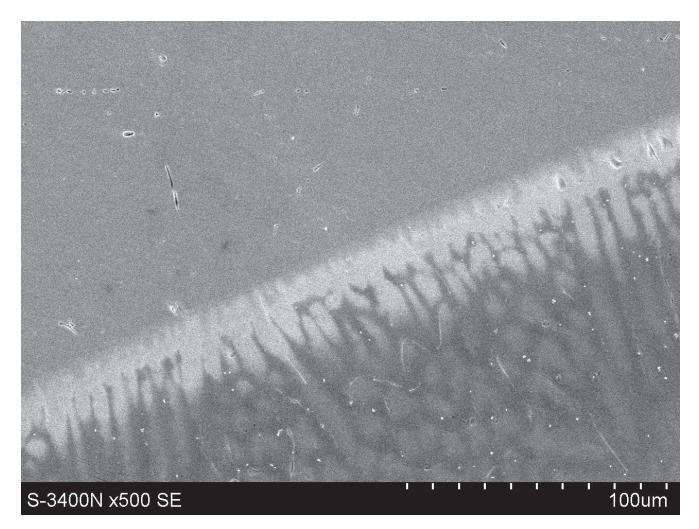
Fig. 6. Fusion line of the fusion weld into the tube made of the X10NiCrAITi32-21 steel

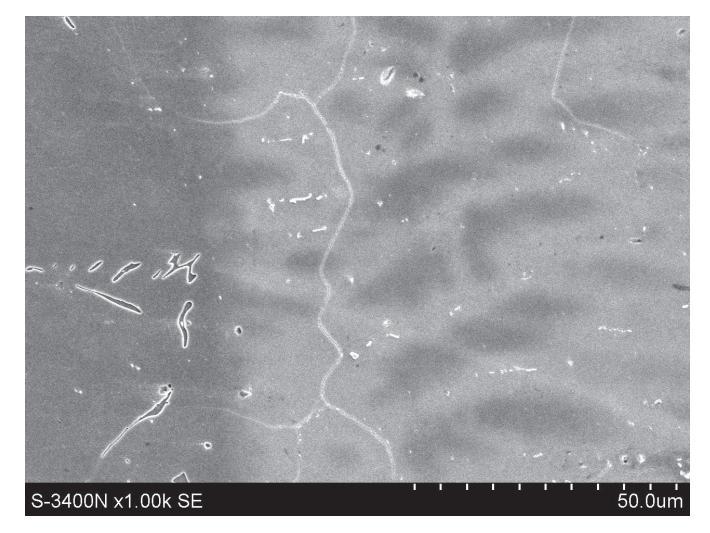
Figure 7 shows liquation cracks. The occurrence of these cracks is conditioned on the presence of a liquid metal layer on the grain boundaries during the cooling process, when thermal tensile stresses develop [5].

Fig 7. Liquation cracks in the HAZ of the fusion weld

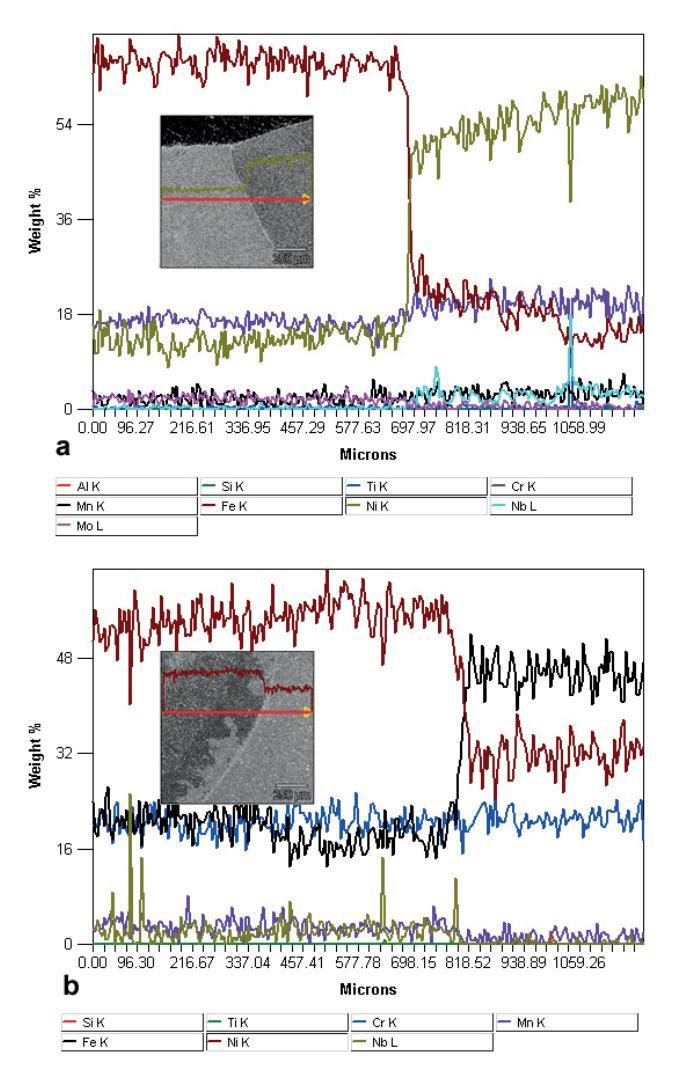
With the application of the EDS unit, one made a linear distribution of the alloying elements in both fusion lines (Fig. 8). The share of nickel in the fusion weld is about 60%. The iron content in the fusion weld decreases, while the nickel content increases. One also revealed changes in the percentage amount of chromium in the HAZ from the side of the X6CrNiMoTi17-12-2 material. However the chromium content in the fusion weld is similar to that in the X10NiCrAITi32-21 material.

Fig 8. Linear distribution of the alloying elements: a) fusion line of the X6CrNiMoTi17-12-2 material, b) HAZ from the side of the X10NiCrAITi32-21 material

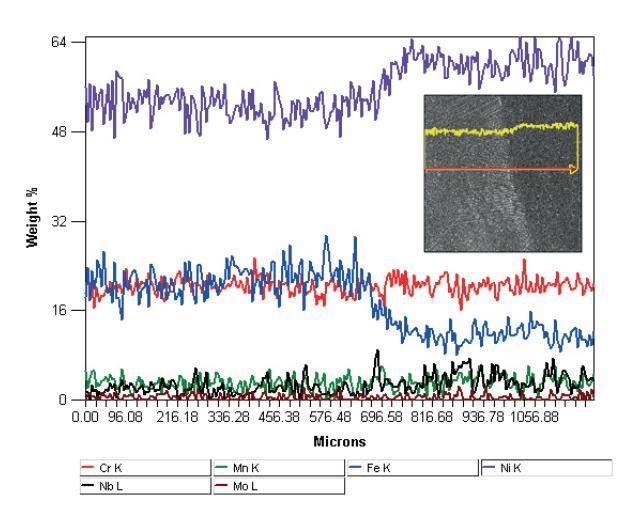
Analysis of the linear distribution of the areal share of the elements showed a difference in the share of nickel and iron in the fusion weld between particular beads, where this content also changes inversely proportionally (Fig. 9).

Fig. 9. Linear distribution of the elements on the fusion line between the layers of the applied fusion welds

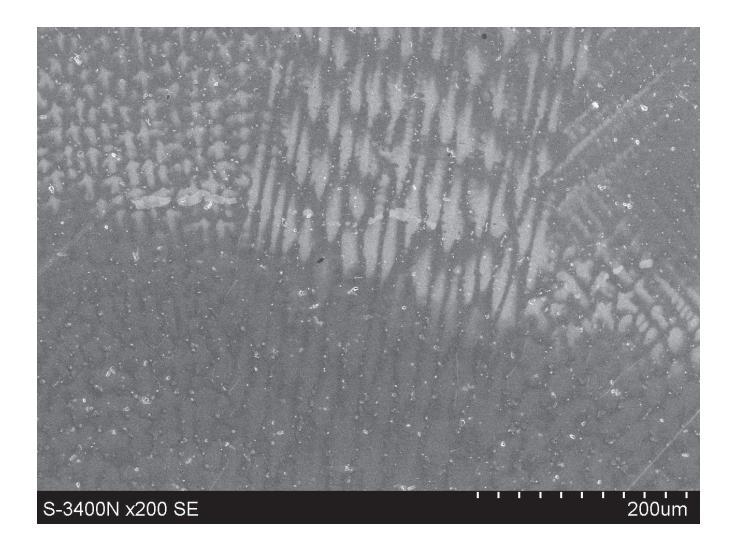
On the fusion line between the layers of the applied fusion weld, one can see the effects of the welding thermal cycle of the successively superimposed layers (Fig. 10). The occurring structures prove the existence of a dendritic and cellular crystallization. One can also see a changed crystallization direction in the form of elongated cellular- dendritic crystallites, formed following the change of the direction of bead arrangement [6].
