Detecting and Locating Signal Leakages from Cable TV Networks – A Case Study

Hussein Taha, and Péter Vári

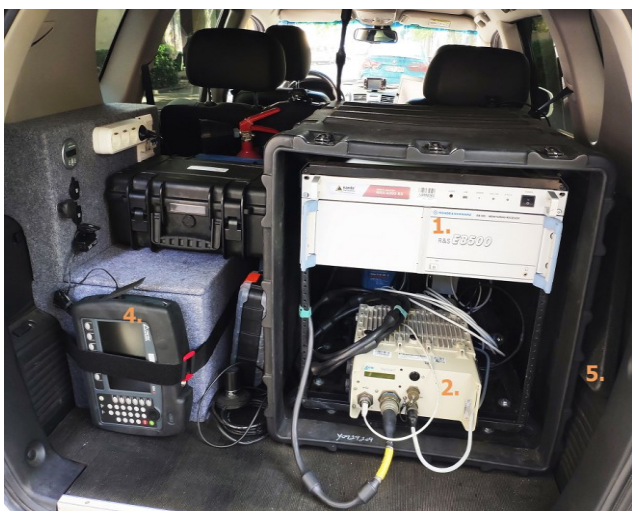
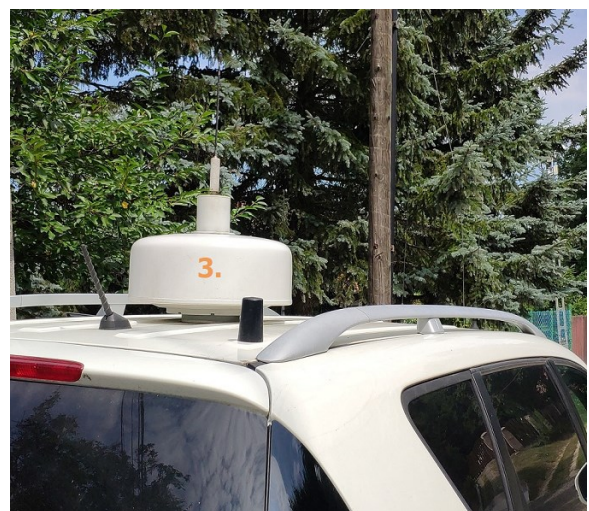
Fig. 3. Measurement set used for the drive test; the devices are denoted by orange numbers and are also listed in Table II

Figure 3 shows the measurement set used for the driving test; a vehicle equipped with high-frequency digital leak detection equipment. Table II lists those technical specifications of the equipment used that are relevant to the topic of this study [23],[24],[25].

The measurement was performed in two steps. Initially, the electric field intensity was measured during driving using the compact multirole spectrum-monitoring system (SkyScan7). Upon detection of digital QAM leakages, the handheld Narda spectrum analyzer with the active high-gain directional antenna was used to identify and locate the sources of the leaks. All measured data were collected, recorded, and forwarded to the cable TV provider serving the same village to repair leakages.

We easily identified and localized leaks in the 700 MHz band at distances up to 3 meters. The spectral display presented the leakage measurements (amplitude versus frequency).

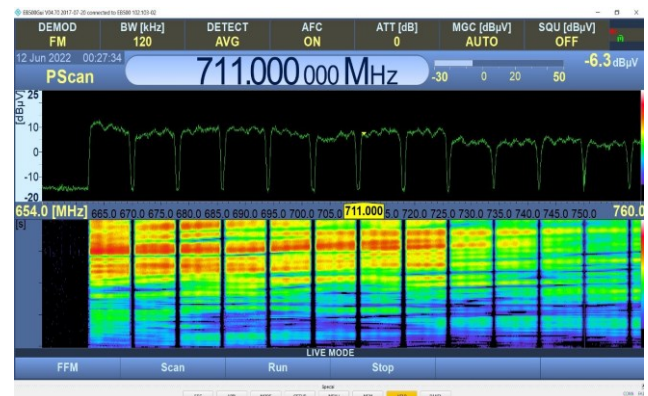
Figure 5 shows the leakage detected at one of the locations in a screenshot captured from the portable spectrum analyzer.

Fig. 5. Screenshot captured from the portable spectrum analyzer of the measured spectrum at a leak point

At the top of the screenshot, the measured spectrum (amplitude versus frequency) is shown. High-level QAM signal leakage is evident across the spectrum range of digital TV broadcasting and digital dividend bands. While the lower part of the screenshot is a waterfall display that presents visually sporadic effects of signal intensity within the sweep frequency range over time. The waterfall display creates a line across the targeted frequency spectrum when it is started, showing the percentage of time a signal is present as a color gradient. Then a growing stack of previous signal activity with varied colors is created by stacking one spectrum time slice line on top of the following time slice that is captured. The color gradients distinguish the signal intensity such that whenever a more frequently a specific frequency and power pixel in the display contains RF energy, that pixel will be “brighter” or “redder”. This indicates that the uplink part of the 700 MHz band is most critical for cable TV signal leakage.

Consequently, the frequency center of the portable spectrum analyzer was set to 706 MHz, which is in the uplink part of the 700 MHz band and is the frequency center of TV channel 50 (702 -710 MHz).

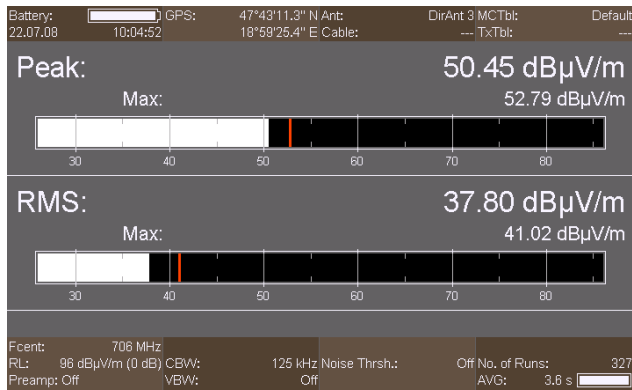
Figure 6 displays the leakage values at the frequency center 706 MHz and the corresponding GPS data in a screenshot captured from the portable spectrum analyzer.

Fig. 6. Screenshot captured from the portable spectrum analyzer of the leakage values at 706 MHz

The peak value of the leakage signal was very high 50.45 dBµV/m, which refers to the maximum value that the leakage signal intensity can reach whereas the (root-mean-square) RMS value was 37.80 dBµV/m, which refers to the effective value of the total waveform. In this study, only the

peak value was considered because the technical standards adopted in the assessment specify the maximum permissible levels of radiated emissions. In this sample, the source of the leakage might be the faulty amplifier or/and hardline connector that is not tightened all the way or over-tightened, as indicated in Fig. 7a.
