A. RUTECKA*, Z.L. KOWALEWSKI**, K. MAKOWSKA**, K. PIETRZAK**, L. DIETRICH*

FATIGUE DAMAGE OF Al/SiC COMPOSITES – MACROSCOPIC AND MICROSCOPIC ANALYSIS

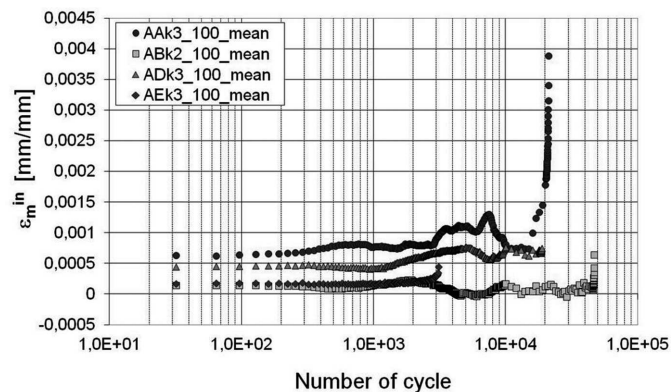
Fig. 1. Mean inelastic strain for Al/SiC composite (second series) tested at stress amplitude equal to 100 MPa. AAK3 – Al matrix, ABk2 – Al+2,5%SiC, ADk3 – Al+7,5%SiC, AEK3 – Al+10%SiC

For the second series of composites it was possible to apply higher stress amplitude equal to 100 MPa. Unfortunately, mean inelastic strain not only increased but also decreased during subsequent cycles (Fig. 1), which made it impossible to use simple mean inelastic strain as a fatigue damage indicator.

Looking at the mean inelastic strain (Fig. 1) and inelastic strain amplitude (Fig. 2) variations during subsequent cycles, one can conclude that in majority cases the highest values were obtained for the matrix material in comparison to the composites. That means higher fatigue strain resistance for aluminium reinforced by SiC in comparison to the aluminium itself. It is worth to notice that for the Al+2,5%SiC similar values of the mean inelastic strain were obtained as those for the Al+10%SiC achieved. However, the former composite exhibited higher lifetime what means its better fatigue properties.

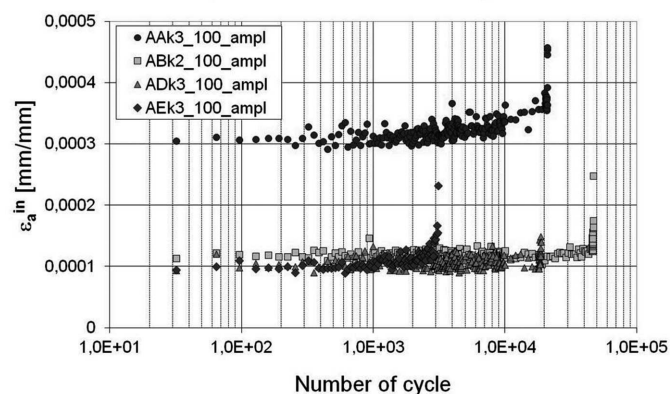
Fig. 2. Inelastic strain amplitude for Al/SiC composite (second series) tested at stress amplitude equal to 100 MPa. AAK3 – Al matrix, ABk2 – Al+2,5%SiC, ADk3 – Al+7,5%SiC, AEK3 – Al+10%SiC

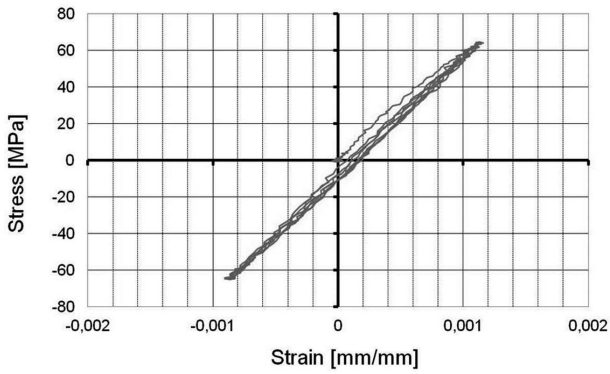
Fig. 3. Hysteresis loops for the initial cycles of fatigue tests. Material Al (second series) tested at stress amplitude equal to 70 MPa

Depending on the level of stress amplitude and SiC content, different changes of hysteresis loops were observed during fatigue tests. Ratcheting was the dominant damage mechanism for the matrix tested at stress amplitude equal to 70 MPa (Figs. 3 and 4). In the case of matrix tested at 100 MPa stress amplitude cyclic plasticity combined with ratcheting were the main fatigue damage mechanisms (Figs. 5 and 6). The composite with 7,5% of SiC tested at 70 MPa exhibited ratcheting towards negative strain values (Fig. 7), while hysteresis loops during fatigue tests of the Al+10%SiC under the same stress amplitude nearly did not change during subsequent cycles (Fig. 8). The Al+2,5%SiC tested at the stress amplitude equal to 100 MPa exhibited cyclic plasticity combined with ratcheting (Figs. 9 and 10). In cases of higher SiC content an influence of damage mechanisms on hysteresis loops was smaller.

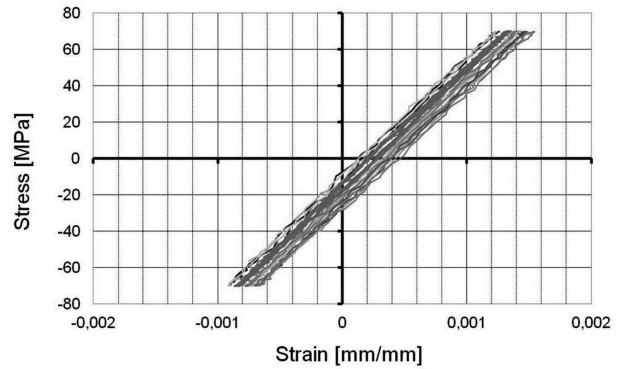
Fig. 4. Hysteresis loops for the cycles over 100 of fatigue tests. Material Al (second series) tested at stress amplitude equal to 70 MPa

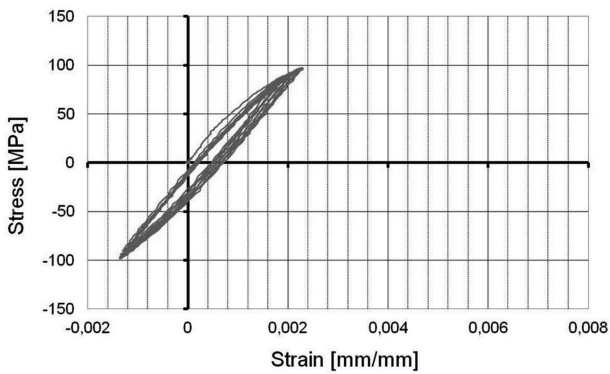
Fig. 5. Hysteresis loops for the initial cycles of fatigue tests. Material Al (second series) tested at stress amplitude equal to 100 MPa

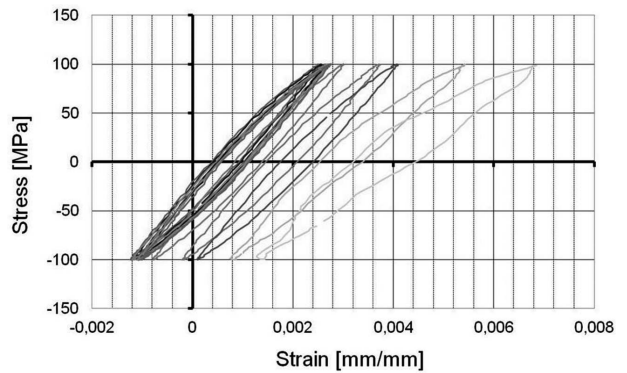
Fig. 6. Hysteresis loops for the cycles over 100 of fatigue tests. Material Al (second series) tested at stress amplitude equal to 100 MPa

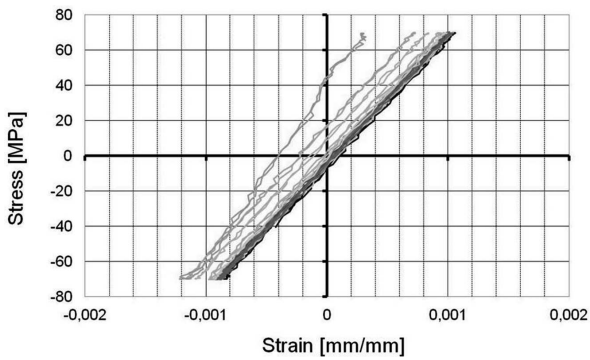
Fig. 7. Hysteresis loops for the cycles over 100 of fatigue tests. Material Al+7,5%SiC (second series) tested at stress amplitude equal to 70 MPa

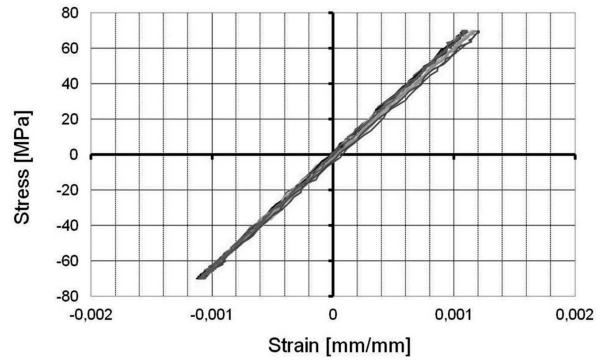
Fig. 8. Hysteresis loops for the cycles over 100 of fatigue tests. Material Al+10%SiC (second series) tested at stress amplitude equal to 70 MPa

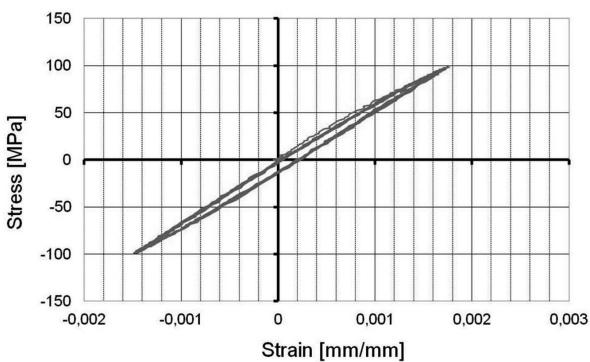
Fig. 9. Hysteresis loops for the initial cycles of fatigue tests. Material Al+2,5%SiC (second series) tested at stress amplitude equal to 100 MPa

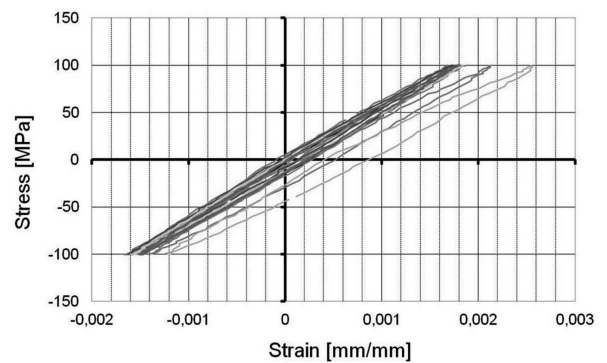
Fig. 10. Hysteresis loops for the cycles over 100 of fatigue tests. Material Al+2,5%SiC (second series) tested at stress amplitude equal to 100 MPa

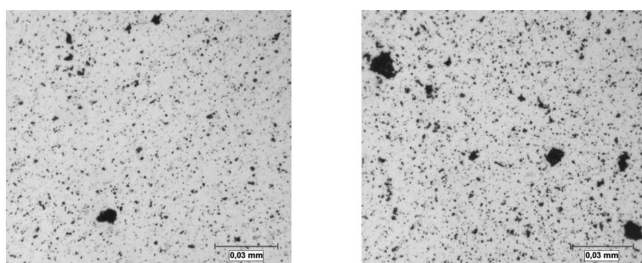
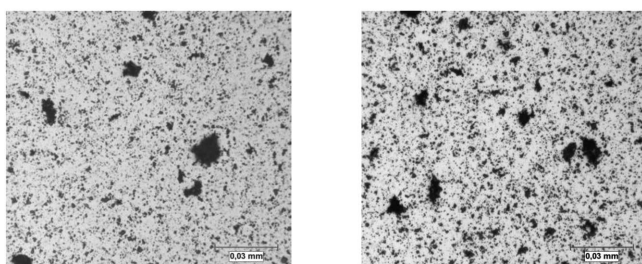
a) Al+2,5% SiC, magn. 500x

b) Al+5% SiC, magn. 500x

c) Al+7,5% SiC, magn. 500x

d) Al+10% SiC, magn. 500x

Fig. 11. Images of microstructure: transversal cross sections of Al/SiC composites (first series) before fatigue tests (magn. 500x)

In the first step of the investigation programme preliminary microstructural observations were carried out before fatigue tests for the first series of Al/SiC composites. Images were taken for the mutually perpendicular cross sections of rods produced using the KOBO method. SiC particles of small sizes uniformly distributed in the composite matrix, as well as SiC particle agglomerates were observed for rods of the first series (Fig. 11). The quantity of SiC agglomerates increases for the higher SiC content. These agglomerates should be treated as microstructural defects and they can be mainly responsible for voids and cracks generation. Moreover they can affect a type of damage mechanism evolution during fatigue tests. An analysis of Al/SiC (first series) microstructure after fatigue tests was presented in the separate paper [8].

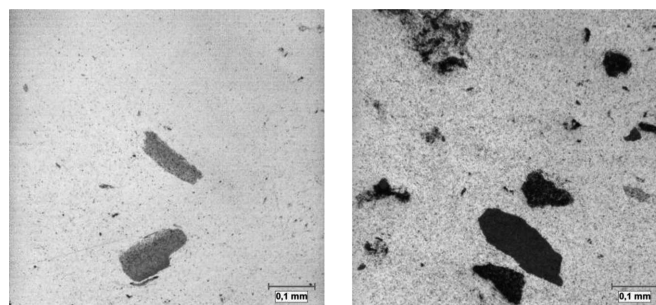
a) Al+2,5%SiC magn. 100x

b) Al+10%SiC magn. 100x

Fig. 12. Images of microstructure: transversal cross sections of Al/SiC composites (second series) before fatigue tests (magn. 100x)

Both transversal and longitudinal cross sections of the second series rods before (Fig. 12, 13) and after fatigue tests (Fig. 14, 15) were taken into account. Non-uniform distribution of SiC particles in the composites examined can be observed for the materials before fatigue tests. A tendency to form SiC agglomerates is stronger for the second series of composites, that it is clearly shown either on transversal or longitudinal cross sections. It is easy to notice that the quantity and size of SiC agglomerates increase with an increase of SiC content in the composites.

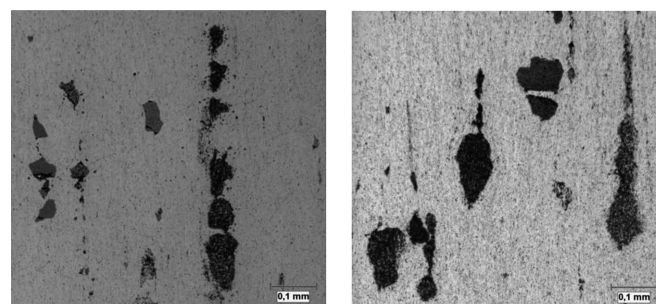
a) Al+2,5%SiC magn. 100x

b) Al+10%SiC magn. 100x

Fig. 13. Images of microstructure: longitudinal cross sections of Al/SiC composites (second series) before fatigue tests (magn. 100x)

A distribution and orientation of the reinforcing agglomerates formed during composites production, especially visible on the longitudinal cross sections (Fig. 13) may be treated as the main disadvantageous microstructural effect.

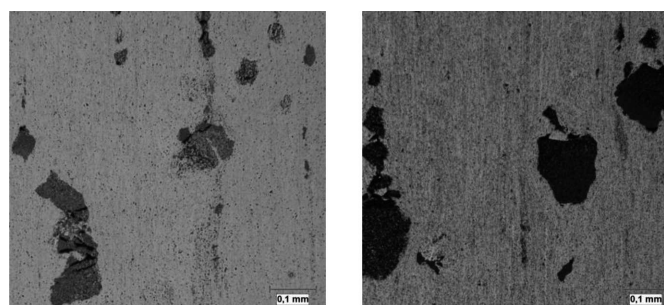
a) Al+2,5%SiC magn. 100x

b) Al+10%SiC magn. 100x

Fig. 14. Images of microstructure: longitudinal cross sections of Al/SiC composites (second series) after fatigue tests (magn. 100x)

Microstructural images observed after fatigue tests for Al/SiC composites (second series – Fig. 14) confirmed such conclusion since the voids and cracks were mainly distributed in places of SiC agglomerates location.

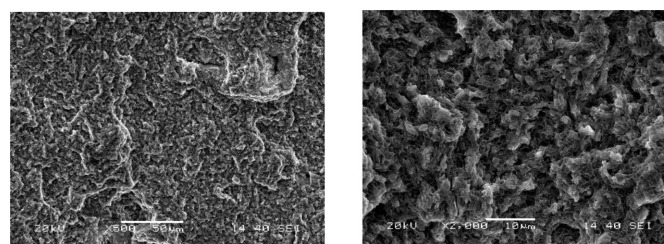
a) magn. 500x

b) magn. 2000x

Fig. 15. Fracture images after fatigue tests for Al+7,5% SiC composite (second series) (SEM)

An analysis of images presenting fracture surfaces after fatigue tests for Al+SiC composites (second series) (Fig. 15) leads to the remark that the fatigue fracture type was observed in majority of tests carried out. Voids and cracks were identified in the fracture areas.
