The effects of mineralogical changes that occur in artificial aggregates

THE EFFECTS OF MINERALOGICAL CHANGES THAT OCCUR IN ARTIFICIAL AGGREGATES

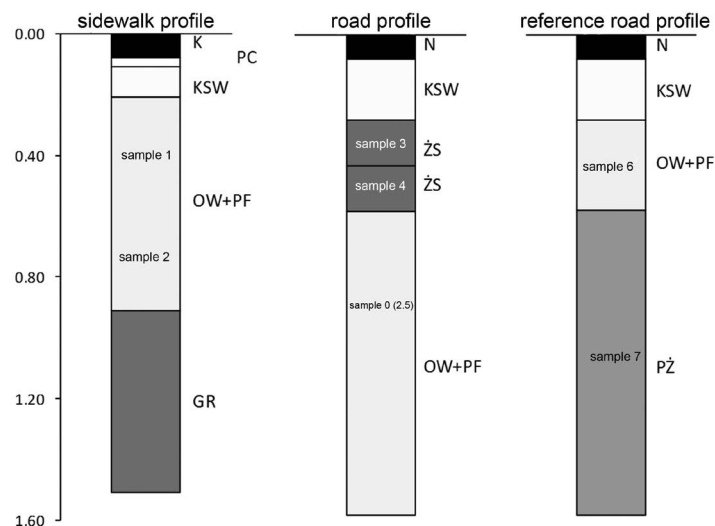
Fig. 1. Schematic profile of the pavement structure and sidewalk with separate bedding layers and the surface GR – native soil, K – stones, KSW – carbonate rock aggregate, N – surface, OW+PF – coal shale with fluidized ash, OW+PL – coal shale with fly ash, PC – sand with cement, PŻ – improved slag sand, ŻS – steelmaking slag

To achieve the above goal, mineralogical tests were conducted on the following samples (Fig. 1, Table 1):

- ◆ samples collected from the profiles of building structures, bedding layers of the sidewalk (samples 1 and 2) and pavement structure (sample 4) where characteristic surface bumps were observed,
- ◆ reference samples (archive, collected during road construction (samples 0 and 3),
- ◆ comparative samples collected from the area where no bumps occurred (samples 6 and 7).

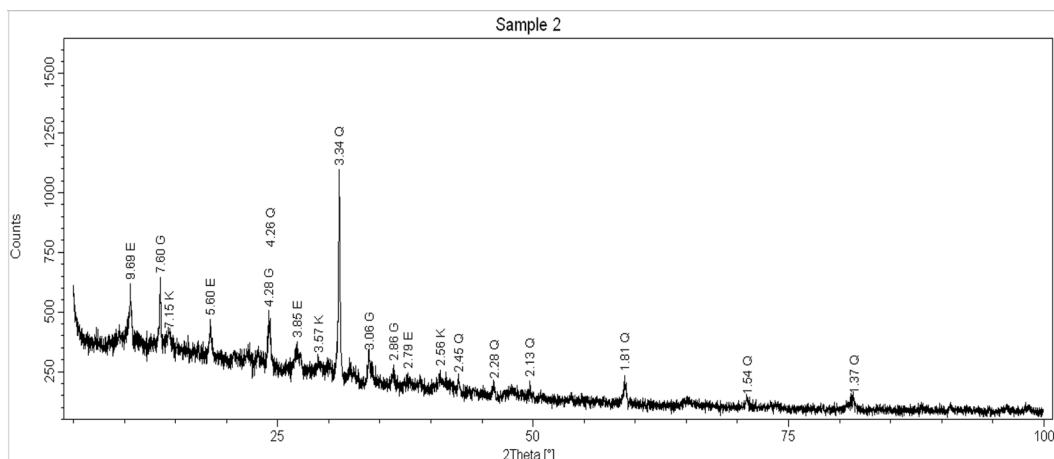
Fig. 2. Diffractogram of sample 2
 Q – quartz, E – ettringite, K – kaolinite, G – gypsum

In terms of mineral composition, samples 1 and 2 are very similar, because they have been identified to contain clay minerals (kaolinite), quartz and organic matter. Moreover, diffractograms of both samples (Fig. 2) showed mainly ettringite reflections (9,70; 5,60; 3,86 Å), while sample 2 also showed gypsum (reflections 7,60; 4,28; 3,06; 2,86 Å) (Fig. 2).

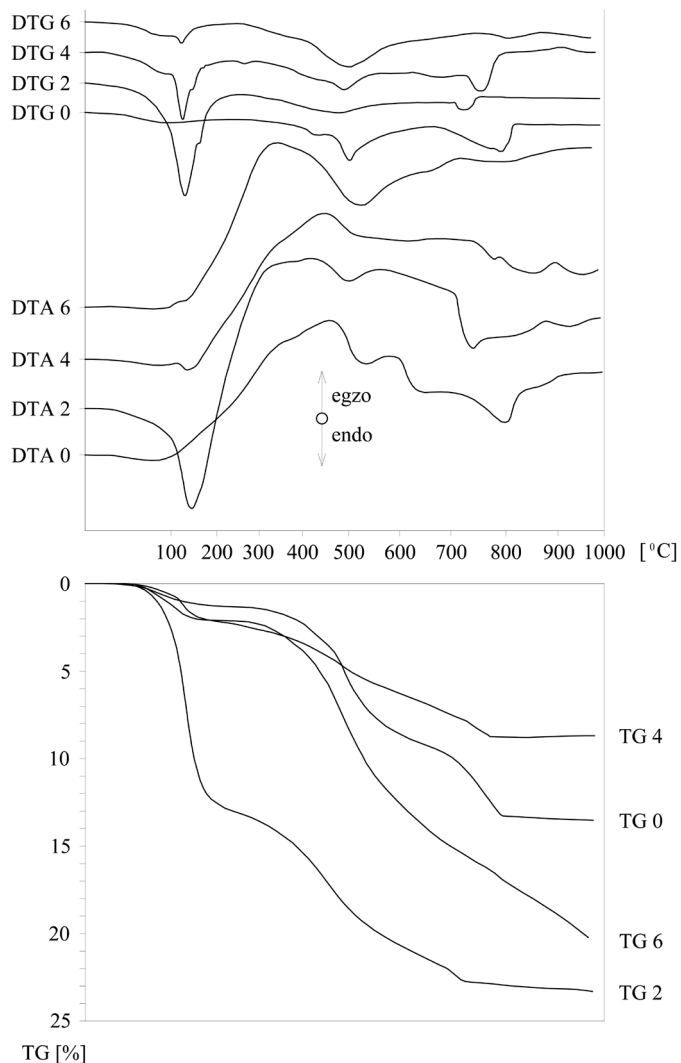
Fig. 3. Derivatograms of samples 0, 2, 4, 6

Thermal analysis also indicated the presence of gypsum and ettringite, as the DTA curve in lower temperatures (100–200°C) showed a thermal effect associated with the hydration of these components (Fig. 3). Both gypsum and ettringite are not typical components of the material from which the aggregates were made, and therefore were most likely secondary components.

Sample 4, due to its high heterogeneity, showed the presence of minerals such as: quartz, gypsum, hematite, clay minerals (kaolinite and Na-montmorillonite), feldspars (anorthite), monticellite, melilite, wustite, sphalerite, glaze and organic matter. Such a composition is characteristic of a mixture of materials of which the aggregate was formed – steelmaking slag and hard coal mining wastes. Only gypsum is not typical for such materials, but the presence of this mineral was documented by a microscopic examination, XRD method (Fig. 5) and with the results of thermal studies (Fig. 3). Gypsum is most likely a secondary component.

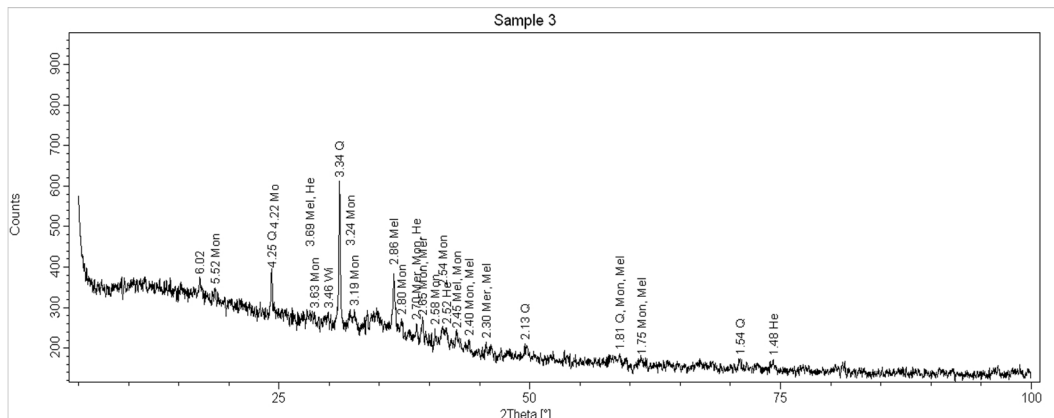
Fig. 4. Diffractogram of sample 3

Q – quartz, Mon – monticellite, Mel – melilite, Mer – merwinite, He – hematite, Wi – willemite

Based on microscopic examination and XRD analysis of the mineral composition of sample 3, the presence of minerals typical for burnt hard coal mining wastes – quartz and hematite as well as minerals typical for steelmaking slag phases – monticellite, melilite, merwinite (Jonczy 2012, 2014) was revealed. In addition, a metallurgical component or an alteration of zinc and lead – sphalerite and willemite was identified (Fig. 4). Glaze constitutes an additional component of this material, which is showed on the diffractogram by an increased background angled at a range of 2 theta 10–35°.

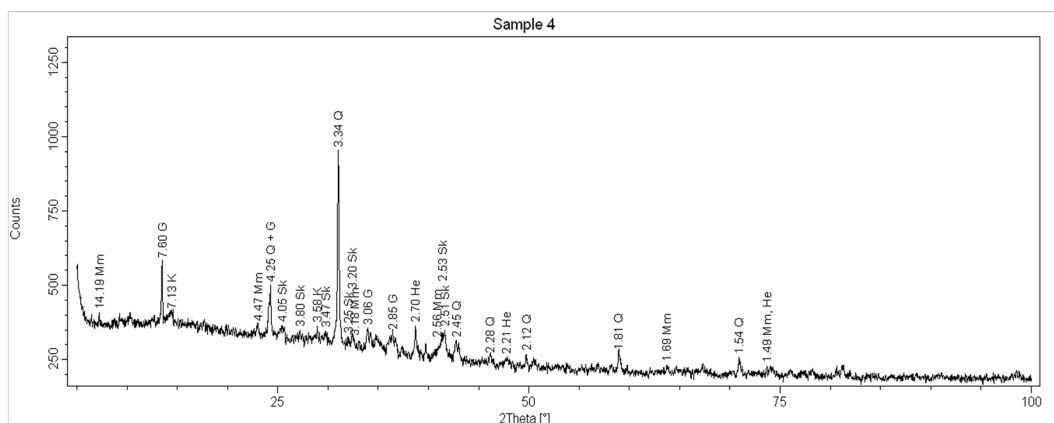
Fig. 5. Diffractogram of sample 4

Q – quartz, Sk – feldspars (anorthite), Mm – montmorillonite (Na), K – kaolinite, He – hematite, G – gypsum

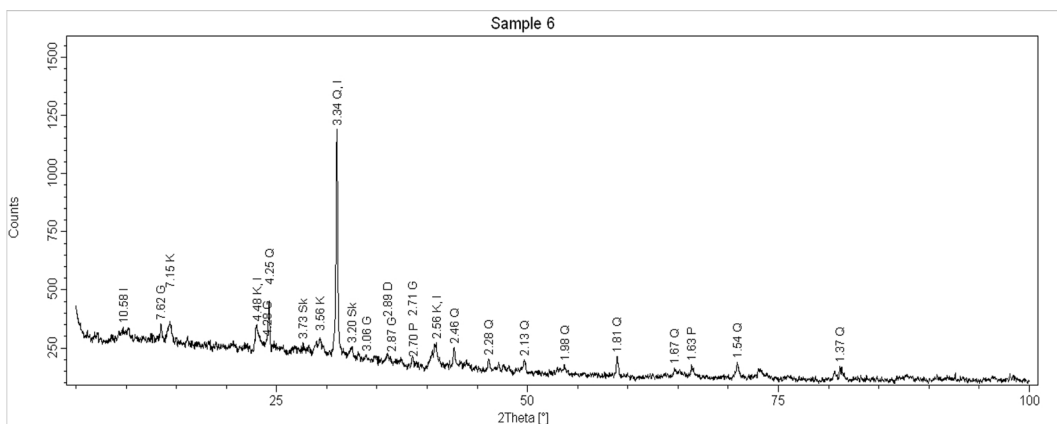
Fig. 6. Diffractogram of sample 6

Q – quartz, K – kaolinite, G – gypsum, I – illite, Sk – feldspars, d – dolomite, P – pyrite

The mineral composition of sample 6 is similar to the composition of sample 0, as its main mineral components include: quartz, clay minerals (kaolinite and illite), feldspars, organic matter and a small amount of pyrite. These minerals are typical of hard coal mining wastes (Galos *et al.* 2009; Jonczy *et al.* 2012; Bzowski 2013). In addition, the aggregate contains glaze with optical and morphological characteristics (spherical shape) typical for glaze present in fly ashes, dolomite and gypsum. Dolomite is most probably a mechanical impurity from the carbonate rock aggregate layer located above the profile, and the gypsum is likely a secondary mineral (Figs 2 and 6).

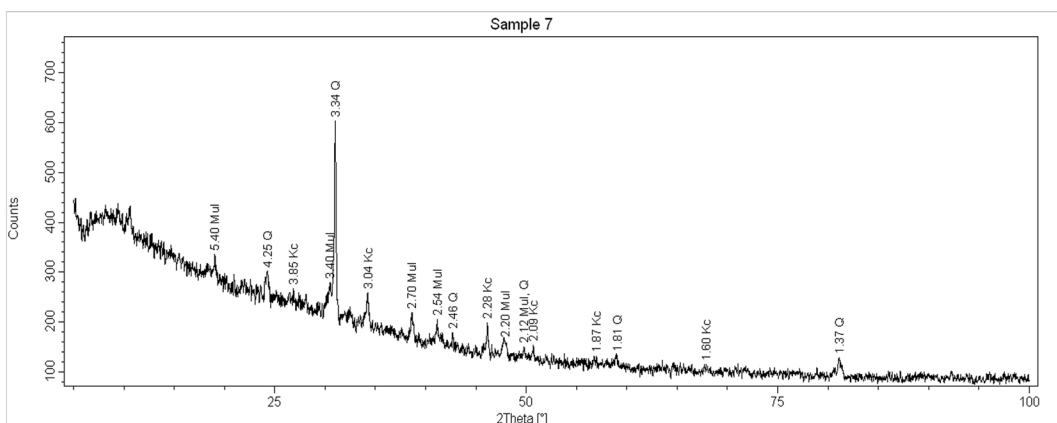
Fig. 7. Diffractogram of sample 7

Q – quartz, Mul – mullite, Kc – calcite

Sample 7 differed from all the others in terms of the development of mineral components. It comprised components typical of wastes from the combustion of hard coal, i.e. mainly glaze in a spherical form, quartz, mullite and spinels (Strzałkowska 2016). Additionally, calcite was present (Fig. 7).
