ECONOMICAL METHODS FOR MEASURING ROAD SURFACE ROUGHNESS

Dariusz Grabowski, Maciej Szczodrak, Andrzej Czyżewski

Gdańsk University of Technology, Faculty of Electronics, Telecommunications and Informatics,
G. Narutowicza 11/12, 80-233 Gdańsk, Poland (✉ ksm@sound.eti.pg.edu.pl, 48 58 347 1114)

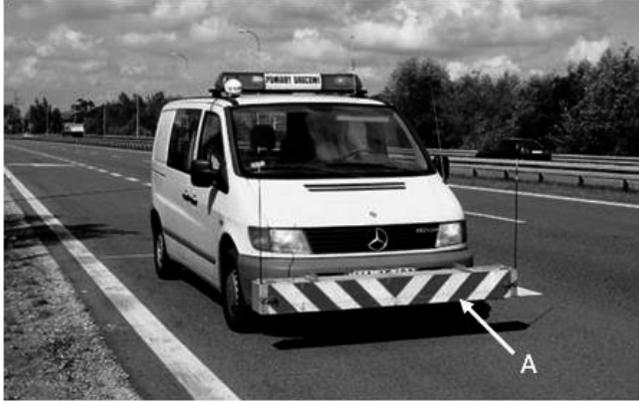
Fig. 1. A professional laser profilograph (A) mounted on a vehicle [11].

Another solution used, among others, by the General Directorate for National Roads and Motorways in Poland, is a laser profilograph [11]. One such device is a Dynatest's product, model 5051 Mk-II Test System. The device is installed on a beam mounted at the front of the vehicle, as shown in Fig. 1, equipped with densely distributed laser sensors. They scan the road surface area approximately every 5 mm and then the obtained data are stored in the fixed memory. The test is based on recording the maximum value of ground clearance between the damaged surface and the horizontal beam [12]. Usually the measurements are taken at 50 km/h, but it is also possible

In addition to laser sensors, the device is equipped with accelerometers, gyros, a GPS receiver and a distance meter. This enables to study the longitudinal and transverse roadway profiles, the curvature of curves, *etc.* [14].

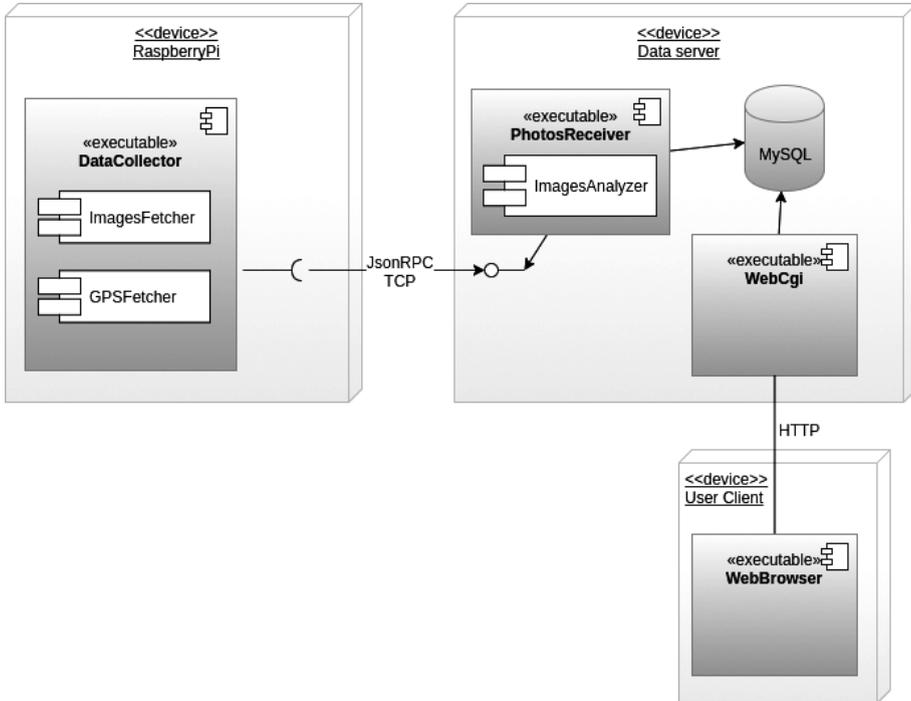
Fig. 2. A diagram of arrangement of software units on processors.

Bringing the design assumptions into work, the system was divided into three interrelated applications, as shown in Fig. 2:

- DataCollector – an application running on client devices, whose task is to collect graphical data and GPS positions and to pre-process this information;
- PhotosReceiver – an application running on the server whose task is to analyse the data sent by DataCollector and to save related information in the database;
- WebCgi – a server-based application that provides a web user application that shows the results on the map.

DataCollector and PhotosReceiver applications communicate with each other via the Json-RPC protocol on TCP sockets. It is an RPC (*remote procedure call*) based on the Json format. An open-source libjson-rpc-cpp library is used for this purpose. Based on the interface created in Json, the generator creates C++ header files for client and server applications. This makes it possible to call up the method remotely without the need for additional parsing of transmitted data – the transport layer remaining invisible to the user.

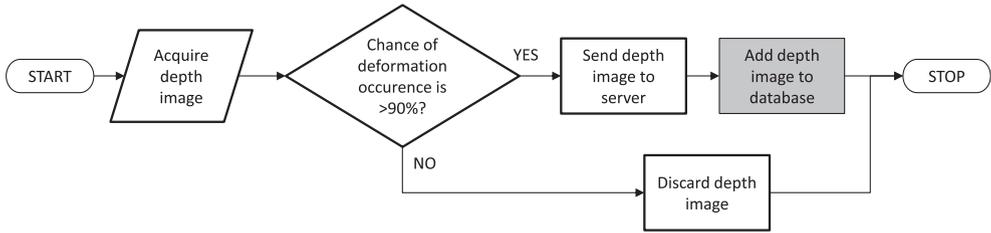
Fig. 3. The flow of depth images through the system. Bolded contours indicate the elements in the client application. The elements of the server application are marked with filling.

Figures 3 and 4 show the flow of depth and RGB colour images through the system. The functions represented by the blocks are discussed later in the description.

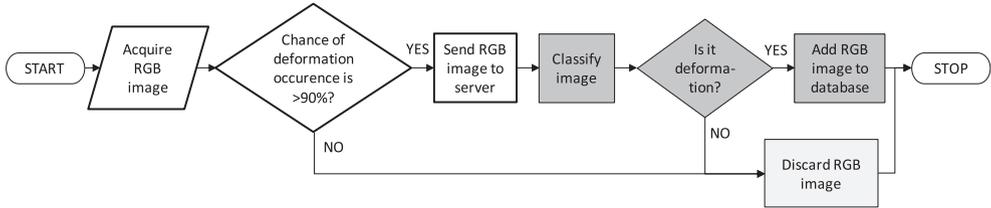
Fig. 4. The flow of RGB images through the system. Unfilled blocks indicate the elements in the client application. The elements of the server application are marked with grey filling. Light grey filling indicates part of both sides.

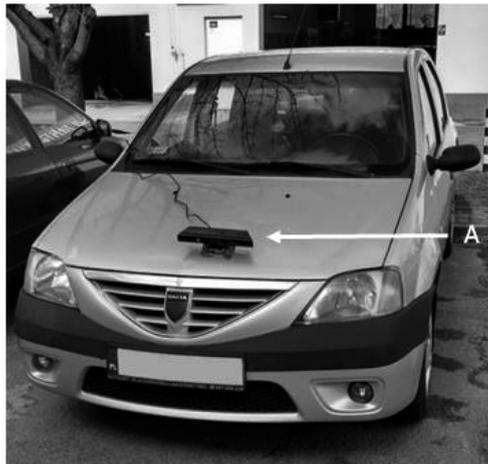
Fig. 5. A car equipped with a Kinect sensor (A).

sensor was mounted on the car engine flap using a mounting tape. The sensor's framerate enabled to drive at a speed of about 30 km/h. A photo of the vehicle setup for the test drive is shown in Fig. 5.

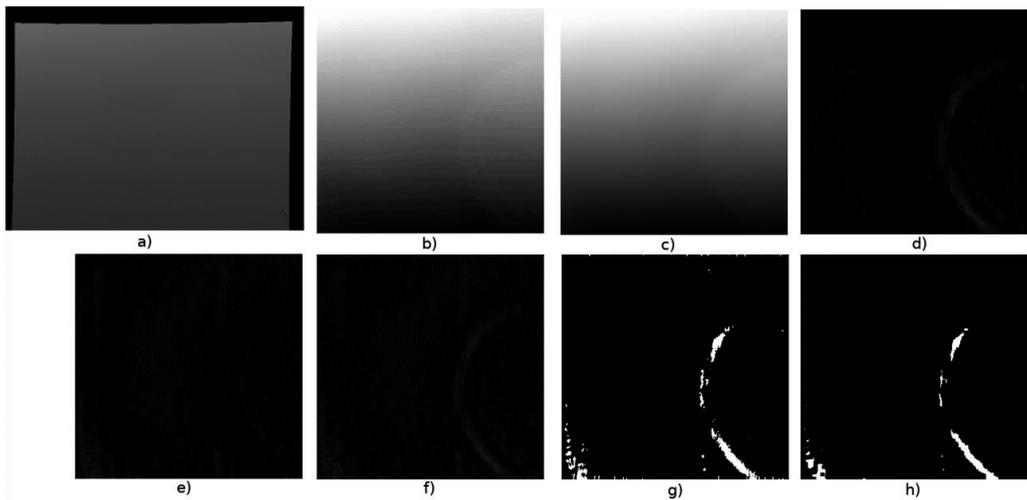
Fig. 6. Steps of processing the depth images.

The consecutive steps of the process presented in Fig. 6 are:

- a) capturing the original depth picture;
- b) equalizing the histogram;
- c) applying a box-type linear low-pass filter with a window size of 19×19 pixels;
- d) using the Sobel operator with a west-eastern mask of size $k = 5$;
- e) using the Sobel operator with an eastern-western mask of size $k = 5$;
- f) combining the images obtained in (d) and (e);
- g) image binarization using a constant $t = 30$;
- h) applying the dilation with a $k = 3$ mask and double erosion with the same mask.

The biggest challenge in the above analysis was to find a suitable algorithm of edge detection. Due to the angle of attack of the camera, it is possible to observe tonal transition from dark (bottom) to light (up). Most of the methods that work well for RGB images, failed here, in the context of detecting the edges between different stripes of lightness. Only the application of aforementioned Sobel's directional operators enabled to solve the problem.

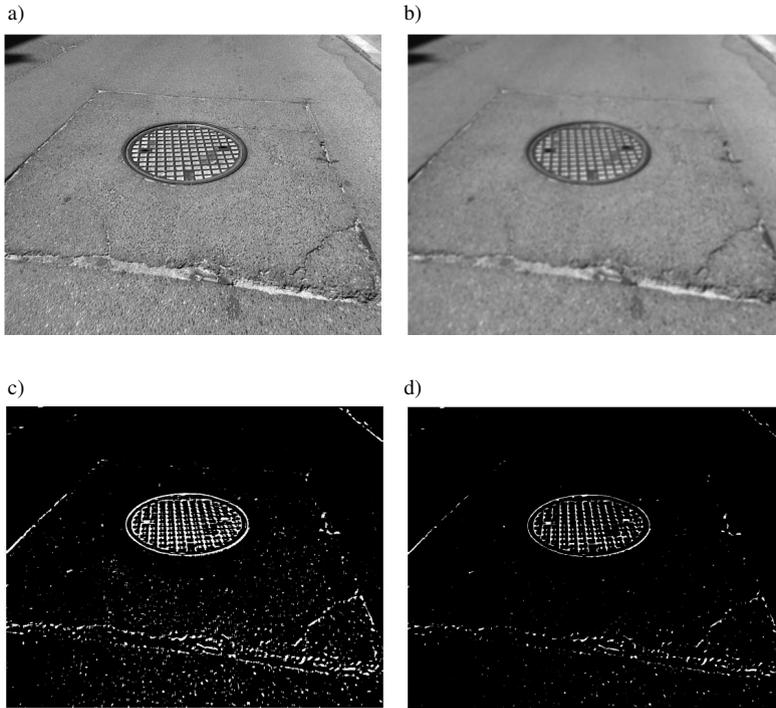
Fig. 7. Steps of initial RGB image processing.

One of the main assumptions for this analysis was the shortest possible time of its execution, therefore complex image processing algorithms were not used. The consecutive steps in this process are presented in Fig. 7:

- a) conversion of the original image to greyscale;
- b) the use of a box-type linear low-pass filter with a window size of 11×11 ;
- c) binarization of the image with the Adaptive Gaussian method, a block size $b = 25$;
- d) applying the dilation with a $k = 3$ mask and double erosion with the same mask.

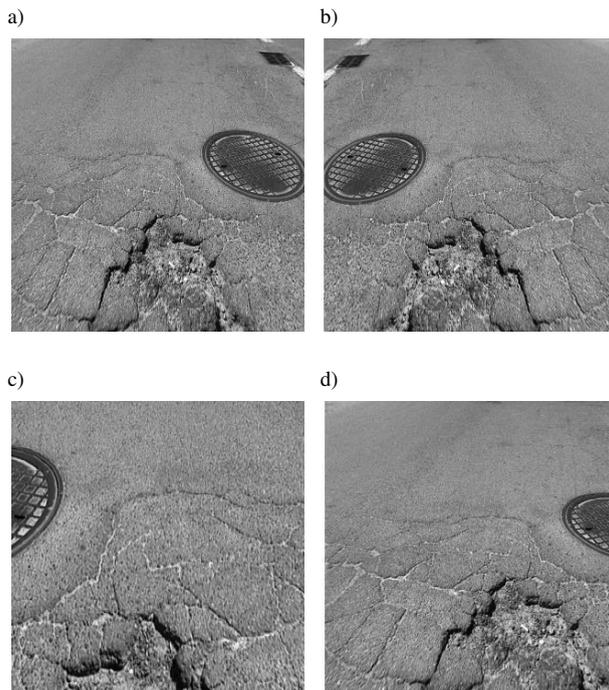
Fig. 8. Selected transformations of the source image original image (a); mirror (b); approximation (c); offset to the right (d).

In the case of a smaller collection (potholes), their photos were downloaded from the Google Images repository. For even better results, it was decided to make a few simple transformations on the collected images, in this way increasing the material input and increasing the learning process efficiency. Examples are shown in Fig. 8, but in practice different combinations of techniques were used. The photos were then binarized by applying:

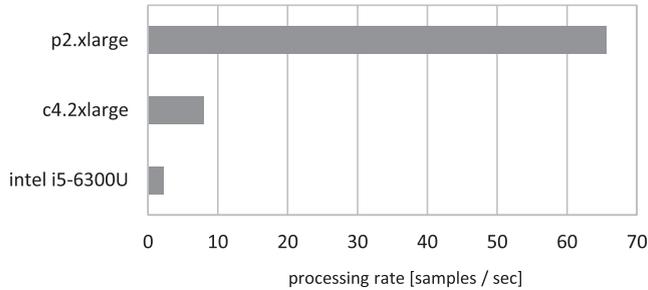
Fig. 9. The amount of processed samples during a 1 s period for different machines: **p2.xlarge** – a machine with 1 Core GPU NVIDIA K80, **c4.2xlarge** – a machine with 8 processor cores Xeon E5-2666 v3, **Intel i5-6300U** – laptop with 4 cores 2.40 GHz.

The network learning was carried out using the Amazon Web Services' cloud computing. The machine selected for the task was a p2.xlarge equipped with an NVIDIA K80 GPU with 12 GB of memory, supporting the CUDA technology. The network learning during the system development was carried out on different machines. Differences in the processing efficiency between them are presented in Fig. 9.

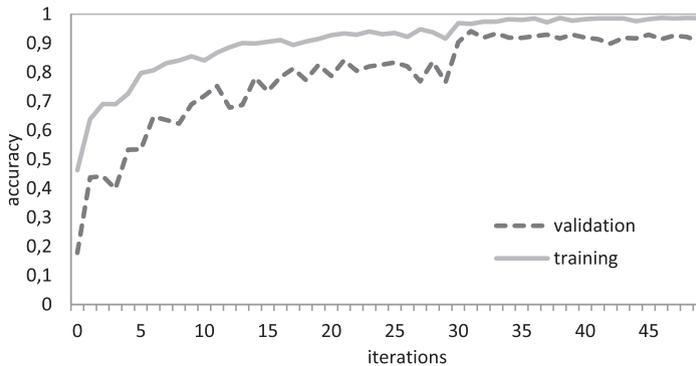
Fig. 10. Learning results in subsequent iterations for the test and learning data.

4500 previously collected photos were used for the learning process. The progress of the process is shown in Fig. 10. The final learning outcome for the test data amounted to 94%.

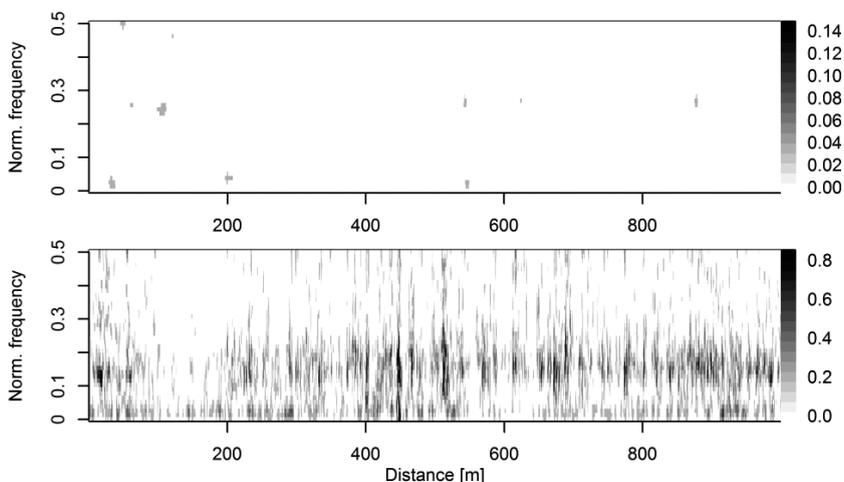
Fig. 11. Comparison of the evaluation method outputs for a flat road (upper plot) and poor-quality road (lower plot).

Figure 11 presents two plots of magnitude of the Gabor coefficients calculated for the vertical acceleration signal, obtained for about 1 km long fragments of good- and poor-quality roads. Significantly different values of magnitude can be observed.
