A. KALWIK^{1*}, K. MORDAL¹, J. REDUTKO¹

ANALYSIS OF CHANGES IN THE PROPERTIES OF POLYMERIC COMPONENTS JOINED BY RESISTANCE WELDING

Keywords: polypropylene pipes, socket fusion welding, thermovision, bending strength, microscopic analysis

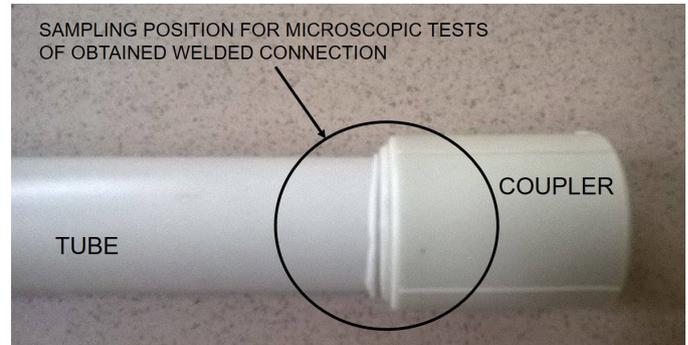
Fig. 2. Connection of polypropylene tube with coupler obtained by means of socket fusion welding

The aim of the conducted research was to analyse the quality of joints made by resistance (socket fusion or polyfusion) welding. Tested samples were obtained from 170 mm long-cut polypropylene tubes (which are made from PP-R according to standard PN-EN ISO 15874-2:2013) with a diameter of $\varnothing 20$ mm and a wall thickness of 3.4 mm, joined by means of couplers (also polypropylene PP-R with length of 36 mm and diameter of $\varnothing 20$ mm), as shown in Fig. 1. In addition, the ends of the specimens have been milled with a special peeler in order to remove the outer layer of ending pipe parts and to fit them to the coupler. In turn, in Fig. 2 a part of connection of polypropylene tube with coupler which was obtained by means of socket fusion welding is presented.

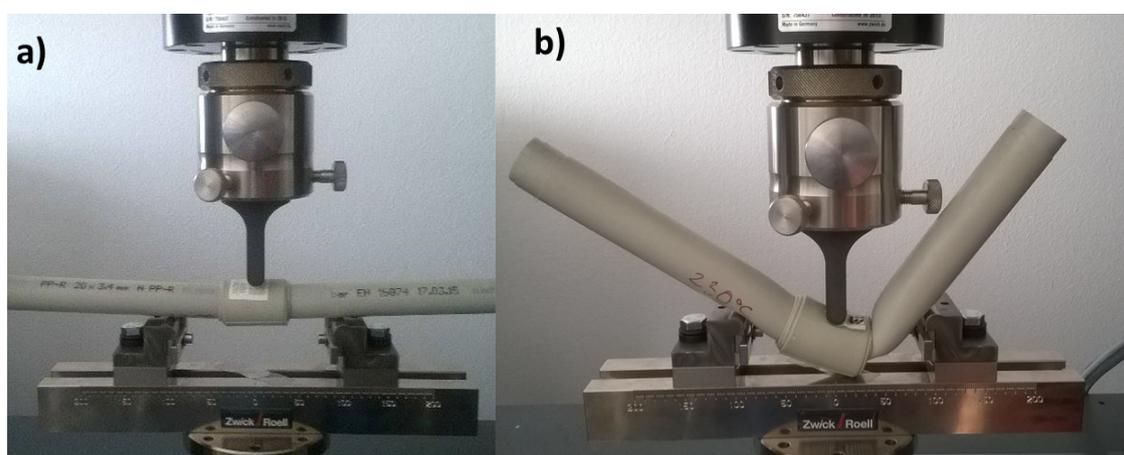
Fig. 3. Three-point bending test: starting position of sample (a) and position of sample at ending stage of test (b)

After the welding process and complete cooling of the joint, the analysis was carried out to assess the bending strength of the joint. The tests were performed on a Zwick/Roell Z020 testing machine with an installed three-point bending fixture according to PN-EN ISO 178 standard [21]. This test consists of supporting the sample at its ends and loading it perpendicularly to the longitudinal axis of the tested material, whereby the distance of the support points is strictly defined and the load is applied symmetrically to them (Fig. 3). The evaluation of bending strength characteristics is only applied to brittle materials that crack during the test. At the moment of bending under the action of load, the upper surface of the specimen decreases and its lower surface lengthens, which is caused by the occurrence of compressive stresses in the upper part of the sample and tensile stresses in its lower part. During bending, the supports were 200 mm apart and the thickness and width of the samples measured on the coupler was 27 mm.

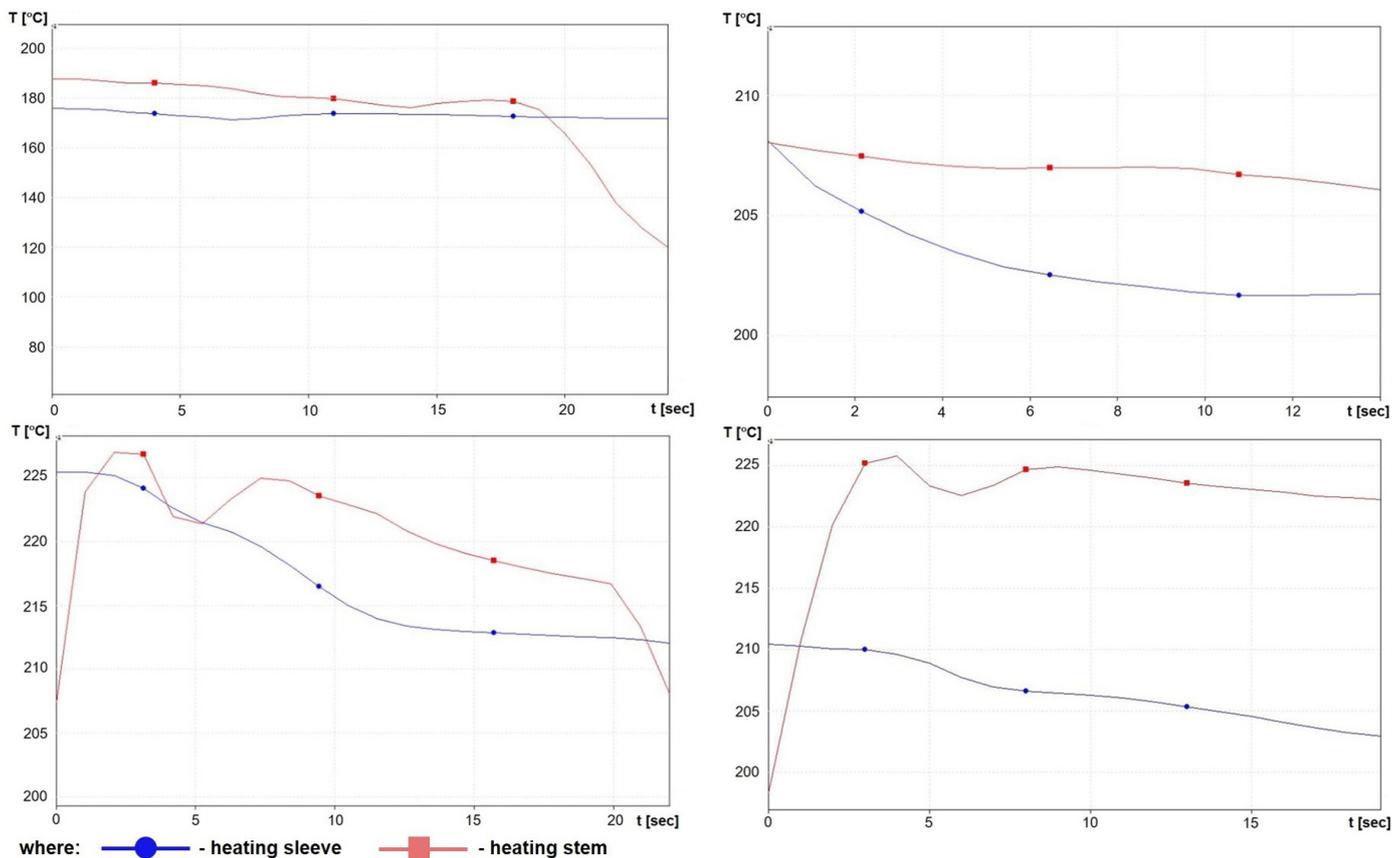
results of these test are thermograms and graphs of temperature distributions. For example, Fig. 4 shows the temperature distribution graphs recorded during the pressure welding of polypropylene pipes at preset welding machine temperatures, whereby the red colour indicates the temperature distribution on the heating pin (stem) and the blue colour indicates the temperature distribution on the heating sleeve.

Fig. 4. Temperature distributions recorded by thermocouples on heating stem and sleeve during pressure welding of pipes at preset temperature of: (a) 200°C, (b) 210°C, (c) 220°C, (d) 230°C

Analysing the results obtained during welding the pipe at 200°C (Fig. 4a), it can be concluded that the temperature value of the heating pin is approximately 15°C lower than the value on the heating sleeve, whereby throughout the entire welding process, the temperature values remained at a similar level. Only after the process was completed the values recorded on the heating pin start to decrease sharply. In turn, in the case of welding pipes at a preset temperature of 210°C (Fig. 4b), it can be observed that the maximum temperature difference between the heating sockets was about 5°C, with the heating sleeve temperature remaining lower than the heating stem temperature. On the other hand during welding at the preset temperature of 220°C on a welding machine (Fig. 4c) the temperature difference between the heating sockets was 8°C, both temperatures were decreasing, but its value on the heating pin was higher. A temporary drop in the value on the curve representing temperature changes of the heating pin may be also noticed, which may be caused by the movement of the thermocouple. In turn, when pipes were welded at 230°C (Fig. 4d) the difference in values on the stem and heating sleeve was 18°C. It can be observed that the temperature values recorded by thermocouples are slightly, but gradually decreasing in the welding time.

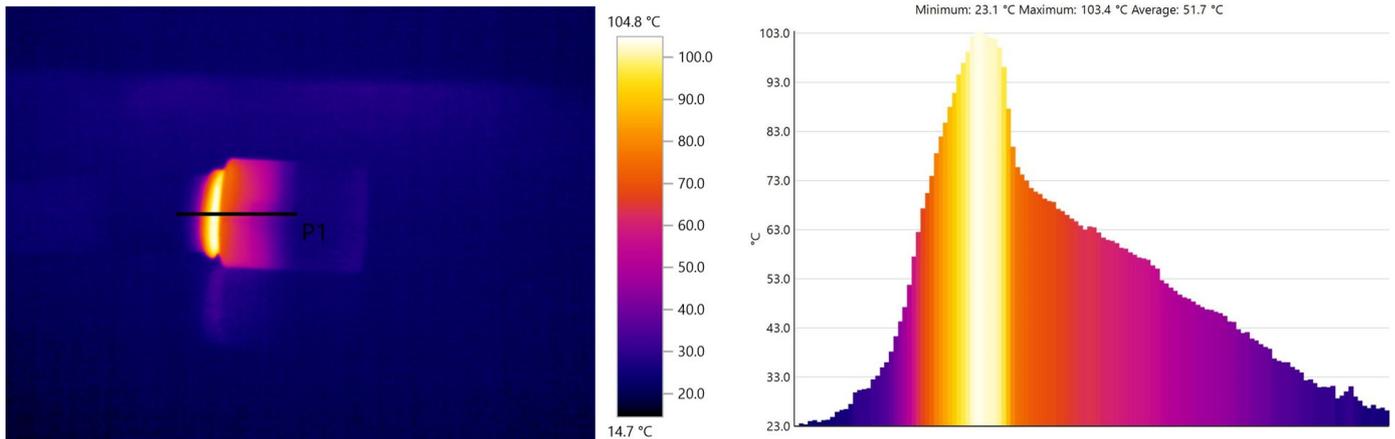
Fig. 5. Thermogram of the welded joint and temperature profile at the set temperature of 200°C just after welding

by an average of 11°C, whereby the cooling time of the samples to 30°C was about 16 minutes. In Fig. 5, it can be seen that the temperature of the material at the joint is much higher than that of the other, farther parts of this connection. In turn, thanks to the temperature profile obtained from the thermal imaging camera, it can be observed that the maximum temperature value at the joint was 103.4°C, while in the part of coupler it was about

70°C. After 30 seconds from the welding process, it can be also seen that the weld has cooled down quickly whereas the temperature of the coupler has not changed. Subsequent thermovision images show that the temperature distribution has become more and more even in process of time until the working surface temperature equals the ambient temperature after 16 minutes.

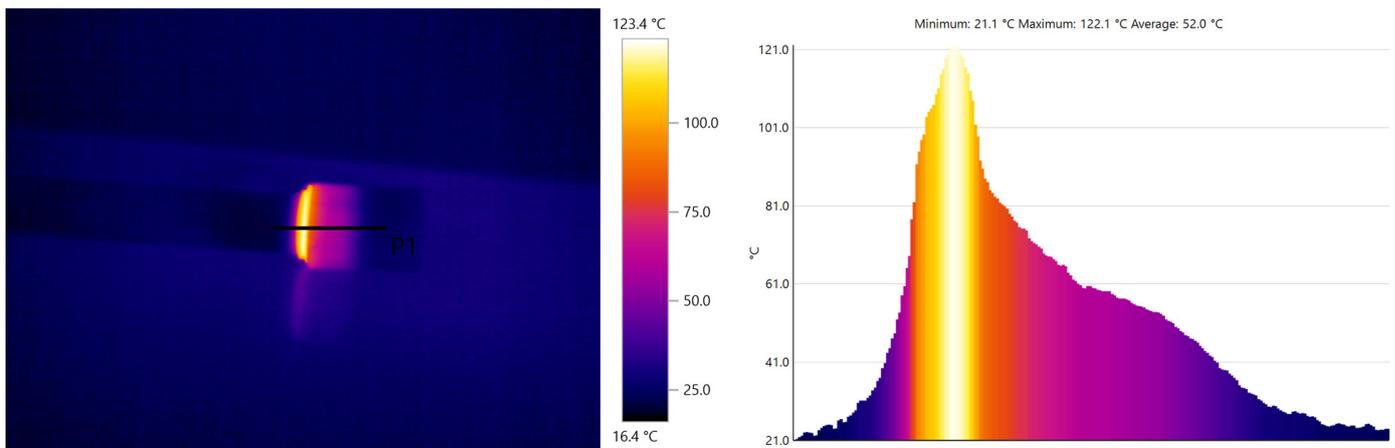
Fig. 6. Thermogram of the welded joint and temperature profile at the set temperature of 210°C just after welding

In the case of welding pipes at 210°C, the weld temperature just after this process was about 118°C, while after 30 seconds it dropped by approx. 20°C, reaching the value of 89°C after a minute. In turn, after 16 minutes, the temperature to which the fitting was cooled was 32°C. Analysis of the thermovision image together with the temperature profile immediately after the welding process (Fig. 6) allows to state that the increased temperature values are only related to places which were in contact with the surfaces of the heating sockets. In this case the maximum temperature recorded by the thermal imaging camera was 120.7°C. The following thermograms showed the situation when an elevated temperature goes beyond the working surface and the highest temperature range moves towards the coupler, matching the joint temperature. It can also be observed that the highest temperature value is located in the upper part of the coupler, which may be caused by heat transfer from the lower part of the fitting to the ground. Analysis of the temperature profiles shows that in process of time the temperature values start to distribute more evenly over the length of the pipe and coupler to reach value of 32°C after 16 minutes.

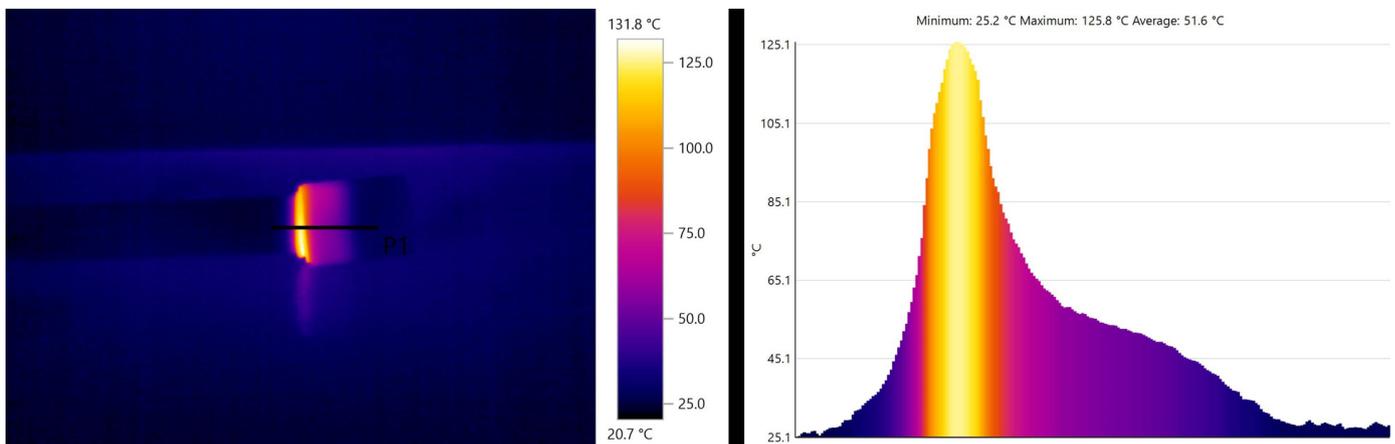
Fig. 7. Thermogram of the welded joint and temperature profile at the set temperature of 220°C just after welding

During welding the pipes at 220°C immediately after the process the temperature value was 121.5°C on average to drop by about 16°C after 30 seconds. Then, after subsequent two minutes, connection temperatures decreased by following 30°C. In this case, cooling to 32°C also took about 16 minutes. Figures taken with a thermal imaging camera directly after the welding process (Fig. 7) represent an image where only the working surfaces are heated immediately after the joining of elements

and the maximum temperature is clearly indicated. After one minute, it can be observed that, in addition to the highest value at the connection between pipe and coupler, small sections of the components that did not have contact with the welding machine were also heated up. In the following minutes it is shown a gradual levelling out of the temperature range on the surface of the pipe and coupling unit, which was caused by heat transfer to lower temperature surfaces.

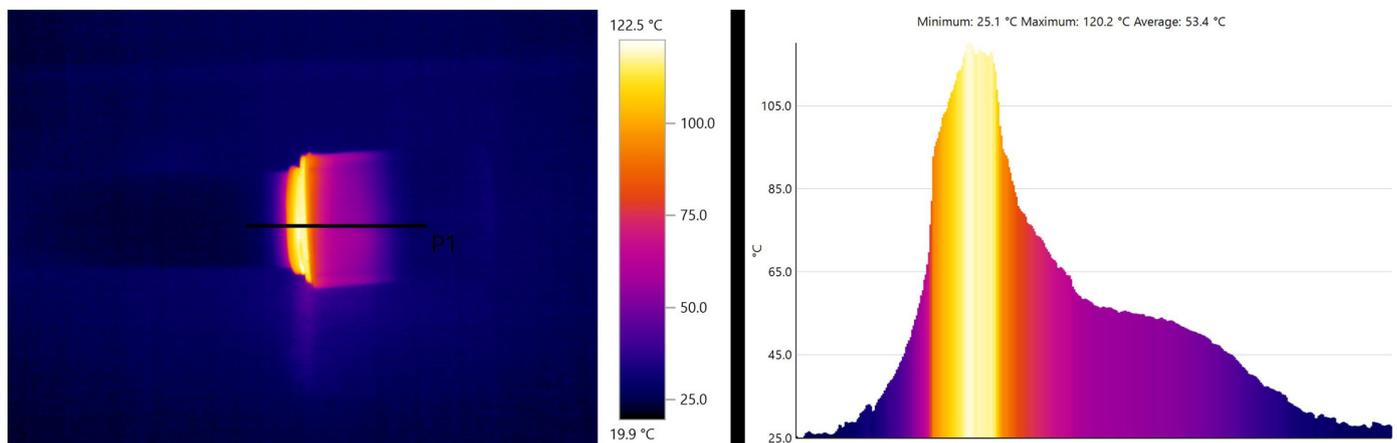
Fig. 8. Thermogram of the welded joint and temperature profile at the set temperature of 230°C just after welding

The maximum temperature during welding pipes at 230°C was 114°C on average and 30 seconds after this process, this value dropped by 12°C. On the other hand, the cooling time of the material to 32°C was longer than in previous tests and was 18 minutes. On the thermogram immediately after the welding process (Fig. 8) the place, where the welded sample reaches its maximum, is clearly visible. On the temperature profile it can be seen that the material is only heated on the working surface of the elements. In the following minutes, the heat was observed to move beyond the surfaces previously in contact with the welding machine. As with welding at lower temperatures, the area with the highest temperature is situated at the top of the coupler.

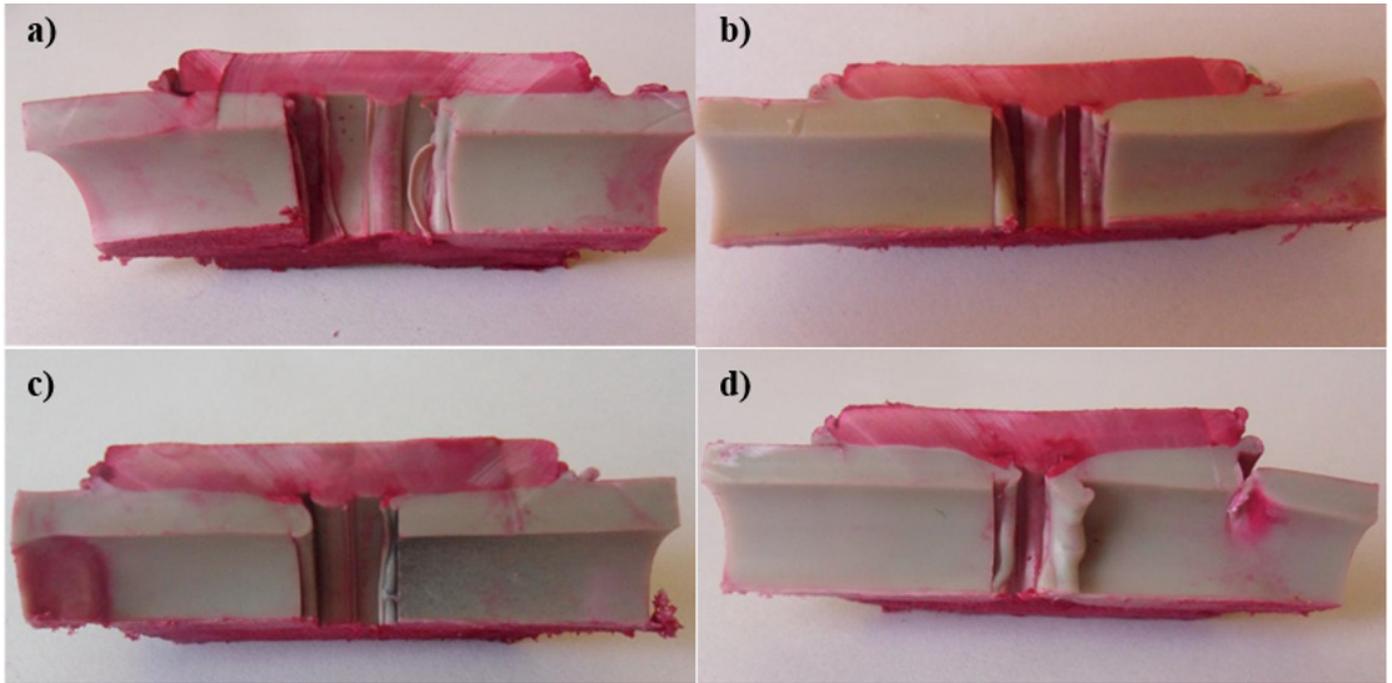
Fig. 9. Pictures of samples of a pipe welded with a coupler at temperature of: (a) 200°C, (b) 210°C, (c) 220°C, (d) 230°C for stereoscopic microscope research

Fig. 9 and Fig. 10 show pictures of whole samples for tests made at different welding temperatures as well as pictures of welded joints. Studies with a stereoscopic microscope showed that at welding temperatures of 200°C and 210°C, the material subjected to the process did not merge thoroughly – at these temperatures the material did not melt and mix. Small polymer flashes can be observed at the ends of the pipes where they connect to the coupler. In turn, small air bubbles can be seen on the lines connecting the coupler to the pipe. However, the material behaved completely different at higher temperatures (220°C and 230°C). The microscopic images show that during the joining, the pipe material has been thoroughly bonded to the coupler material. The material from both welded elements has been mixed, hence no air bubbles are visible on the connecting lines. The point of flowing up of the polymer material is clearly visible at the ends of the pipes.

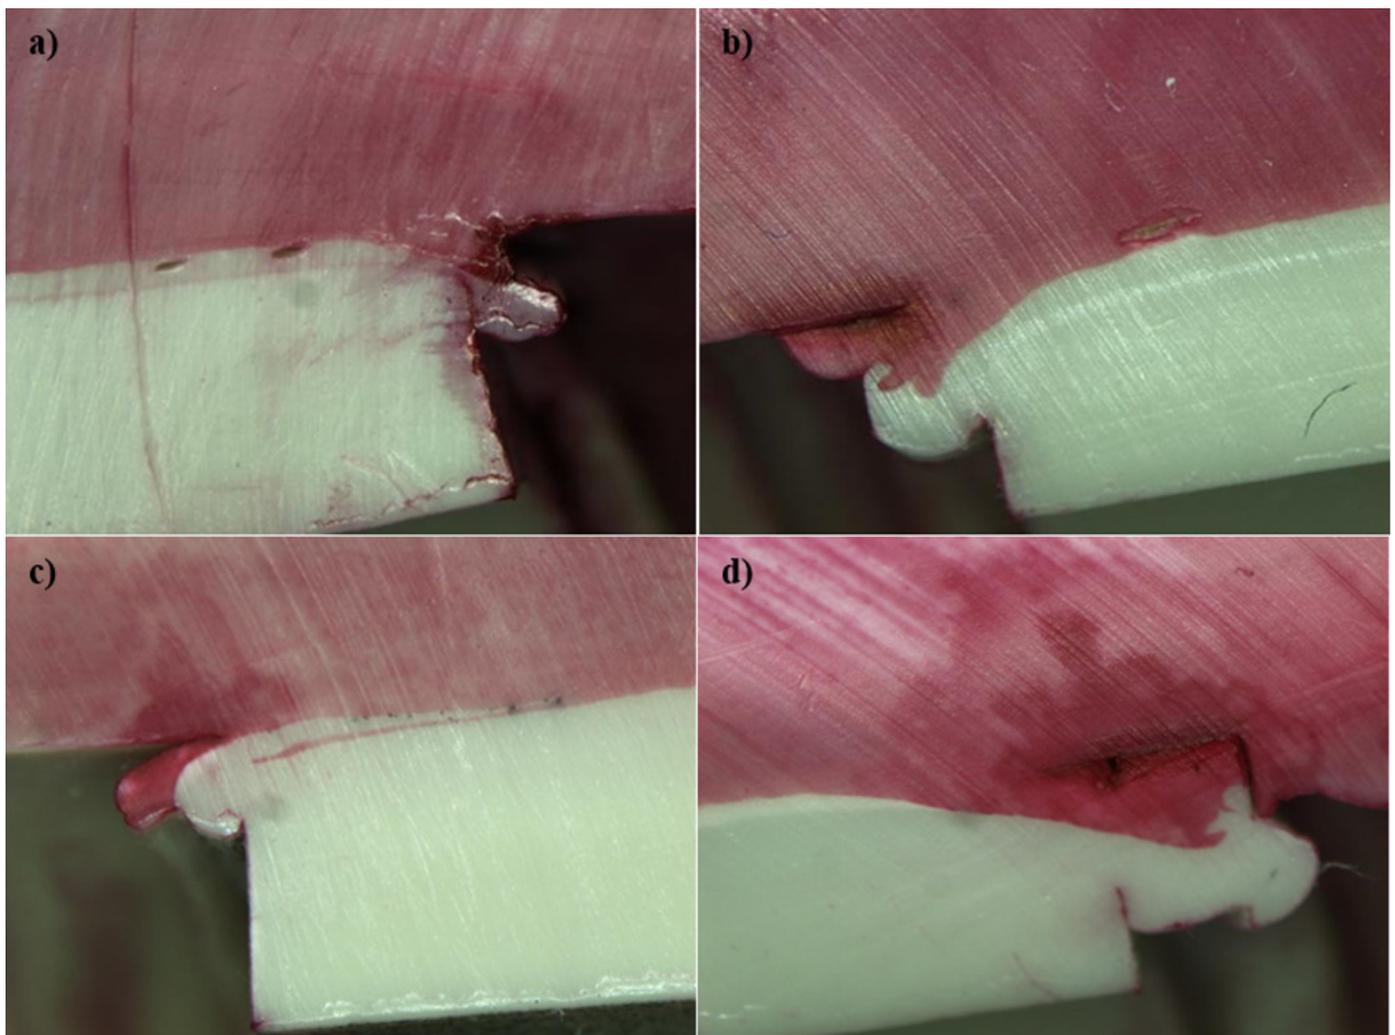
Fig. 10. Pictures of a joint welded at: (a) 200°C, (b) 210°C, (c) 220°C, (d) 230°C obtained as a result of the stereoscopic microscope research

On the other hand, from the observations on the stereoscopic microscope it can be concluded that in the case of samples welded at a temperature of 220°C and 230°C obtained joints of pipe material with coupler material are more accurate than those welded at lower temperatures (200°C and 210°C), where small polymer flashes as well as and air bubbles could be seen at the point of contact of both elements. These differences were caused by the fact that the material in these parameters was not completely melted and mixed.
