DOI: <https://doi.org/10.24425/amm.2022.141067>P. WIDOMSKI^{1*}, M. KASZUBA¹, J. KRAWCZYK¹, B. NOWAK^{1,2}, A. LANGE¹,
P. SOKOŁOWSKI¹, Z. GRONOSTAJSKI¹

INVESTIGATING THE POSSIBILITY OF REGENERATION BY HARDFACING FOR FORGING TOOLS BASED ON ANALYSIS OF TOOL WORKING CONDITIONS AND WEAR EVALUATION

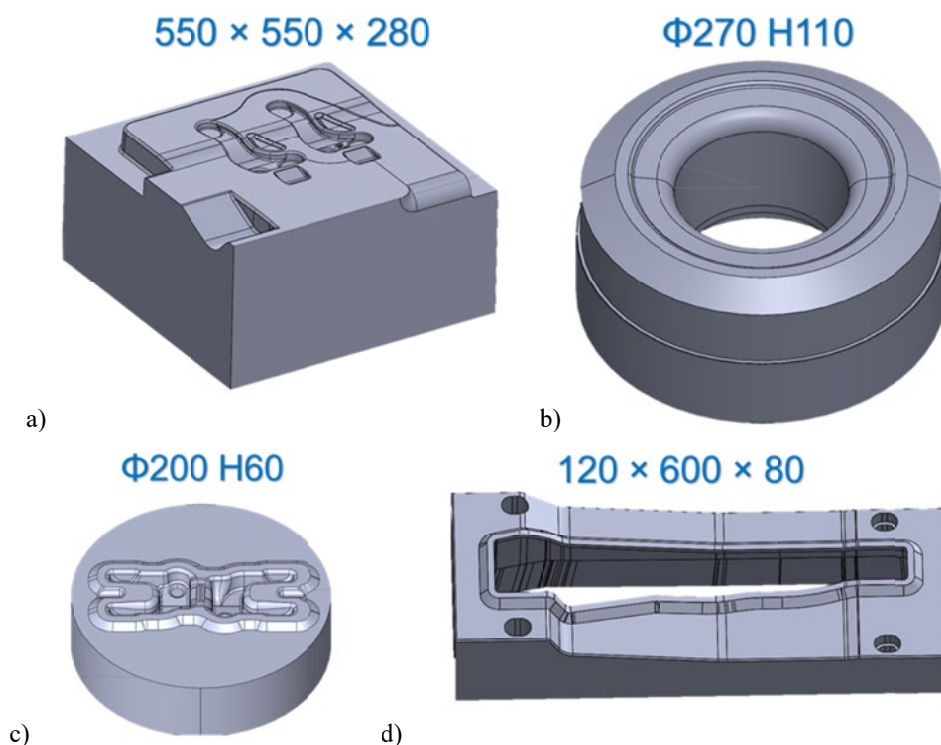
Fig. 1. Examples of forging tools: a) hammer forging die, b) axially symmetrical die insert, c) die insert with irregular cavity shape and d) trimming tool (dimensions given in millimeters)

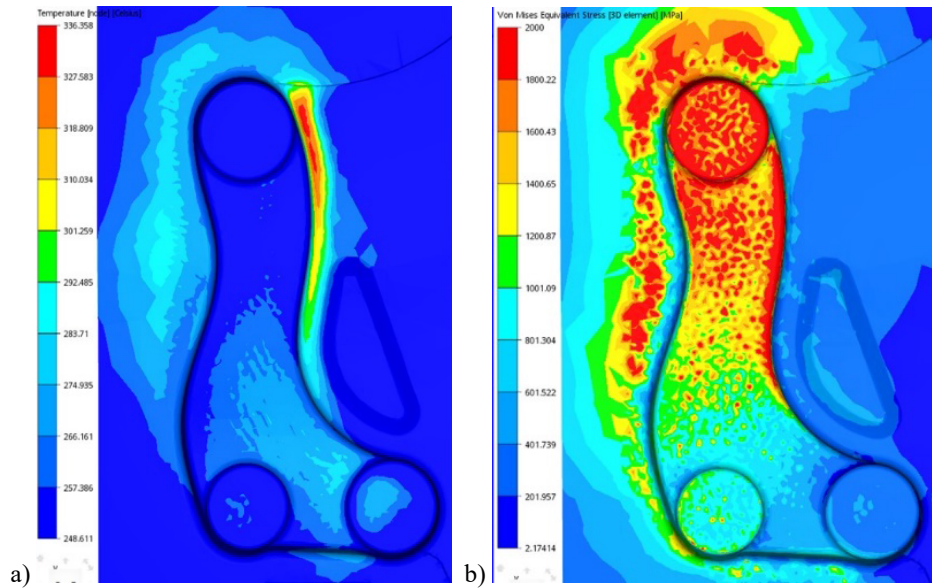
Fig. 2. Tool working conditions of the **hammer forging die** preliminary forging cavity determined by FEM: a) temperature, b) Huber-Mises reduced stress

temperature values on the surface and reduced stresses on the die surface) were determined based on the numerical model of the forging process, made in FORGE software. Fig. 2 presents selected results of this analysis.

As demonstrated, hammer forging tools work at a temperature up to 350°C and are exposed to high pressures. These conditions contribute to faster tool wear, which mainly occurs due to abrasive wear. Successive figures show the results of analysis of die wear in this process, where the die underwent 2411 forging cycles and was then withdrawn from operation. The die was made from 55NiCrMoV6 steel, which was hardened, heat-treated by hardening and double tempering in order to achieve a hardness of approx. 35-37 HRC (approx. 330-350 HV) throughout its entire volume. The tool was not subjected to surface treatment for improving its lifetime. Wear analysis was first conducted by scanning, where the scan before forging was compared to the scan after forging. This measurement made it possible to identify critical areas where the greatest wear occurred. Fig. 3a presents the results of wear analysis, and Fig. 3b indicates critical area X where wear was analyzed.

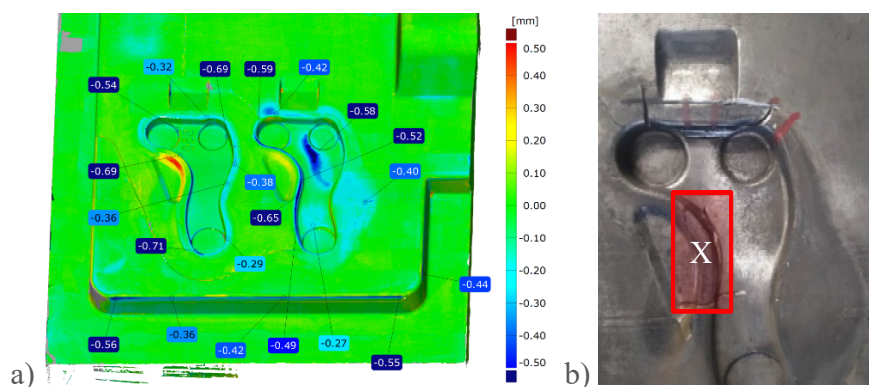
Fig. 3. Results of worn hammer forging die preliminary forging cavity surface analysis: a) comparison of scans of the tool's working surface before and after forging and b) site from which the sample was cut out for analysis

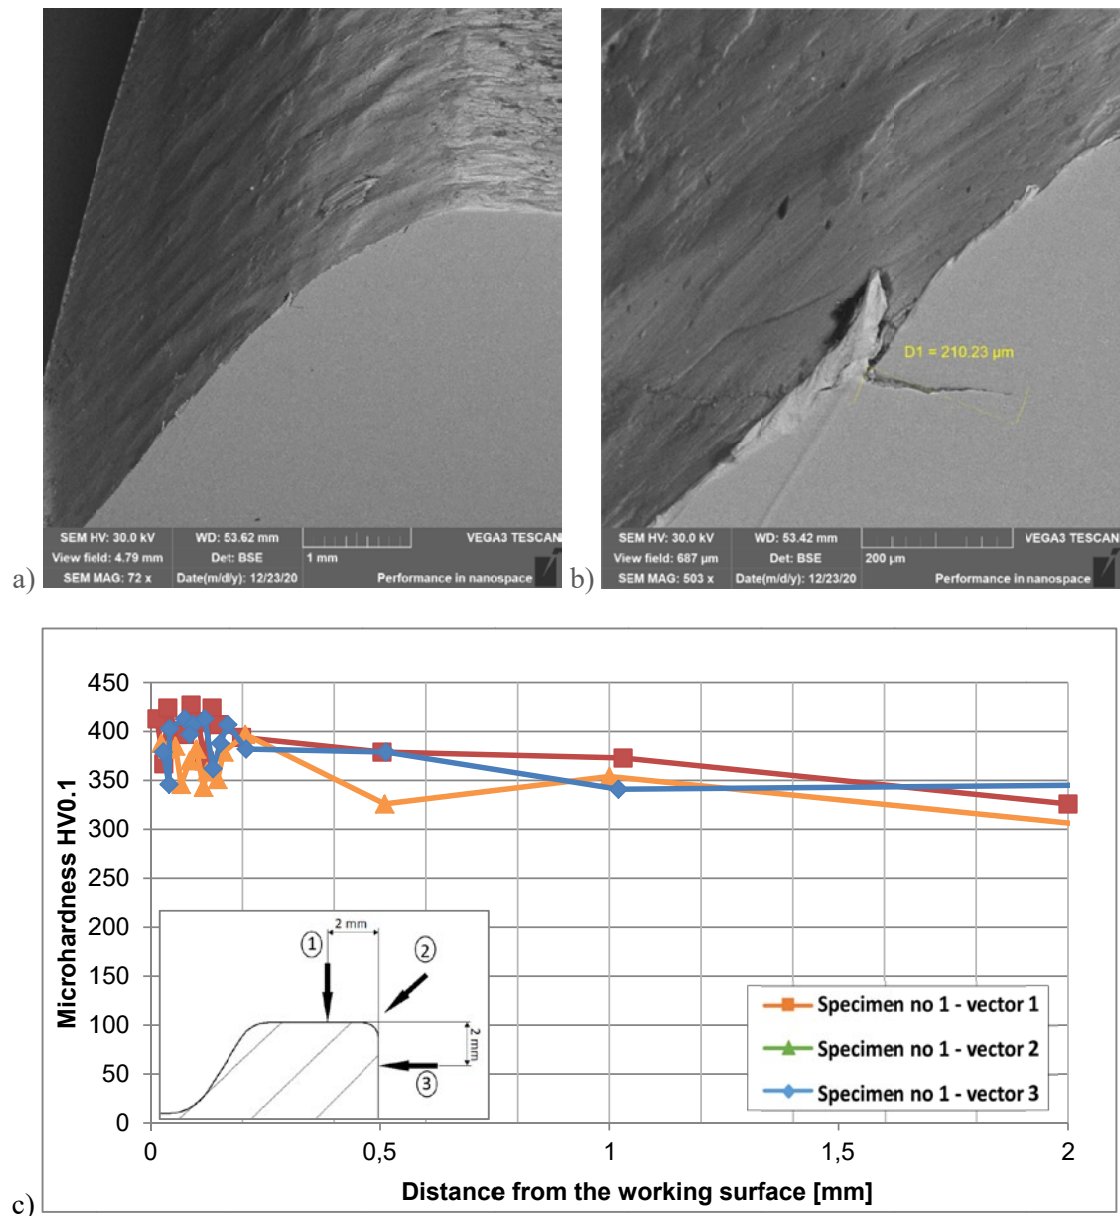
The effects of wear, i.e. cracks, abrasive furrows and oxides, were observed under a scanning electron microscope. In addition, microhardness was measured in the surface layer in order to determine whether tempering of the material occurred. The results of observations in area X are presented in Fig. 4.

The wear analysis results presented in Fig. 4 indicate the presence of abrasive wear, which causes removal of layers of the material from the die's surface. Tempering does not occur, since the temperature does not rise above 350°C, as previously demonstrated and confirmed by hardness measurement. Cyclically variable stresses cause the occurrence of cracks with a depth of approx. 200 μm, however, they are not dense and do not readily propagate into the die.

Fig. 4. Results of worn hammer forging die preliminary forging cavity analysis in cross-section: a) view of working surface in SEM, b) magnification of crack and measurement of its depth, c) results of microhardness measurement as a function of distance from the tool's working surface

- Hammer forging dies are exposed to temperatures in the range 200-400°C and are damaged by abrasive wear and fatigue cracking. It is recommended to use a material with a hardness of 40-45 HRC, e.g. Castolin DO*341, for their surfacing. The possibility of making a surfacing from this material has been confirmed.

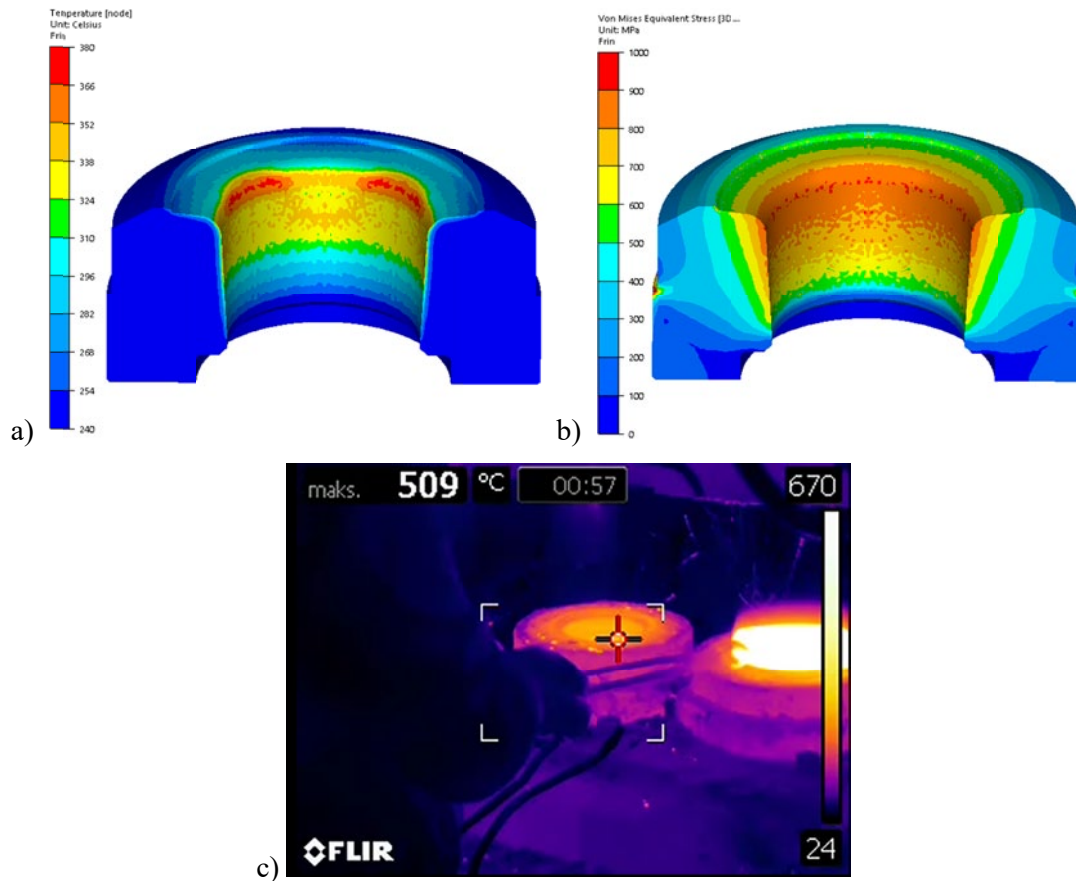
Die working conditions were analyzed on the lower forging die for preliminary forging, which is subjected to successive impacts in every forging cycle. These conditions (max. temperature values on the surface and reduced stresses on the die surface) were determined based on the numerical model of the forging process, made in FORGE software. Fig. 5 presents selected results of this analysis compared with the result of thermovision analysis.

As demonstrated, axially symmetrical forging tools work at a temperature up to 380°C and are exposed to high pressures. Thermovision examinations revealed that, in the forging process, the tool reaches an instant temperature even above 500°C . These conditions contribute to faster tool wear, which mainly occurs due to abrasive wear and tempering of the material. Successive figures show the results of analysis of die wear in this process, where the die underwent 11000 forging cycles and was then with-

Fig. 5. Tool working conditions of the preliminary forging die insert determined by FEM: a) temperature, b) Huber-Mises reduced stress and c) max. temperature measured by thermovision

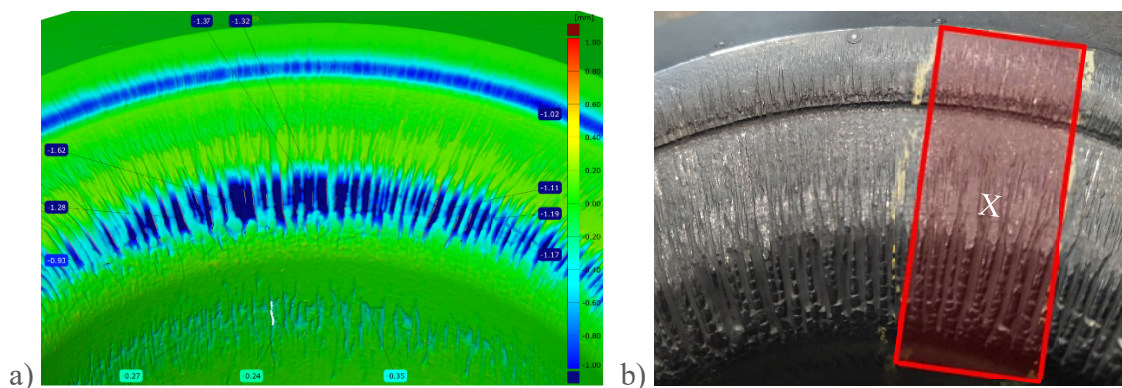
drawn from operation. The die was made from X37CrMoV5-1 steel, which was hardened, heat-treated by hardening and double tempering in order to achieve a hardness of approx. 45 HRC (approx. 450 HV) throughout its entire volume. The tool was not subjected to surface treatment for the purpose of improving its lifetime. Wear analysis was first conducted by scanning, where the scan before forging was compared to the scan after forging. This measurement made it possible to identify critical areas where the greatest wear occurred. Fig. 6a presents the results of wear analysis, and Fig. 6b indicates critical area X where wear was analyzed.

Fig. 6. Results of worn preliminary forging die insert surface analysis: a) comparison of scans of the tool's working surface before and after forging and b) site from which the sample was cut out for analysis

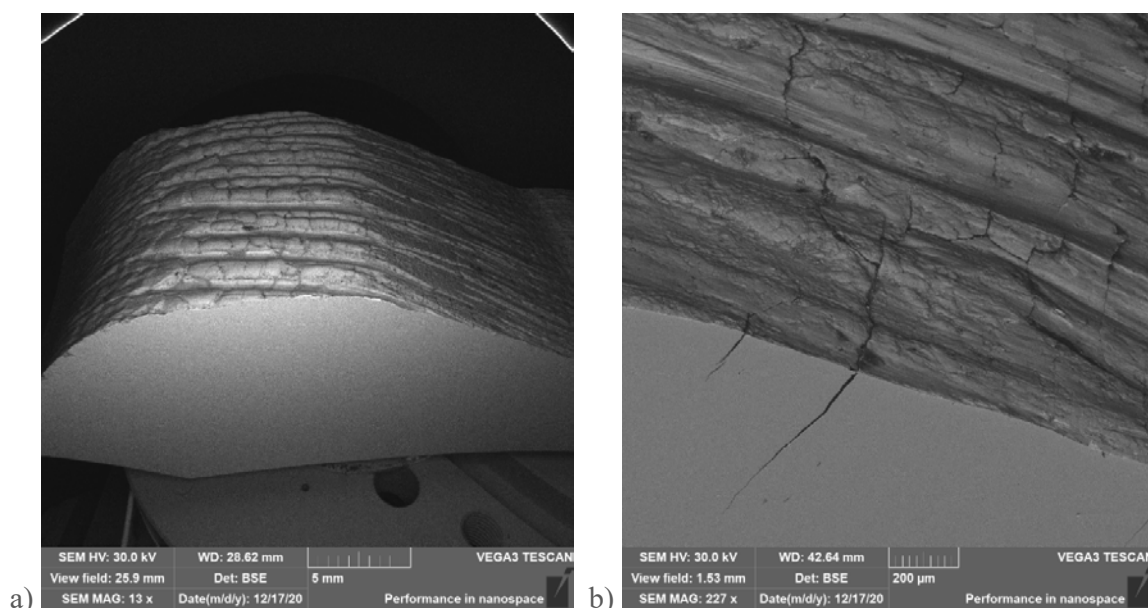
The effects of wear, i.e. cracks, abrasive furrows and oxides, were observed under a scanning electron microscope. In addition, microhardness was measured in the surface layer in order to determine whether tempering of the material occurred. The results of observations in area X are presented in Fig. 7.

The wear analysis results presented in Fig. 7 indicate the presence of abrasive wear, which causes removal of layers of the material from the die's surface. Tempering also occurs, since the temperature rises above 500°C in instants, as it was previously demonstrated in numerical modelling. Cyclically variable stresses cause the occurrence of cracks with a depth

Fig. 7. Results of worn preliminary forging die insert analysis in cross-section: a) view of working surface in SEM, b) magnification of crack and detailed view of die surface

of approx. 500 μm , which are dense and readily propagate into the die. This is why the cause of wear should be accepted to be abrasive wear, which is intensified by the action of the thermo-mechanical fatigue mechanism and tempering of the material's surface layer.

- Axially symmetrical insert dies are exposed to temperatures in the range of 400-600°C and are damaged by abrasive wear, thermomechanical fatigue and tempering. It is recommended to use a material with a hardness of 50-55 HRC, e.g. Castolin DO*360X, Eureka Alloys 852, UTPA702 for their surfacing. The possibility of surfacing with a similar material Castolin DO*04 has been confirmed.

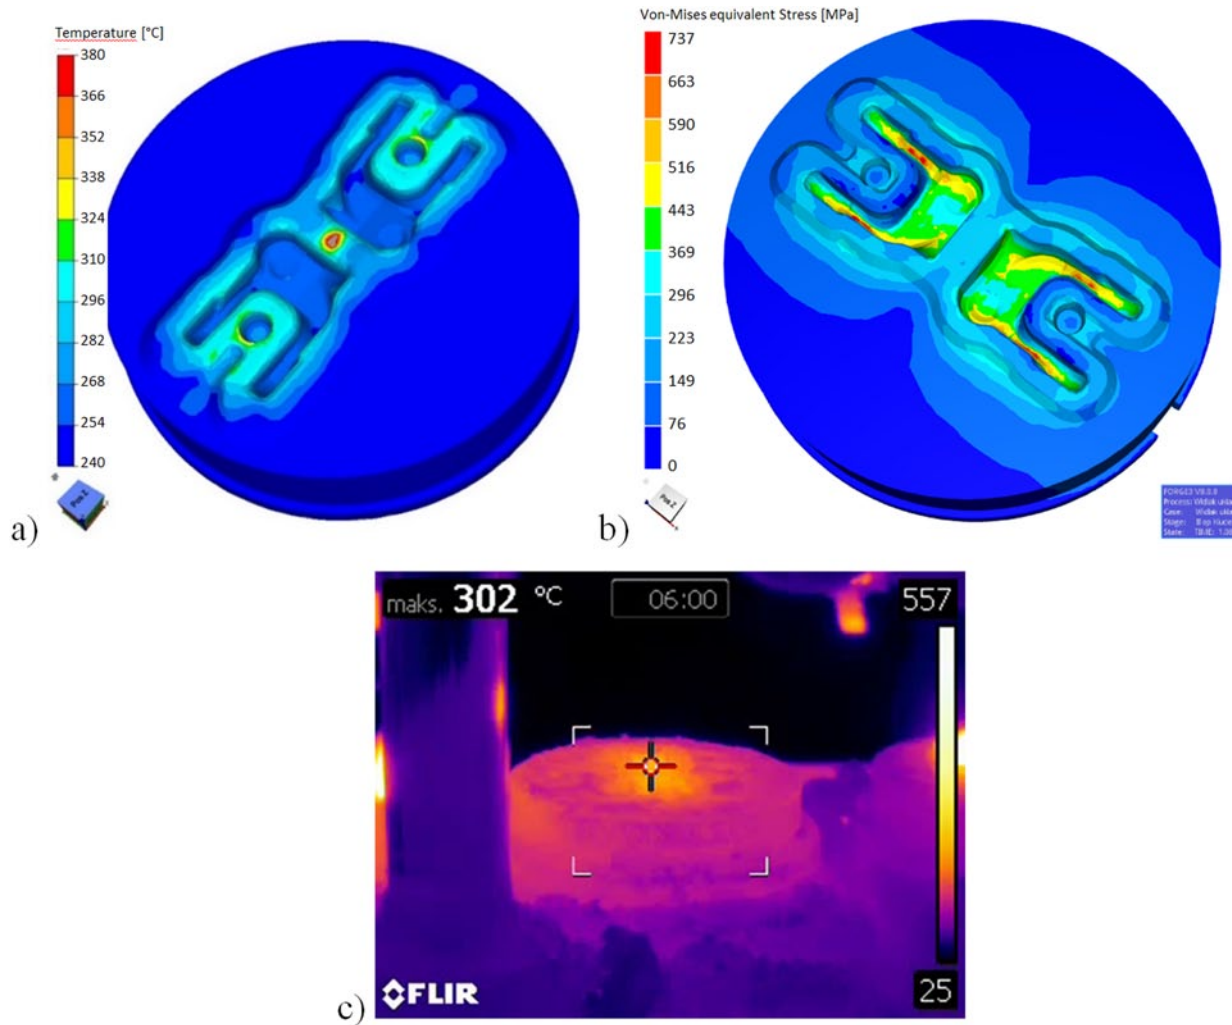
Die working conditions were analyzed on the lower forging die for preliminary forging, which is subjected to successive impacts in every forging cycle. These conditions (max. temperature values on the surface and reduced stresses on the die surface) were determined based on the numerical model of the forging process, made in FORGE software. Fig. 8 shows distribution of temperature and Huber-Mises reduced stress on the surface of the die's cavity.

As demonstrated, axially symmetrical forging tools work at a temperature up to 380°C and are exposed to high pressures. Thermovision examinations revealed that, in the forging process, the tool's temperature is about 300°C. These conditions contribute to rapid tool wear, which mainly occurs due to abrasive wear, and partially, tempering of the material. Successive figures show the results of analysis of die wear in this process, where the die underwent 7500 forging cycles and was then withdrawn from operation. The die was made from X40CrMoV5-1 steel, which was hardened, heat-treated by hardening and double tempering in order to achieve a hardness of approx. 50-52 HRC (approx. 500-550 HV) throughout its entire volume. The tool was not subjected to surface treatment for the purpose of improving its lifetime. Wear analysis was first conducted by scanning, where the scan before forging was compared to the scan after forging. This measurement made it possible to identify critical areas where the greatest wear occurred. Fig. 9a presents the results of wear analysis, and Fig. 9b indicates critical area X where wear was analyzed.

Fig. 8. Tool working conditions of the preliminary forging die insert determined by FEM: a) temperature, b) Huber-Mises reduced stress and c) max. temperature measured by thermovision

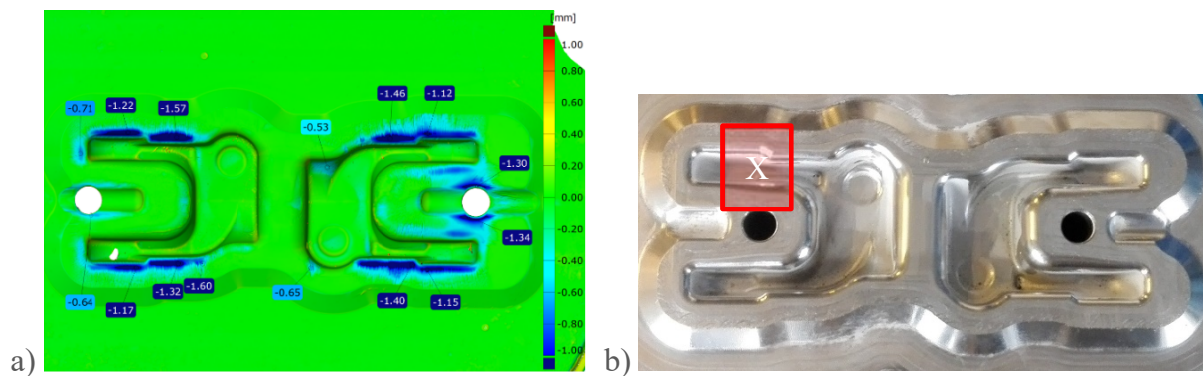
Fig. 9. Results of worn preliminary forging die insert surface analysis: a) comparison of scans of the tool's working surface before and after forging and b) site from which the sample was cut out for analysis

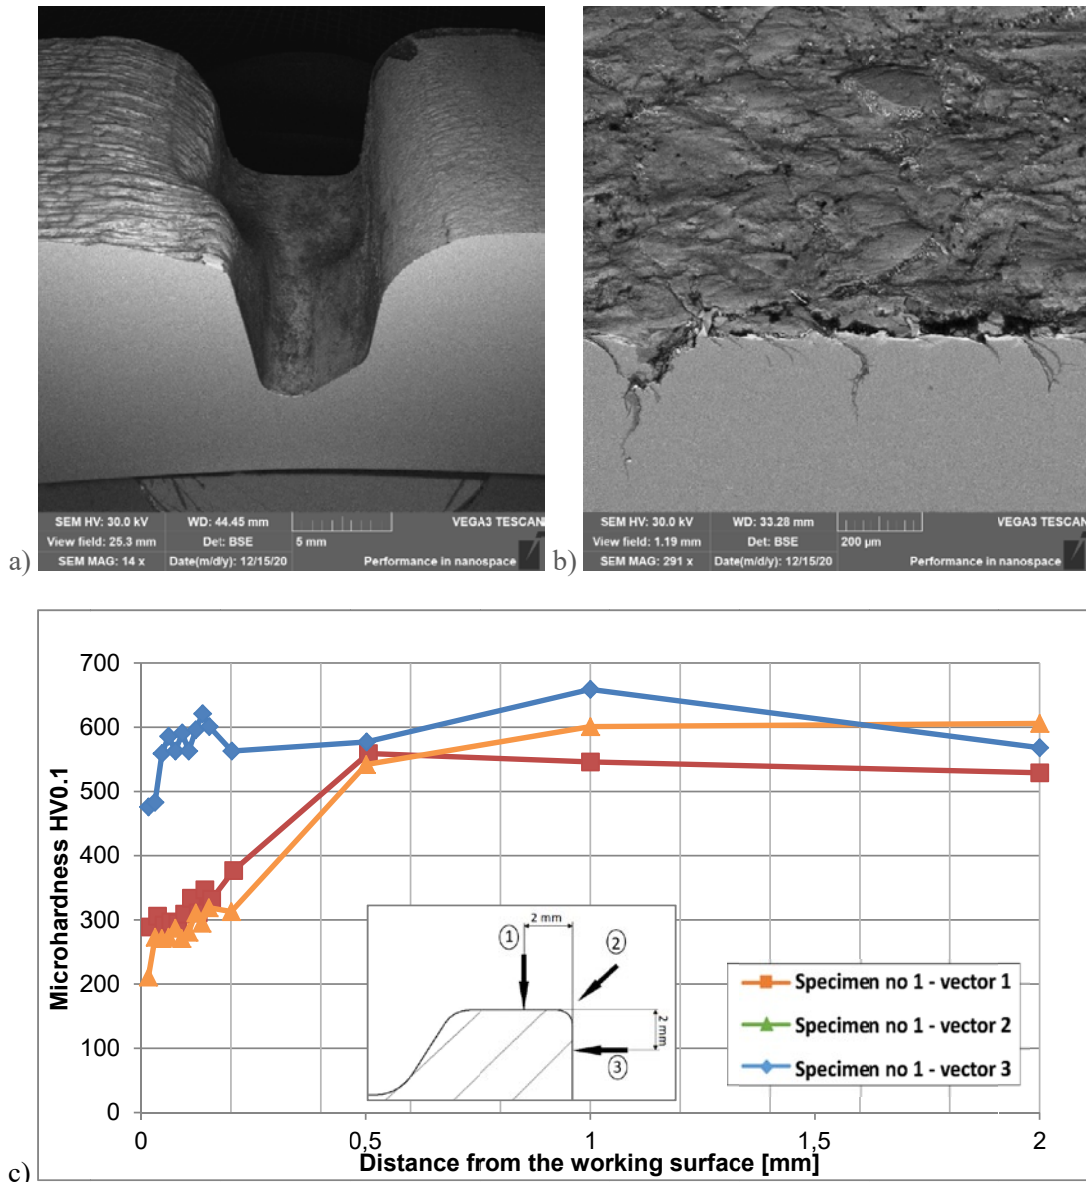
in order to determine whether tempering of the material occurred. The results of observations in area X are presented in Fig. 10.

The wear analysis results presented in Fig. 10 indicate the presence of abrasive wear, which causes removal of layers of the material from the die's surface. Tempering of the material also occurs, which may be caused by overheating in contact with the hot material of the forging and intensive friction. The

tempering effect is confirmed by the hardness measurement result (Fig. 10c). Cyclically variable stresses cause the occurrence of cracks with a depth of approx. 200-300 μm , which are dense and readily propagate into the die. This is why the cause of wear should be accepted to be abrasive wear, which is intensified by the action of the thermomechanical fatigue mechanism and tempering of the material's surface layer.

Fig. 10. Results of worn preliminary forging die insert analysis in cross-section: a) view of working surface in SEM, b) magnification of cracks and detailed view of die surface, c) results of microhardness measurement as a function of distance from the tool's working surface

- Die inserts with irregular cavity shape are exposed to temperatures in the range of 300-500°C and are damaged by abrasive wear, thermomechanical fatigue and tempering. It is recommended to use hard facing material with a hardness of 45-50 HRC, e.g. Castolin DO*04, Castolin DO*360X, Eureka Alloys 852 for their surfacing. The feasibility of hard facing with Castolin DO*04 has been confirmed.

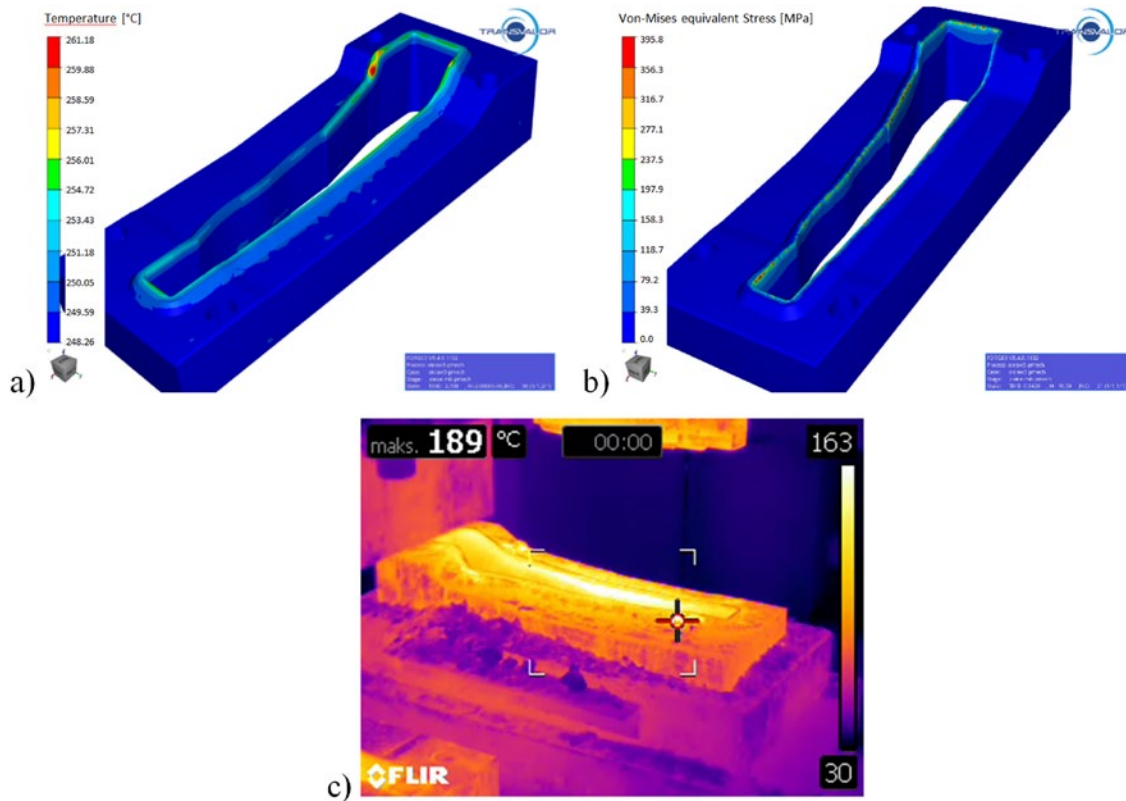
These conditions (max. temperature values on the surface and reduced stresses on the die surface) were determined based on the numerical model of the forging process, made in FORGE software. Fig. 11 shows distribution of temperature and Huber-Mises reduced stress on the surface of the tool's trimming edge.

As demonstrated, trimming tools work at a temperature up to 260°C and are exposed to relatively lower pressures. Thermovision examinations revealed that, in the forging process, the temperature of tools is about 200°C. It should therefore be presumed that these tools will work under conditions of the strong friction that occurs when flash is trimmed from the forging. These conditions contribute to rapid tool wear, which mainly occurs due to abrasive wear, without tempering of the material. Tools are not cooled, so the thermomechanical fatigue mechanism should not occur. Successive figures show the results of analysis of tool wear in this process, where the tool underwent 3000 forging cycles and was then withdrawn from operation. The trimmer

Fig. 11. Tool working conditions of the trimming tool determined by FEM: a) temperature, b) Huber-Mises reduced stress and c) max. temperature measured by thermovision

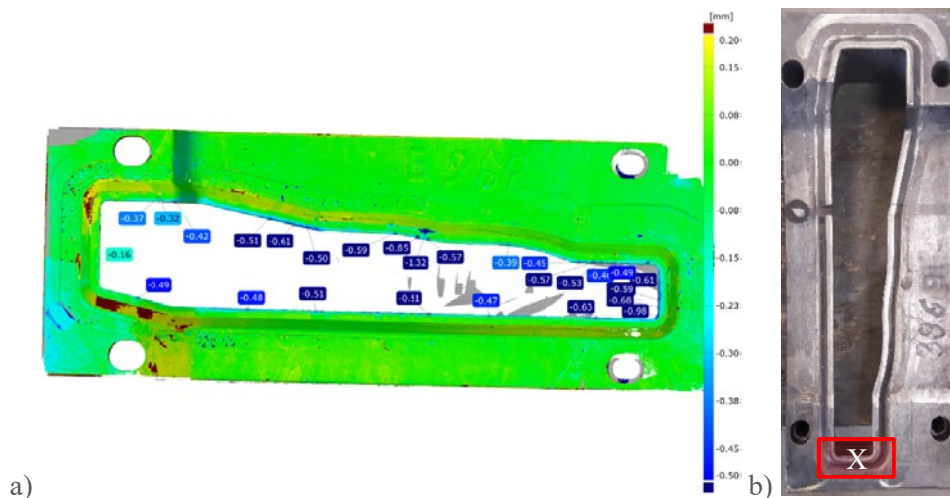
was made from X37CrMoV5-1 steel, which was hardened, heat-treated by hardening and double tempering in order to achieve a hardness of approx. 50 HRC (approx. 500 HV) throughout its entire volume. The tool was not subjected to surface treatment for the purpose of improving its lifetime. Wear analysis was first conducted by scanning, where the scan before trimming was compared to the scan after trimming. This measurement made it possible to identify critical areas where the greatest wear occurred. Fig. 12a presents the results of wear analysis, and Fig. 12b indicates critical area X where wear was analyzed.

Fig. 12. Results of worn trimming tool surface analysis: a) comparison of scans of the tool's working surface before and after trimming and b) site from which the sample was cut out for analysis

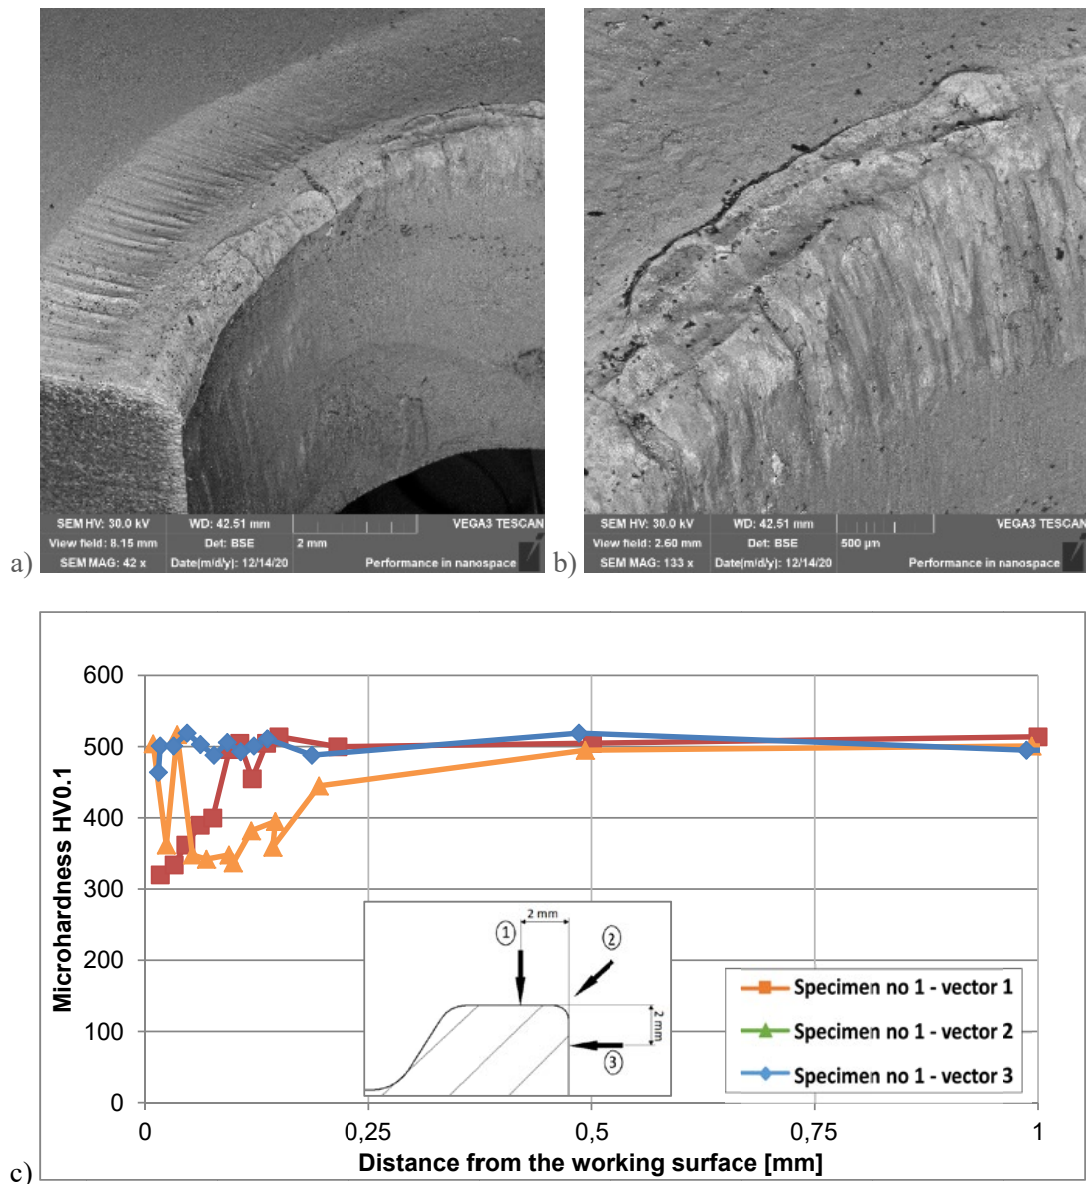
The effects of wear, i.e. cracks, abrasive furrows and oxides, were observed under a scanning electron microscope. In addition, microhardness was measured in the surface layer in order to determine whether tempering of the material occurred. The results of observations in area X are presented in Fig. 13.

The wear analysis results presented in Fig. 13 indicate the presence of abrasive wear, which causes removal of layers of the material from the die's surface. Tempering of the material also occurs, which may be caused by overheating in contact with the hot material of the forging and intensive friction. The

Fig. 13. Results of worn trimming tool analysis in cross-section: a) view of working surface in SEM, b) magnification of cracks and detailed view of die surface, c) results of microhardness measurement as a function of distance from the tool's working surface

tempering effect is confirmed by the hardness measurement result (Fig. 13c). Not too many cracks were observed. This is why the cause of wear should be accepted to be abrasive wear, which is intensified by tempering of the material's surface layer.

- Trimming tools are exposed to temperatures between 150-300°C and are subject to abrasive wear and tempering damage. It is recommended to use a hardness grade 50-60 HRC, e.g. Castolin DO*15 for their surfacing. The feasibility of surfacing with this material has been confirmed.

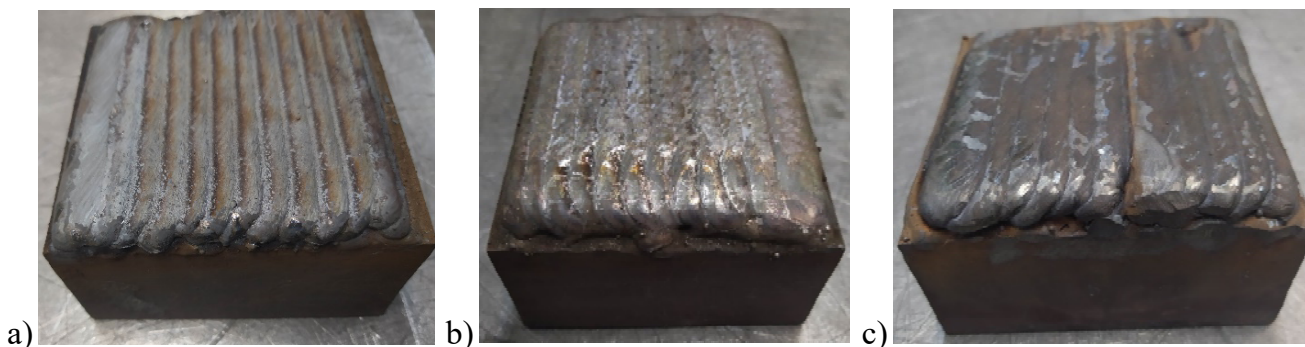
Subsequently, the metallographic specimens were made and the microstructure of the welds was observed. Similarly, the microhardness and approximate chemical composition of the welds were also studied. The Fig. 14 shows photographs of samples after the surfacing process.

Fig. 14. Photographs of samples after the surfacing process: a) DO*341, b) DO*04, c) DO*15

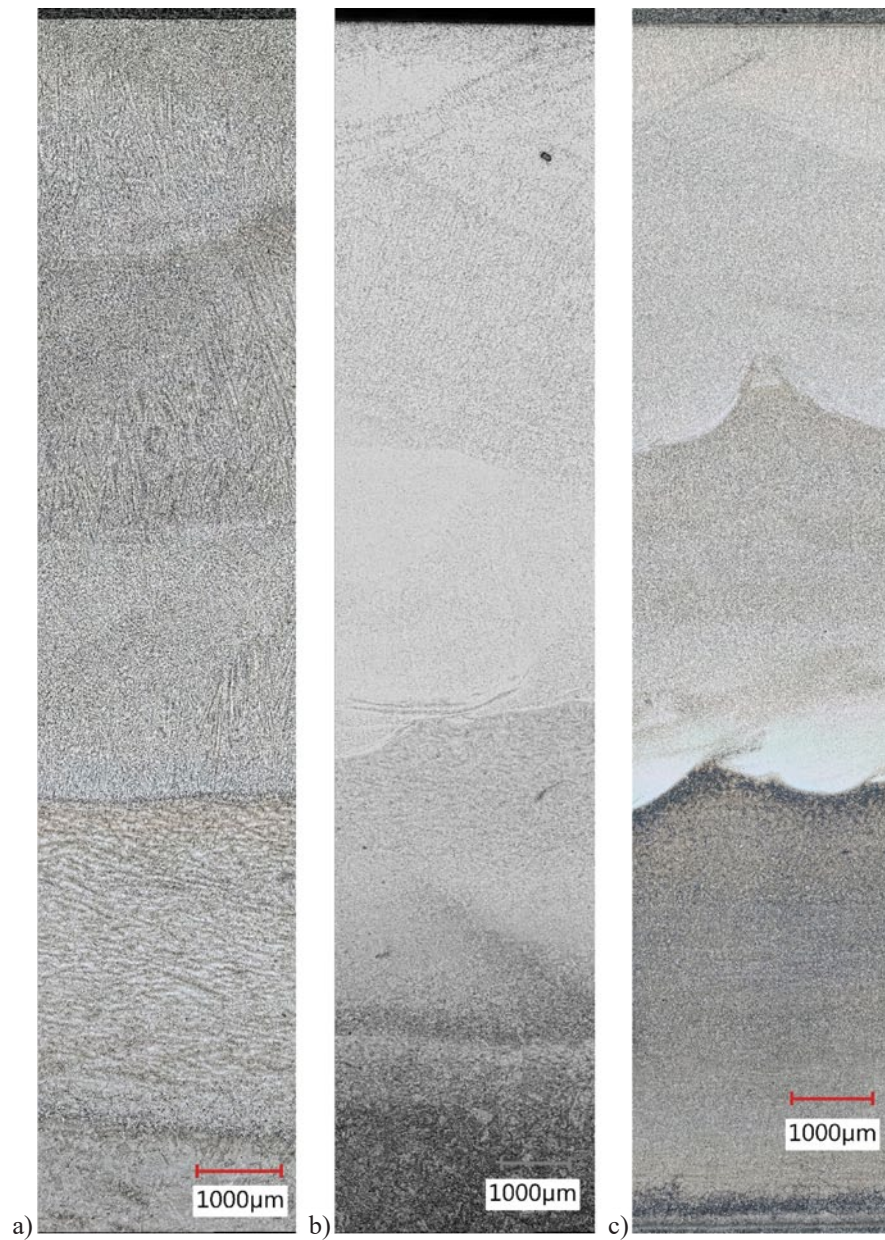
The samples were planed on the surface and then cut transversely to the direction of surfacing. The microstructure of the surfacing layer was observed in this section. Selected results of these observations are shown in Fig. 15.

The results of the microstructure observations confirm the homogeneous structure of the deposited layers containing HAZ,

the mixed zone and 3 layers of deposited cladding. The layers are characterised by high metallurgical purity, good fusion both with the base material and between the individual welded layers. No welding imperfections such as blisters or cracks were observed.

The layer of hardfacing material obtained on DO*04 wire is characterised by high metallurgical purity, good penetration into both the base material and the individual welded layers. No welding imperfections such as blisters, non-metallic inclusions or cracks were observed. The weld deposited layer contains columnar grains, perpendicular to the fusion line, with a dendritic structure. In the top layer of the deposit, the structure consists of austenite with small amounts of chromium and molybdenum carbides and a small amount of martensite.

In the DO*15, the structure is similar to that of DO*341, but with a higher content of carbides, which has an influence on the higher secondary hardness of the deposit.

Fig. 15. Microstructure test results of samples made of a) DO*341, b) DO*04, c) DO*15

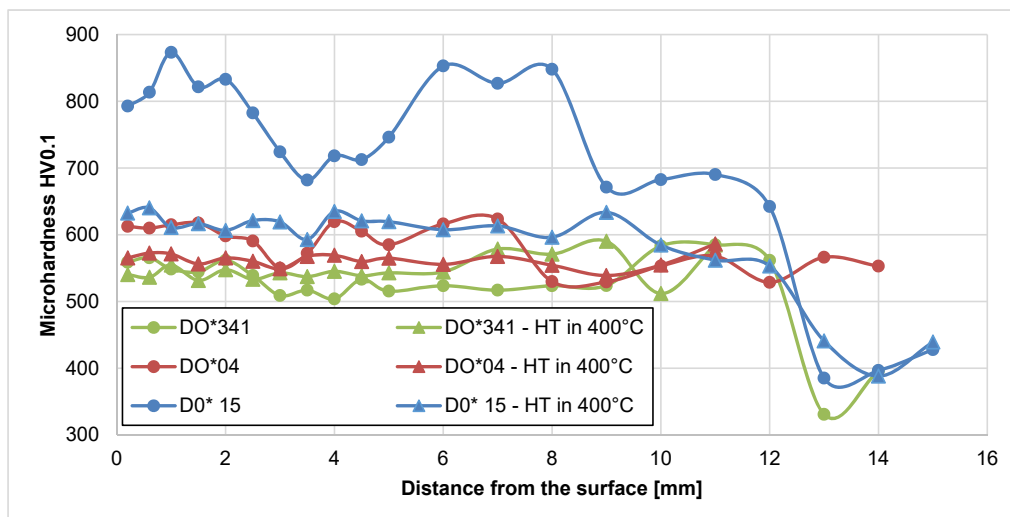
The next stage of the research was the measurement of the microhardness of the obtained welds. Fig. 16 shows the results of these tests.

Fig. 16. Results of the microhardness test of deposited layers
