TECHNOLOGY OF WELDING JOINTS MIXED WITH DUPLEX STEEL

Results of the examinations of sample plates of mixed joints with the duplex steel were discussed. Examinations were taken on the sample plates of mixed joints of sheet plates type P355NL1 and X2CrNiMoN22-5-3 welded by the flux-cored wire DW-329A by the Kobelco company of the following category T 22 9 3 NL RC/M3 in the gas shroud M21 (Ar+18%CO₂) (plate no.1), and nickel covered electrodes E Ni 6082 by the Böhler company (plate no. 2). Results of the side bend test of welded joint, transverse tensile test, stretching of the weld metal, impact strength, micro and macroscopic metallographic examinations, and measurements of the delta ferrite content were presented.

Keywords: welding, duplex steel, mixed joints

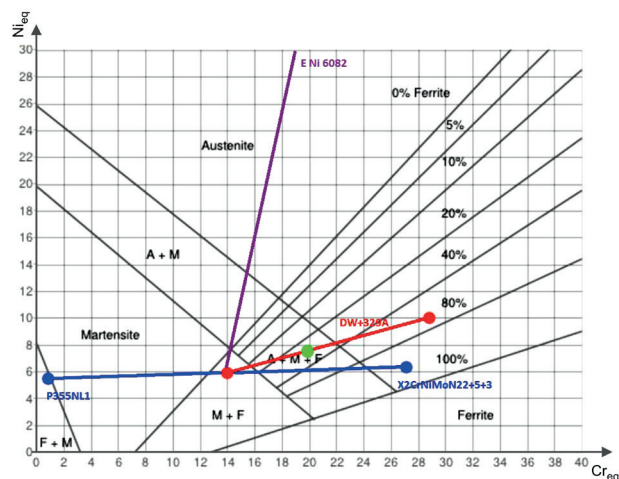
Fig. 1 The Schaeffler's diagram [17]

On the base of a chemical composition of both metal sheets and used filler materials, expected structures of the welds' materials made during processes were specified. The Schaeffler's diagram was used to illustrate it. (Fig. 1)

After calculating an equivalent of chromium and nickel (formula 1, 2) and applying the results to the diagram, following data was obtained:

- an austenite-ferrite-martensite mixed structure with an approximate value of ferrite 10% by using a flux-cored duplex wire.
- a diagram does not cover in its range material of such high content of nickel (clearly shows a plain austenite structure) by using nickel covered electrodes

It is necessary to point that the Schaeffler's diagram relates to the constant cooling conditions of the weld, thus a real result

may considerably differ. Above differences result from the dynamics of a welding process, and particularly an influence of heat which is difficult to predict, and the foremost conditions of cooling the weld [8-11].

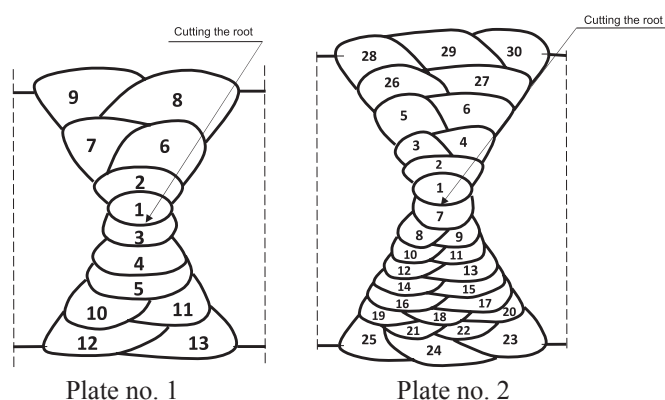
Fig. 2. An order of applying beads

An order of applying beads is presented in the picture 2, while the real parameters obtained during the process of welding are included in the table 6.

Used parameters allowed to obtain a proper amount of inserted heat (linear energy ranges from 0,3 to 1,7 kJ/mm), does not exceed recommended values (maximum value of a linear energy is 2,5 kJ/mm).

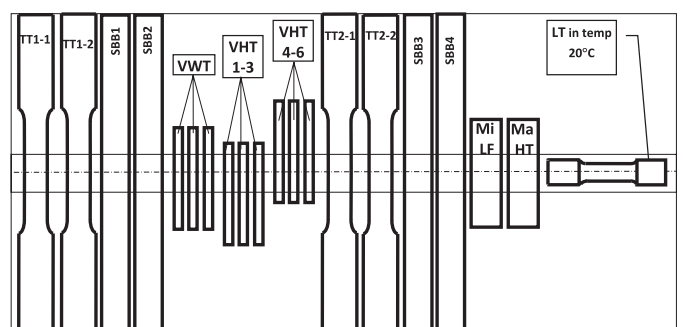
Fig. 3. Places of collecting samples from the sample plates. TT – tension-torsion, SBB – surface band bending, Mi – micro, Ma – macro, VWT, VHT – notch impact value, HT – hardness testing, LF – ferrite number, LT – tension of weld metal [15,22]

A way of collecting samples according to the PN-EN ISO 15614-1 is depicted in the picture 3.

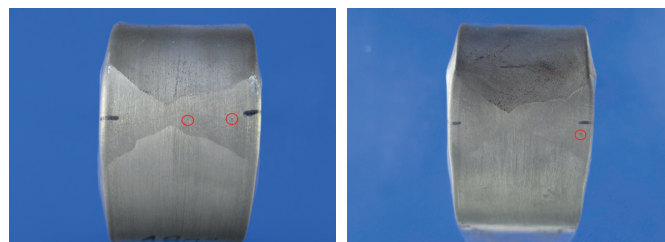
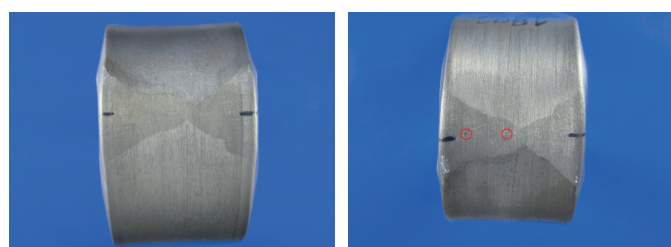
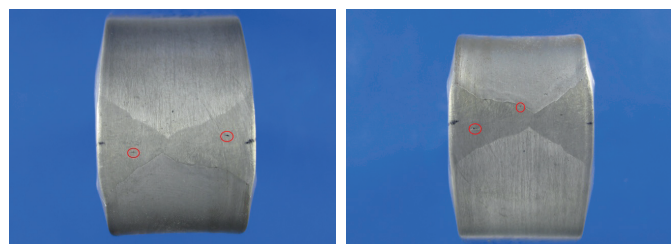
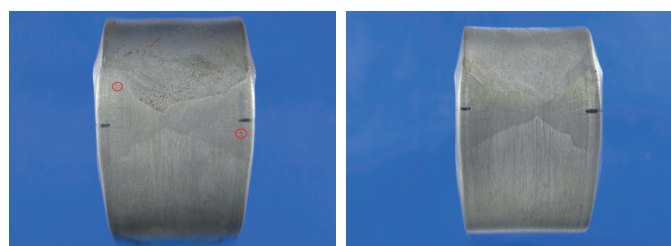
Fig. 5 Pictures of the samples after side bend

SBB4 – Plate 1 – 136 SBB4– Plate 2 – 111

Bending tests did not reveal any discrepancies in the base materials, welds and heat-affected zones. In case of both sample plates there appeared only slight cracks, which do not disqualify the joint. A result of an examination was positive (table 8, Fig. 5)

SBB1 – Plate 1 – 136 SBB1 – Plate 2 – 111

SBB2 – Plate 1 – 136 SBB2 – Plate 2 – 111

SBB3 – Plate 1 – 136 SBB3 – Plate 2 – 111

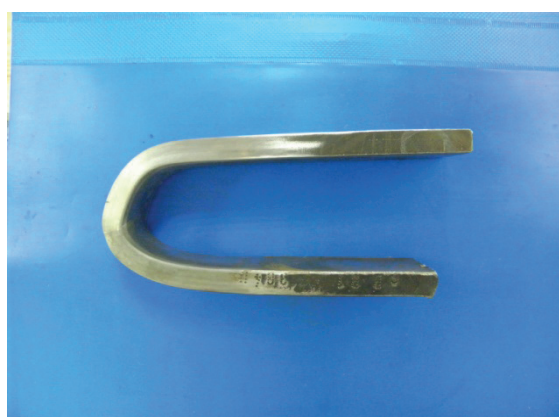
Fig. 6. A phenomena of non-axial deformation of bent samples

It is vital to point that PN-EN ISO 15614-1 standard allows to use 2 tests of bending longitudinal samples instead of 4 tests of side bend in case of mixed joints. It is done to avoid a problem of non-axial deformation of samples during examination, which is caused by too high difference of a resistance and plasticity of both materials. It was observed in the above experiment (Fig. 6). Above test was done in order to examine the joint in difficult technological conditions, therefore more risky 4 side bends were made [15, 18, 22].

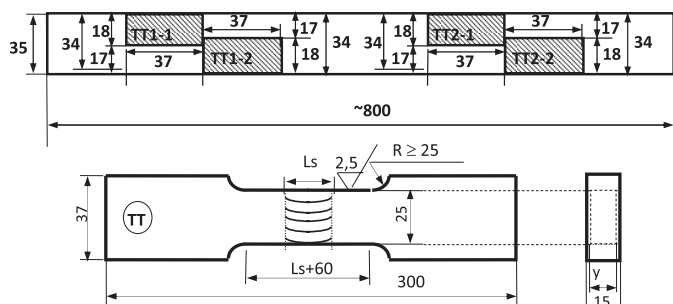
Fig. 7. A way of taking and preparing samples for tension [23]

Transverse tensile test was done on four samples prepared according to the picture 7 in the room temperature in accordance with the PN-EN ISO 4136 standard. Sizes of the samples were fixed to the possibilities of the tensile testing machine of 400kN power. Taking into account a high tensile

strength of the duplex steel, it was necessary to take two samples from the joint. A minimum criteria for the joint was equal to 470MPa [23].

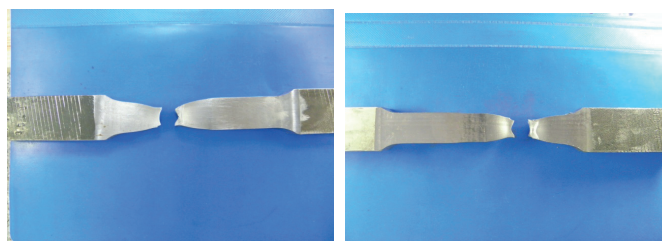
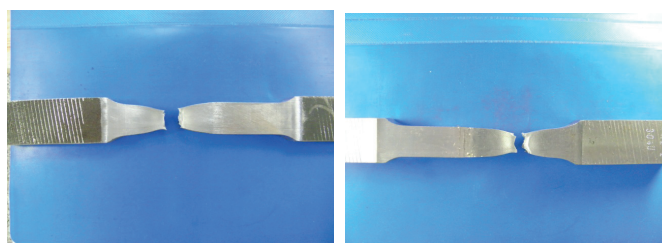
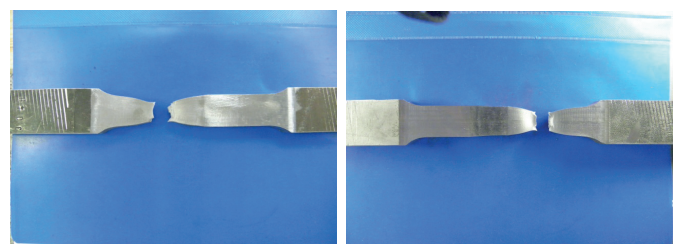
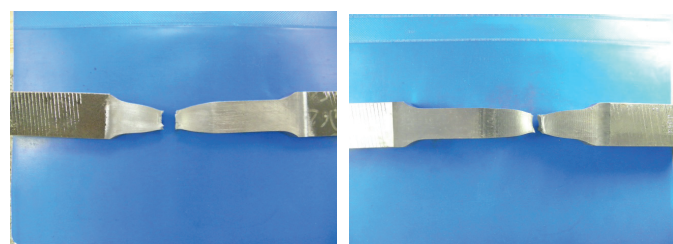
Fig. 8. Pictures of the samples after transverse tensile

TT2 – 1 – Plate 1 – 136 TT2 – 1 – Plate 2 - 111

TT2 – 2 – Plate 1 – 136 TT2 – 2 – Plate 2 - 111

TT1 – 1 – Plate 1 – 136 TT1 – 1 – Plate 2 - 111

TT1 – 2 – Plate 1 – 136 TT1 – 2 – Plate 2 - 111

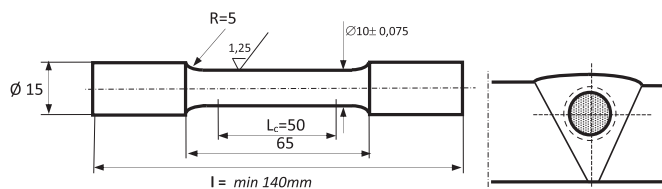
Fig. 9. A way of taking and preparing a sample to stretch the weld metal. [26]

Weld metal tensile test was done according to the PN-EN ISO 876 standard in order to measure tensile strength of the same weld. A way of preparing a sample presents picture 9 [13].

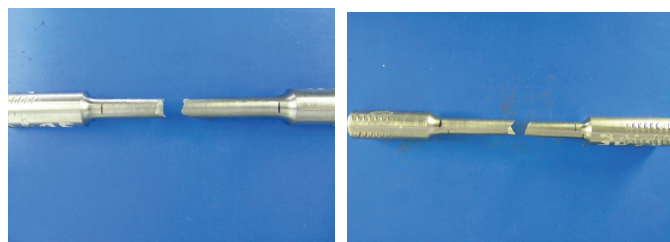
Fig. 10 Pictures of the samples after tension of the weld metal

LT – 1 – Plate 1 – 136

LT – 1 – Plate 2 – 111

Except of measuring tensile strength of the weld, there was also a measurement of elongation A5, and the

limit of plasticity. An examination was taken in the room temperature. Following criteria were taken into account: $R_e \geq 315\text{MPa}$, $A \geq 21\%$, $R_m \geq 470\text{MPa}$ (table 10) [26]. Higher resistance and plasticity values were obtained in case of the plate no. 2, which is the result of using nickel based electrodes.

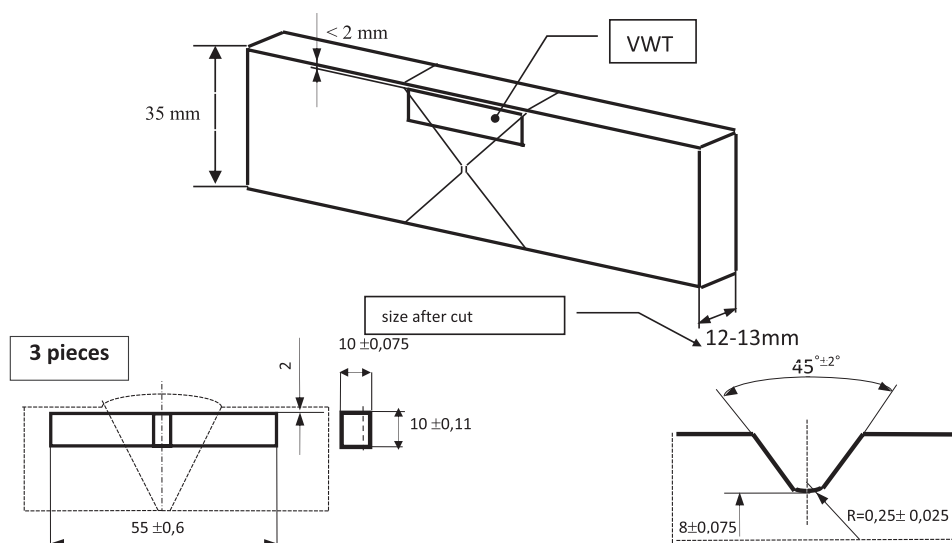
Fig. 11. A way of preparing samples taken from the weld to the impact strength tests [14]

Due to the mixed connection, except of a standard three-set samples taken from the weld and three from heat-affected zones, an additional set was used from the heat-affected zone of the second material. Recommendations from PN-EN ISO 9016 and PN-EN ISO 148-1 standards were used. Pictures 11 and 12 depict a way of taking each set. An examination was

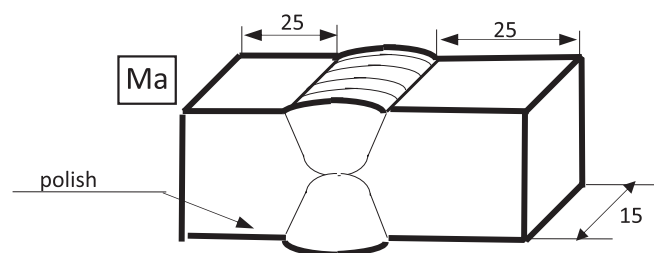
Fig. 14. A way of preparing a metallographic specimen [10]

Macroscopic examination was taken according to PN-EN 1321 standard on a previously taken and etched metallographic specimen (fig. 14). Adler's solution was used to etch. [20]

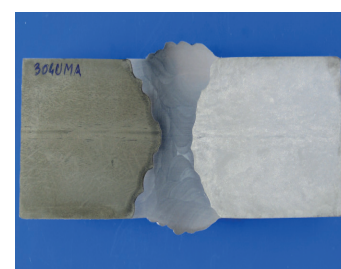
Fig. 15. Macroscopic pictures of plates

Macroscopic examination did not reveal any of unaccepted discrepancies in the section of examined plates (fig. 15)

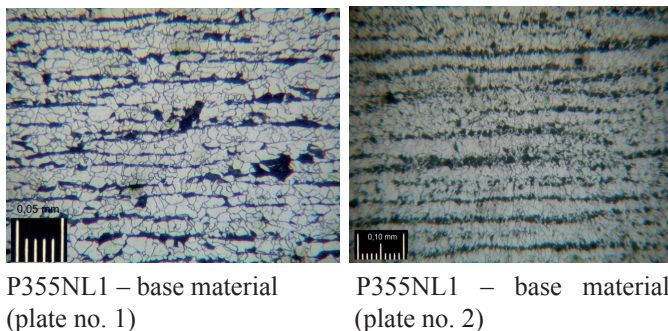
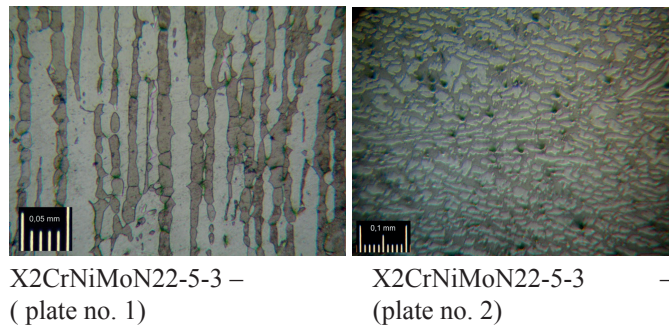
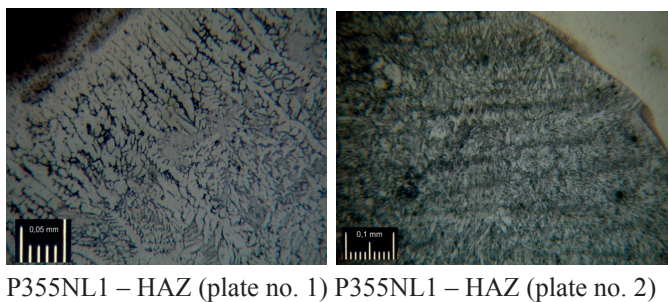
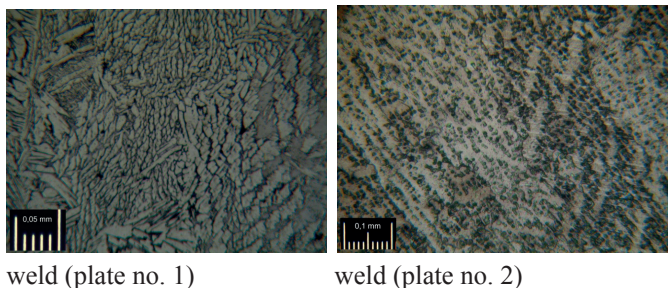
Fig. 16. Microscopic pictures of plates

Microscopic images were taken on the metallographic specimen etched by the agent consisting of nital and Mi20Fe (fig. 16). Zoom 200:1 was used. An examination was taken according to the PN-EN 1321 standard [20]

A structure of a heat-affected zone on the side of the duplex steel in case of the plate no. 1 includes about 40-50% ferrite. The weld indicates a ferrite-austenite structure with a required share of ferrite i.e. 30-70%

Microscopic examination in case of the plate no. 2 does not reveal any microcracks or other discrepancies. It was stated that the base material on the side of the carbon steel has a ferrite-pearlite structure, and on the side of the duplex steel has a ferrite-austenite structure with a ferrite content of about 45%. The weld is characterised by the ferrite-austenite structure of grown austenite grains with a ferrite content not exceeding a value of 85% near the weld line (fig. 16).

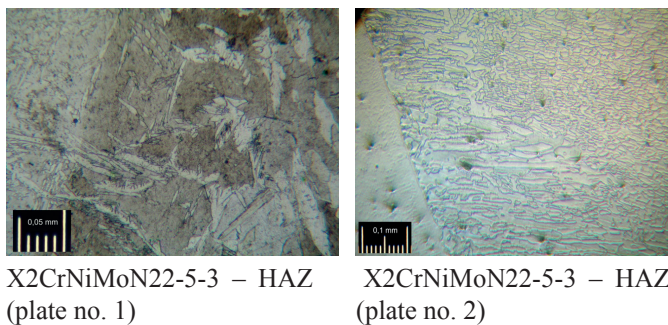
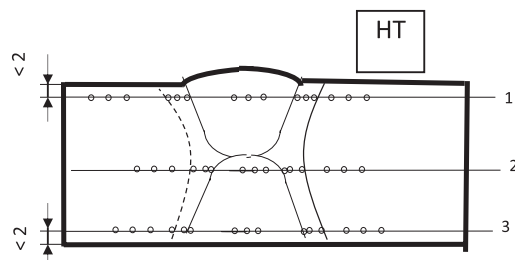
Fig. 17. A way of doing a hardness test [19]

Hardness test by the Vickers method was done on the metallographic specimen, previously used in the macroscopic examination. Hardness test was done according to the PN-EN ISO 9015-1 standard along specified measurement lines (fig. 17). Vickers testing device was used 430 SVD with the load of HV10 [19].

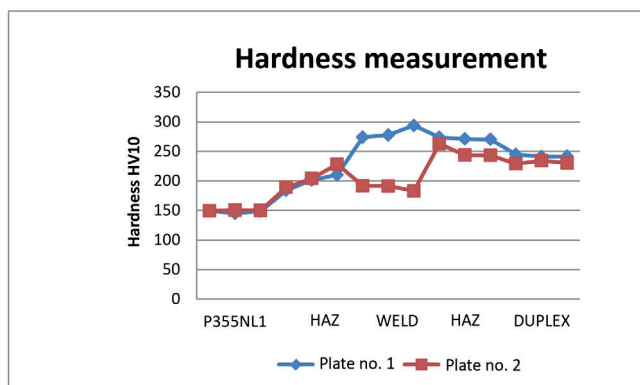
Fig. 18. Results of the hardness measurement

Results of the hardness tests are depicted in the picture 18

In case of the plate no. 1, the lowest hardness was stated inside the P355NL1 metal sheet, its value is much higher in the duplex steel, and definitely the highest in the weld (table 12, 13). Hardness of both base materials plate no. 2 is very close to the measurement of the plate no. 1, whereas in case of the weld much lower hardness was observed in the joint made by the nickel based electrodes. It is caused by the high plastic properties of mentioned electrodes.

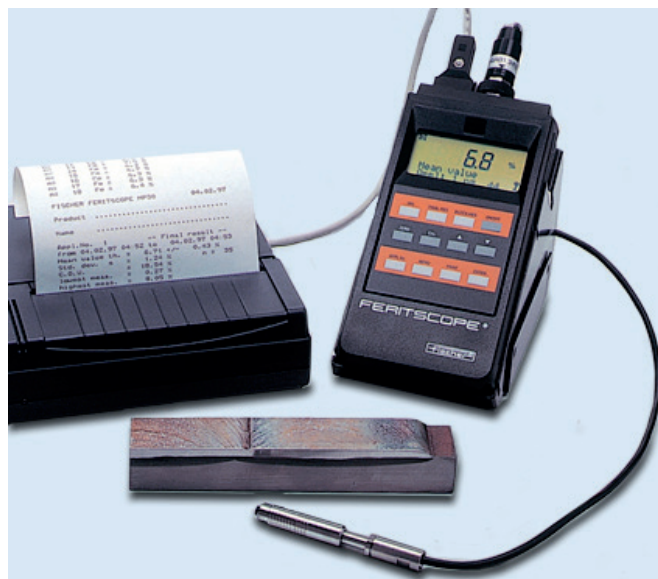
Fig. 19. The Fisher MP 30E-S Feritscope

Examining a content of delta ferrite was taken according to the PN-EN ISO 8249 standard by the Fischer MP 30E-S Feritscope (fig. 19) on the previously used for an examination a metallographic specimen. Measurements refer an area of the weld, the duplex steel, and the black steel [21].
